## Profile/Photo Observation Report

Street:	<b>LAURA LN</b>	Flow Control:	<b>Not Controlled</b>
City:	<b>Hobart, IN</b>	Year Renewed:	
Location:	<b>Yard</b>	Tape/Media #:	
Purpose:	<b>Routine Assessment</b>	Dia/Height:	<b>8"</b>
Use:	<b>Sanitary</b>	Material:	<b>PVC</b>
Drain Area:	<b>NA</b>	Lining:	
Category:	<b>NA</b>		
Comment:	<b>Flow direction marked wrong.</b>

Location Details:		Direction of Survey:	<b>Upstream</b>
US MH:	<b>M-607-024</b>	DS MH:	<b>M-607-029</b>
		Total Length Surveyed (ft):	<b>147.1</b>

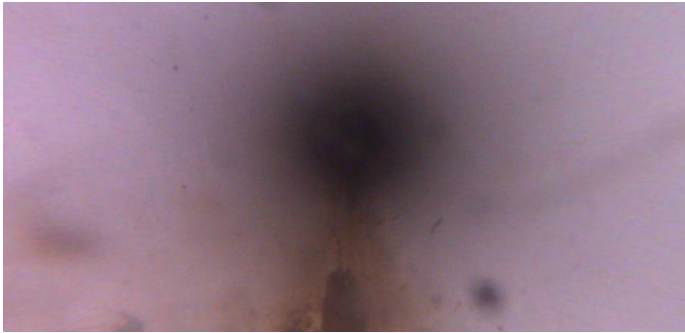
Code:	<b>MWL</b>
Description:	<b>Water Level</b>

Distance (ft):	<b>.0</b>
Structural Grade:	<b>0</b>
O&M Grade:	<b>0</b>
Clock Start/From:	
Clock To:	
1st Value:	
2nd Value:	
Value Percent:	<b>5.000</b>
Continuous Index:	
Within 8" of Joint:	<b>NO</b>
Remarks:

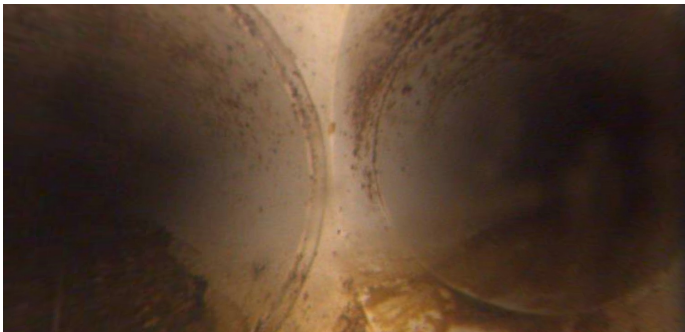
Code:	<b>TF</b>
Description:	<b>Tap Factory</b>

Distance (ft):	<b>69.4</b>
Structural Grade:	<b>0</b>
O&M Grade:	<b>0</b>
Clock Start/From:	<b>9</b>
Clock To:	
1st Value:	<b>4.000</b>
2nd Value:	
Value Percent:	
Continuous Index:	
Within 8" of Joint:	
Remarks:

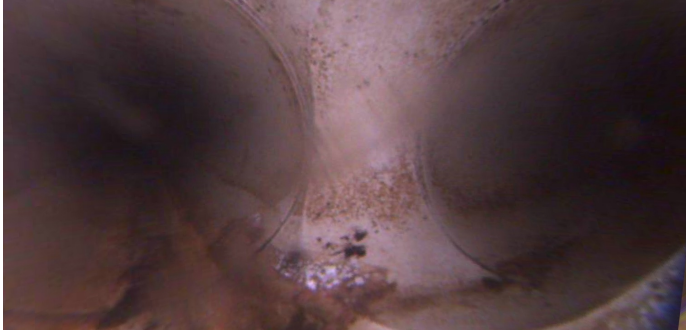
Code: **TF**  
Description: **Tap Factory**

Distance (ft): **82.4**  
Structural Grade: **0**  
O&M Grade: **0**  
Clock Start/From: **3**  
Clock To:  
1st Value: **4.000**  
2nd Value:  
Value Percent:  
Continuous Index:  
Within 8" of Joint:  
Remarks:

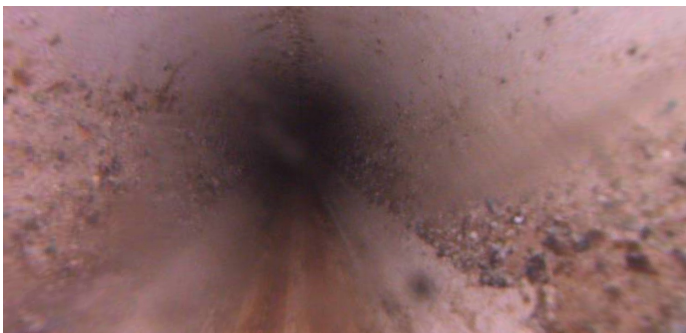
Code: **DAGS**  
Description: **Deposits Attached Grease**

Distance (ft): **134.9**  
Structural Grade: **0**  
O&M Grade: **2**  
Clock Start/From: **8**  
Clock To: **4**  
1st Value:  
2nd Value:  
Value Percent: **5.000**  
Continuous Index: **S01**  
Within 8" of Joint: **NO**  
Remarks:

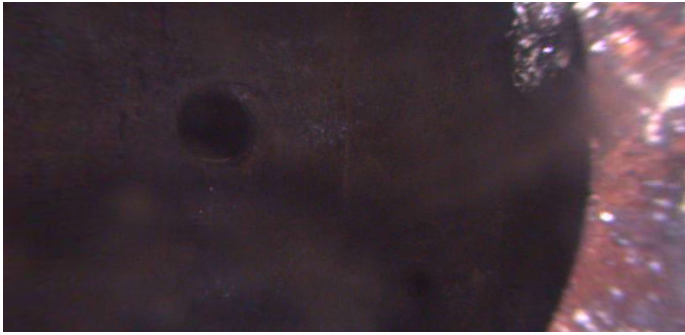
Code: **DAGS**  
Description: **Deposits Attached Grease**

Distance (ft): **146.3**  
Structural Grade: **0**  
O&M Grade: **2**  
Clock Start/From: **8**  
Clock To: **4**  
1st Value:  
2nd Value:  
Value Percent: **5.000**  
Continuous Index: **F01**  
Within 8" of Joint: **NO**  
Remarks:

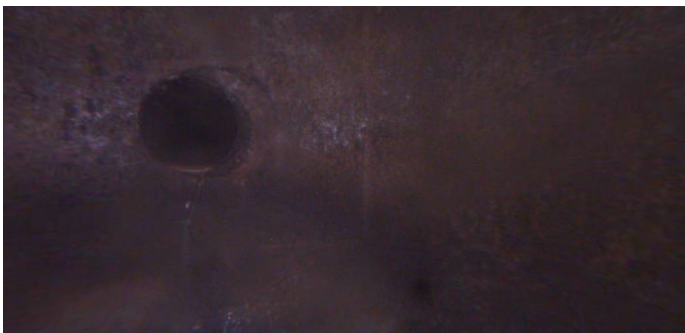
Code: **AMH**  
Description: **Manhole**

Distance (ft): **147.1**  
Structural Grade: **0**  
O&M Grade: **0**  
Clock Start/From:  
Clock To:  
1st Value:  
2nd Value:  
Value Percent:  
Continuous Index:  
Within 8" of Joint: **NO**  
Remarks: **M-607-024**
