## Profile/Photo Observation Report

Street:	<b>FOXCROFT STREET</b>	Flow Control:	<b>Not Controlled</b>
City:	<b>Hobart, IN</b>	Year Renewed:	
Location:	<b>Yard</b>	Tape/Media #:	
Purpose:	<b>Routine Assessment</b>	Dia/Height:	<b>8"</b>
Use:	<b>Sanitary</b>	Material:	<b>PVC</b>
Drain Area:	<b>NA</b>	Lining:	
Category:	<b>NA</b>		
Comment:	<b>Flow direction marked wrong.</b>

Location Details:		Direction of Survey:	<b>Upstream</b>
US MH:	<b>M-607-024</b>	DS MH:	<b>M-607-029</b>
		Total Length Surveyed (ft):	<b>147.1</b>

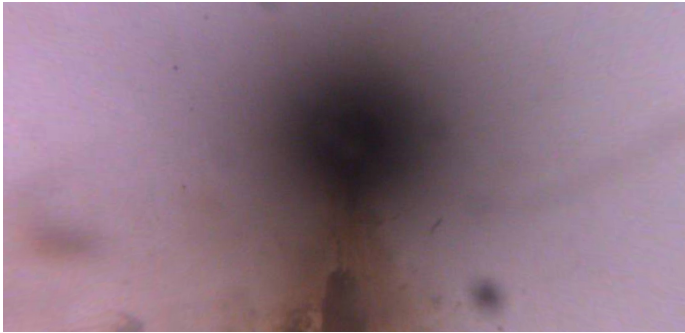
Code:	<b>MWL</b>
Description:	<b>Water Level</b>

Distance (ft):	<b>.0</b>
Structural Grade:	<b>0</b>
O&M Grade:	<b>0</b>
Clock Start/From:	
Clock To:	
1st Value:	
2nd Value:	
Value Percent:	<b>5.000</b>
Continuous Index:	
Within 8" of Joint:	<b>NO</b>
Remarks:

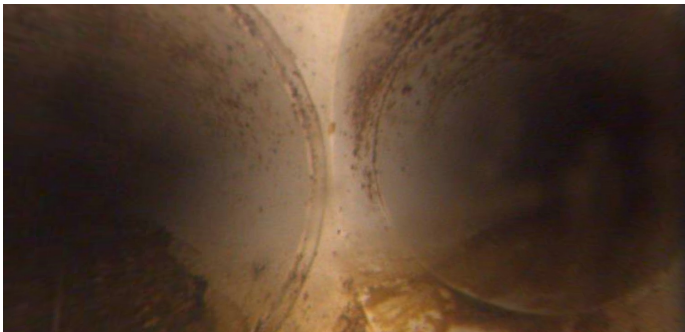
Code:	<b>TF</b>
Description:	<b>Tap Factory</b>

Distance (ft):	<b>69.4</b>
Structural Grade:	<b>0</b>
O&M Grade:	<b>0</b>
Clock Start/From:	<b>9</b>
Clock To:	
1st Value:	<b>4.000</b>
2nd Value:	
Value Percent:	
Continuous Index:	
Within 8" of Joint:	
Remarks:

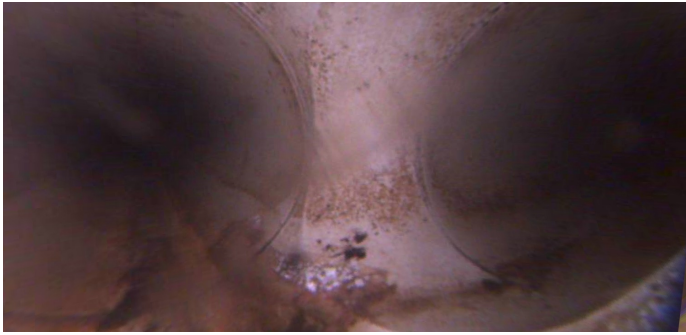
Code: **TF**  
Description: **Tap Factory**

Distance (ft): **82.4**  
Structural Grade: **0**  
O&M Grade: **0**  
Clock Start/From: **3**  
Clock To:  
1st Value: **4.000**  
2nd Value:  
Value Percent:  
Continuous Index:  
Within 8" of Joint:  
Remarks:

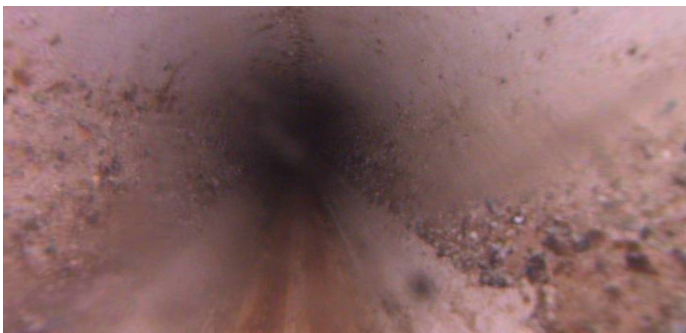
Code: **DAGS**  
Description: **Deposits Attached Grease**

Distance (ft): **134.9**  
Structural Grade: **0**  
O&M Grade: **2**  
Clock Start/From: **8**  
Clock To: **4**  
1st Value:  
2nd Value:  
Value Percent: **5.000**  
Continuous Index: **S01**  
Within 8" of Joint: **NO**  
Remarks:

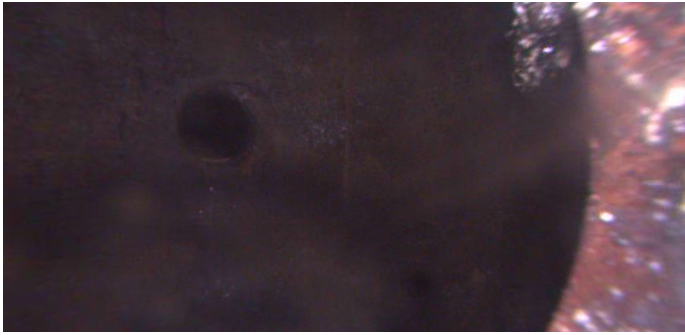
Code: **DAGS**  
Description: **Deposits Attached Grease**

Distance (ft): **146.3**  
Structural Grade: **0**  
O&M Grade: **2**  
Clock Start/From: **8**  
Clock To: **4**  
1st Value:  
2nd Value:  
Value Percent: **5.000**  
Continuous Index: **F01**  
Within 8" of Joint: **NO**  
Remarks:

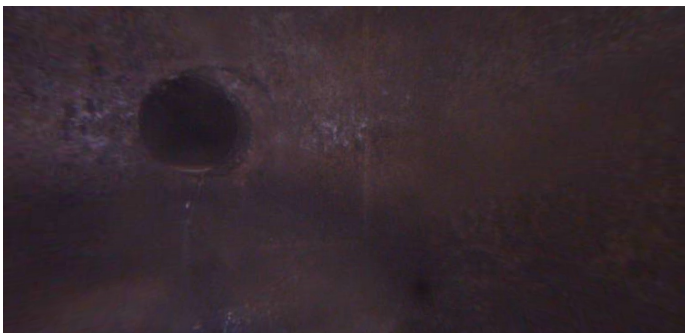
Code: **AMH**  
Description: **Manhole**

Distance (ft): **147.1**  
Structural Grade: **0**  
O&M Grade: **0**  
Clock Start/From:  
Clock To:  
1st Value:  
2nd Value:  
Value Percent:  
Continuous Index:  
Within 8" of Joint: **NO**  
Remarks: **M-607-024**
