Profile/Photo Observation Report

Street:	FOXCROFT STREET	Flow Control:	Not Controlled
City:	Hobart, IN	Year Renewed:	
Location:	Yard	Tape/Media #:	
Purpose:	Routine Assessment	Dia/Height:	8"
Use:	Sanitary	Material:	PVC
Drain Area:	NA	Lining:	
Category:	NA		
Comment:	Flow direction marked wrong.

Location Details:		Direction of Survey:	Upstream
US MH:	M-607-024	DS MH:	M-607-030
		Total Length Surveyed (ft):	228.6

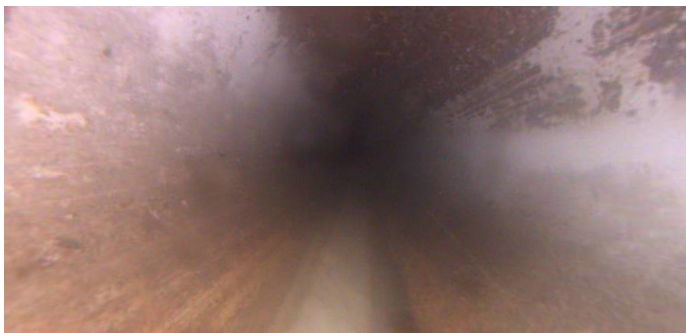
Code: **AMH**
Description: **Manhole**

Distance (ft): **.0**
Structural Grade: **0**
O&M Grade: **0**
Clock Start/From:
Clock To:
1st Value:
2nd Value:
Value Percent:
Continuous Index:
Within 8" of Joint: **NO**
Remarks: **M-607-030**

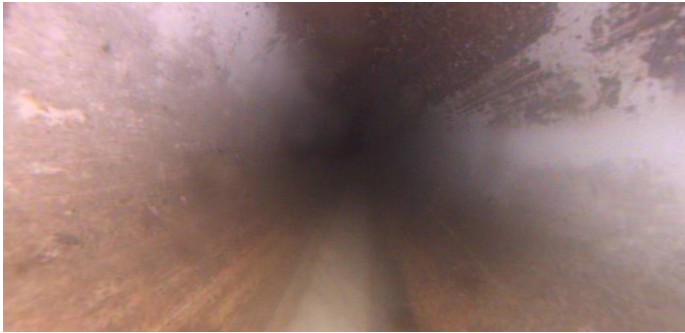
Code:	MWL
Description:	Water Level

Distance (ft):	.0
Structural Grade:	0
O&M Grade:	0
Clock Start/From:	
Clock To:	
1st Value:	
2nd Value:	
Value Percent:	5.000
Continuous Index:	
Within 8" of Joint:	NO
Remarks:

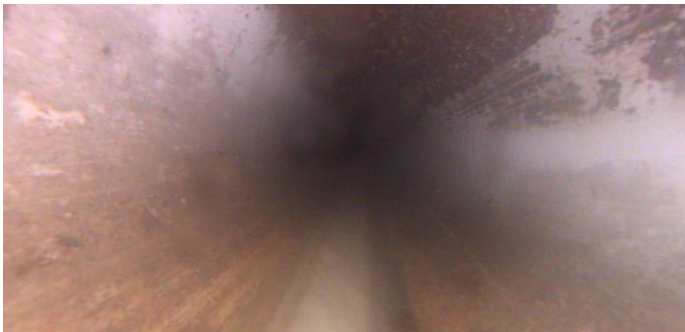
Code:	DAGS
Description:	Deposits Attached Grease

Distance (ft):	.0
Structural Grade:	0
O&M Grade:	2
Clock Start/From:	8
Clock To:	4
1st Value:	
2nd Value:	
Value Percent:	5.000
Continuous Index:	S01
Within 8" of Joint:	NO
Remarks:

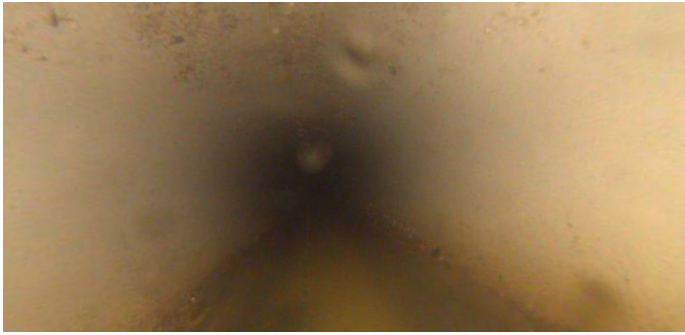
Code: **MGO**
Description: **General Observation**

Distance (ft): **16.6**
Structural Grade: **0**
O&M Grade: **0**
Clock Start/From:
Clock To:
1st Value:
2nd Value:
Value Percent:
Continuous Index:
Within 8" of Joint: **NO**
Remarks: **REAR CAMERA**

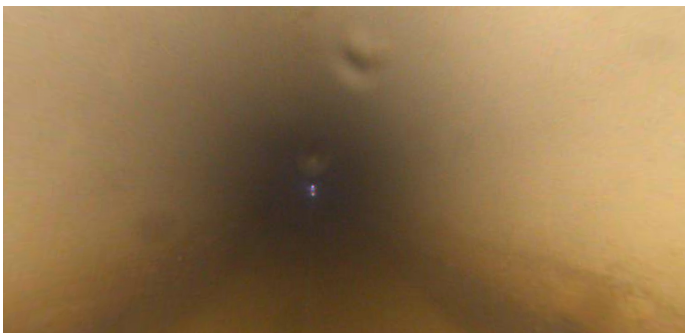
Code: **DAGS**
Description: **Deposits Attached Grease**

Distance (ft): **47.3**
Structural Grade: **0**
O&M Grade: **2**
Clock Start/From: **8**
Clock To: **4**
1st Value:
2nd Value:
Value Percent: **5.000**
Continuous Index: **F01**
Within 8" of Joint: **NO**
Remarks:

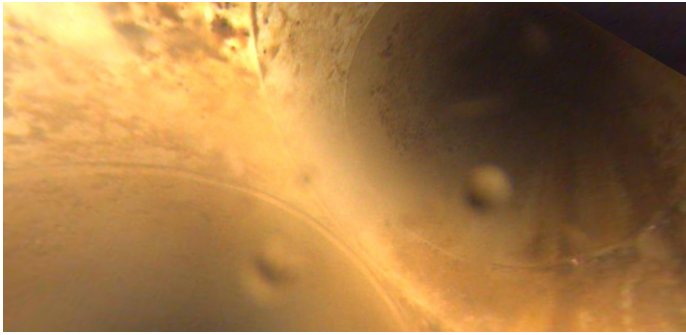
Code: **TF**
Description: **Tap Factory**

Distance (ft): **78.0**
Structural Grade: **0**
O&M Grade: **0**
Clock Start/From: **11**
Clock To:
1st Value: **4.000**
2nd Value:
Value Percent:
Continuous Index:
Within 8" of Joint:
Remarks:

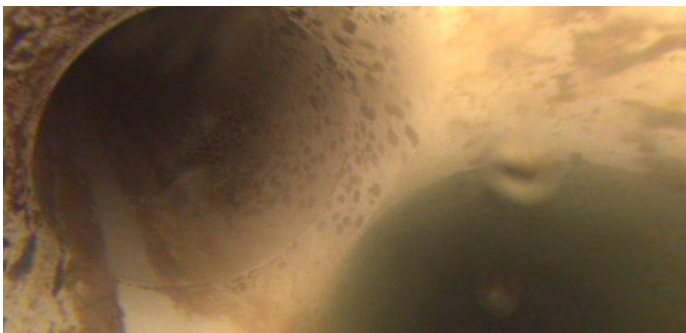
Code: **TF**
Description: **Tap Factory**

Distance (ft): **86.3**
Structural Grade: **0**
O&M Grade: **0**
Clock Start/From: **2**
Clock To:
1st Value: **4.000**
2nd Value:
Value Percent:
Continuous Index:
Within 8" of Joint:
Remarks:

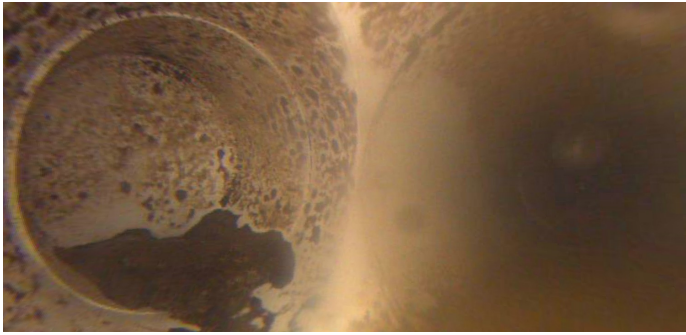
Code: **TFC**
Description: **Tap Factory Capped**

Distance (ft): **91.4**
Structural Grade: **0**
O&M Grade: **0**
Clock Start/From: **3**
Clock To:
1st Value: **4.000**
2nd Value:
Value Percent:
Continuous Index:
Within 8" of Joint:
Remarks:

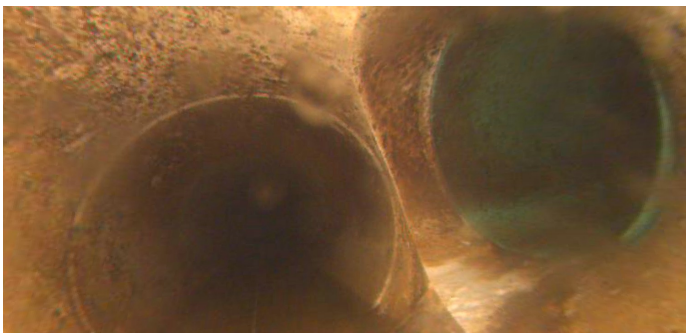
Code: **TFA**
Description: **Tap Factory Active**

Distance (ft): **140.8**
Structural Grade: **0**
O&M Grade: **0**
Clock Start/From: **9**
Clock To:
1st Value: **4.000**
2nd Value:
Value Percent:
Continuous Index:
Within 8" of Joint:
Remarks:

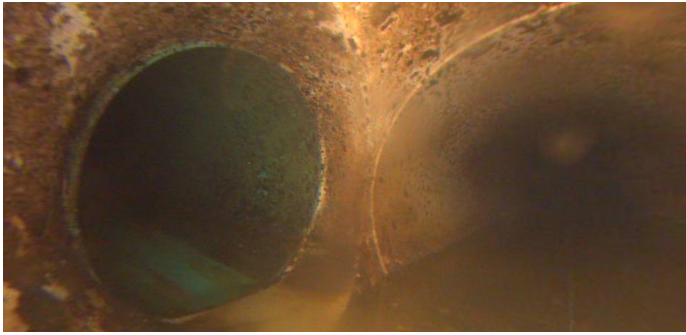
Code: **TFA**
Description: **Tap Factory Active**

Distance (ft): **149.4**
Structural Grade: **0**
O&M Grade: **0**
Clock Start/From: **3**
Clock To:
1st Value: **4.000**
2nd Value:
Value Percent:
Continuous Index:
Within 8" of Joint:
Remarks:

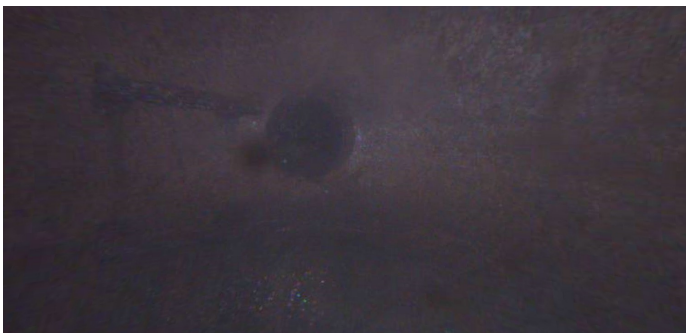
Code: **AMH**
Description: **Manhole**

Distance (ft): **228.6**
Structural Grade: **0**
O&M Grade: **0**
Clock Start/From:
Clock To:
1st Value:
2nd Value:
Value Percent:
Continuous Index:
Within 8" of Joint: **NO**
Remarks: **M-607-024**
