Profile/Photo Observation Report

Street:	FOXCROFT STREET	Flow Control:	Not Controlled
City:	Hobart, IN	Year Renewed:	
Location:	Yard	Tape/Media #:	
Purpose:	Routine Assessment	Dia/Height:	8"
Use:	Sanitary	Material:	PVC
Drain Area:	NA	Lining:	
Category:	NA		
Comment:	Flow direction is marked wrong.

Location Details:		Direction of Survey:	Downstream
US MH:	M-607-027	DS MH:	M-607-028
		Total Length Surveyed (ft):	274.6

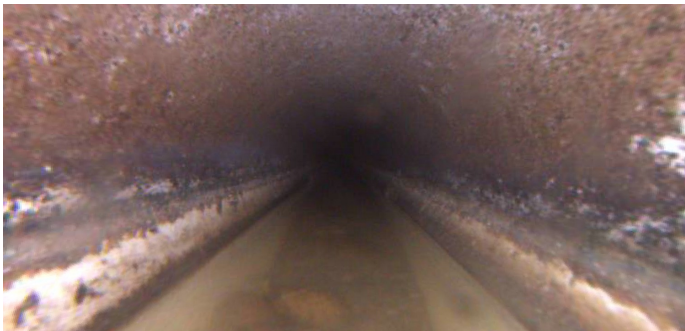
Code: **AMH**
Description: **Manhole**

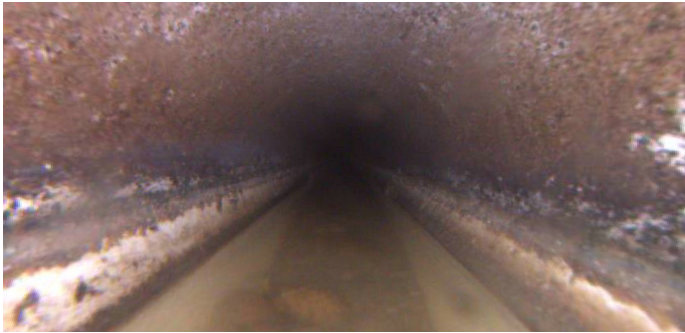
Code:	MWL
Description:	Water Level

Distance (ft):	.0
Structural Grade:	0
O&M Grade:	0
Clock Start/From:	
Clock To:	
1st Value:	
2nd Value:	
Value Percent:	20.000
Continuous Index:	
Within 8" of Joint:	NO
Remarks:

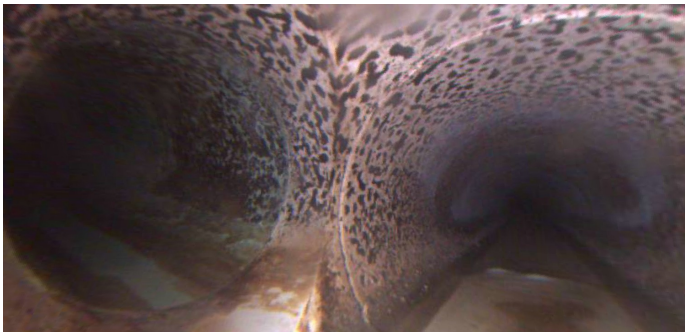
Code:	TF
Description:	Tap Factory

Distance (ft):	26.3
Structural Grade:	0
O&M Grade:	0
Clock Start/From:	9
Clock To:	
1st Value:	4.000
2nd Value:	
Value Percent:	
Continuous Index:	
Within 8" of Joint:	
Remarks:

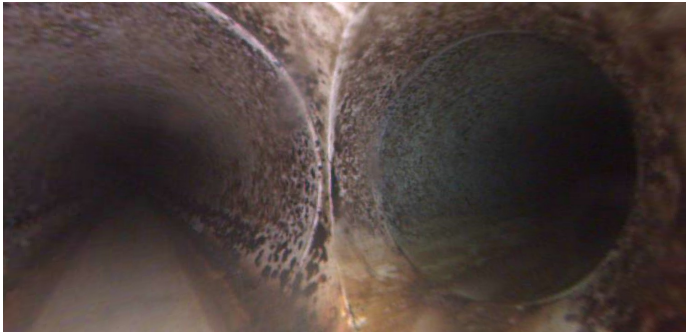
Code: **TFA**
Description: **Tap Factory Active**

Distance (ft): **115.4**
Structural Grade: **0**
O&M Grade: **0**
Clock Start/From: **3**
Clock To:
1st Value: **4.000**
2nd Value:
Value Percent:
Continuous Index:
Within 8" of Joint:
Remarks:

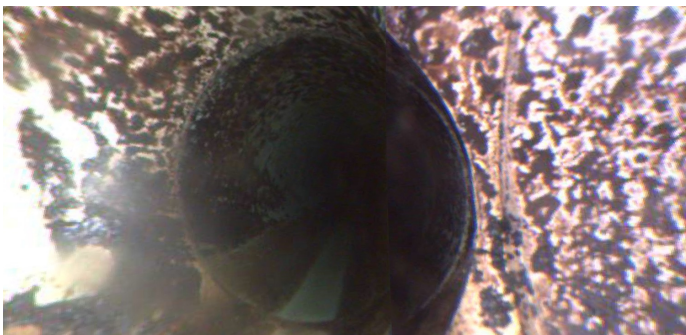
Code: **TF**
Description: **Tap Factory**

Distance (ft): **122.3**
Structural Grade: **0**
O&M Grade: **0**
Clock Start/From: **9**
Clock To:
1st Value: **4.000**
2nd Value:
Value Percent:
Continuous Index:
Within 8" of Joint:
Remarks:

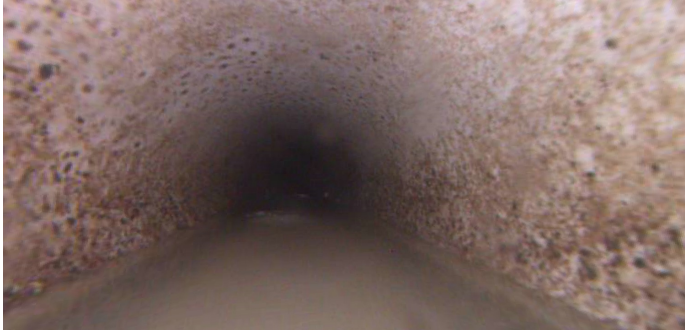
Code: **MWL**
Description: **Water Level**

Distance (ft): **193.5**
Structural Grade: **0**
O&M Grade: **0**
Clock Start/From:
Clock To:
1st Value:
2nd Value:
Value Percent: **30.000**
Continuous Index:
Within 8" of Joint: **NO**
Remarks:

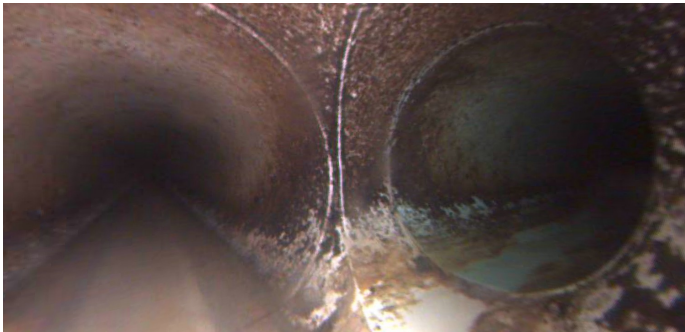
Code: **TF**
Description: **Tap Factory**

Distance (ft): **215.0**
Structural Grade: **0**
O&M Grade: **0**
Clock Start/From: **3**
Clock To:
1st Value: **4.000**
2nd Value:
Value Percent:
Continuous Index:
Within 8" of Joint:
Remarks:

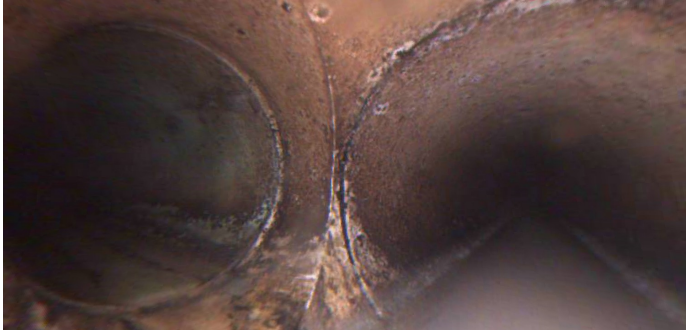
Code: **TFA**
Description: **Tap Factory Active**

Distance (ft): **223.7**
Structural Grade: **0**
O&M Grade: **0**
Clock Start/From: **9**
Clock To:
1st Value: **4.000**
2nd Value:
Value Percent:
Continuous Index:
Within 8" of Joint:
Remarks:

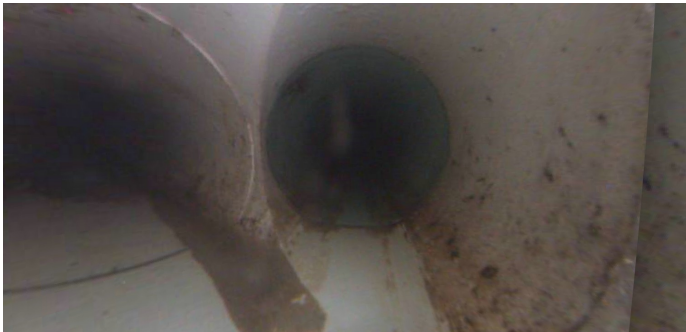
Code: **TFA**
Description: **Tap Factory Active**

Distance (ft): **254.0**
Structural Grade: **0**
O&M Grade: **0**
Clock Start/From: **3**
Clock To:
1st Value: **4.000**
2nd Value:
Value Percent:
Continuous Index:
Within 8" of Joint:
Remarks:

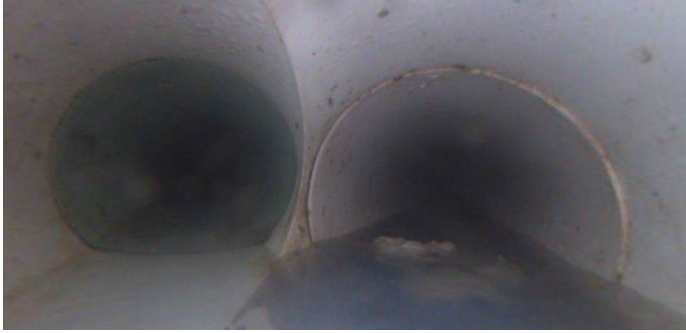
Code: **TFA**
Description: **Tap Factory Active**

Distance (ft): **267.3**
Structural Grade: **0**
O&M Grade: **0**
Clock Start/From: **9**
Clock To:
1st Value: **4.000**
2nd Value:
Value Percent:
Continuous Index:
Within 8" of Joint:
Remarks:

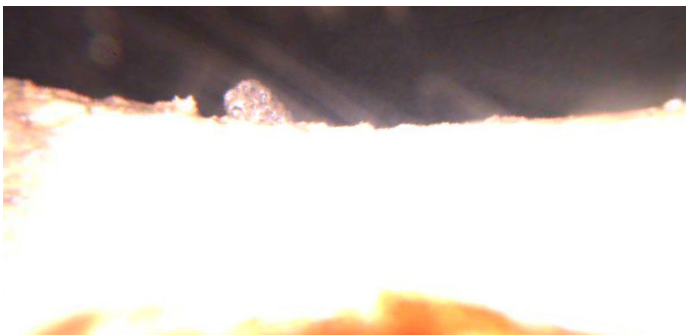
Code: **AMH**
Description: **Manhole**

Distance (ft): **274.6**
Structural Grade: **0**
O&M Grade: **0**
Clock Start/From:
Clock To:
1st Value:
2nd Value:
Value Percent:
Continuous Index:
Within 8" of Joint: **NO**
Remarks: **M-607-028**
