Profile/Photo Observation Report

Street:	LAURA LN	Flow Control:	Not Controlled
City:	Hobart, IN	Year Renewed:	
Location:	Yard	Tape/Media #:	
Purpose:	Routine Assessment	Dia/Height:	8"
Use:	Sanitary	Material:	PVC
Drain Area:	NA	Lining:	
Category:	NA		
Comment:	Flow direction marked wrong.

Location Details:		Direction of Survey:	Downstream
US MH:	M-607-030	DS MH:	M-607-031
		Total Length Surveyed (ft):	198.7

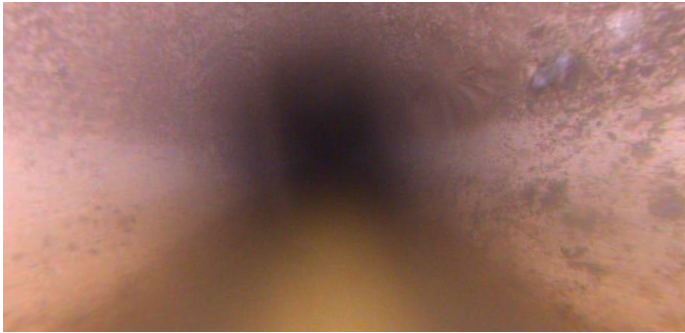
Code:	MWL
Description:	Water Level

Distance (ft):	.0
Structural Grade:	0
O&M Grade:	0
Clock Start/From:	
Clock To:	
1st Value:	
2nd Value:	
Value Percent:	5.000
Continuous Index:	
Within 8" of Joint:	NO
Remarks:

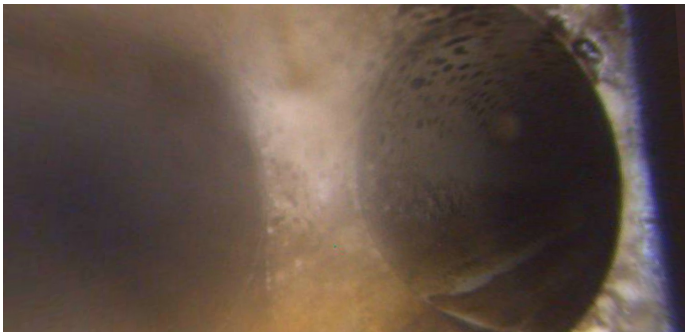
Code:	TF
Description:	Tap Factory

Distance (ft):	78.1
Structural Grade:	0
O&M Grade:	0
Clock Start/From:	9
Clock To:	
1st Value:	4.000
2nd Value:	
Value Percent:	
Continuous Index:	
Within 8" of Joint:	
Remarks:

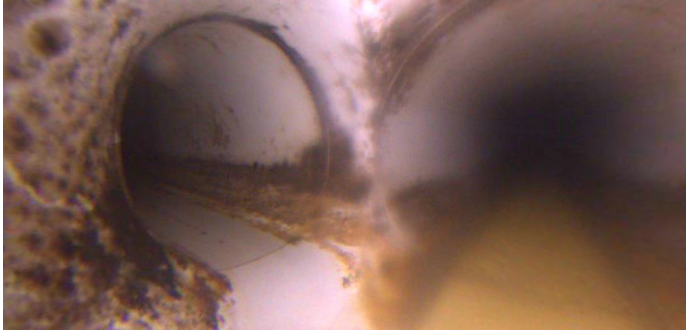
Code: **TFA**
Description: **Tap Factory Active**

Distance (ft): **165.7**
Structural Grade: **0**
O&M Grade: **0**
Clock Start/From: **9**
Clock To:
1st Value: **4.000**
2nd Value:
Value Percent:
Continuous Index:
Within 8" of Joint:
Remarks:
