## Profile/Photo Observation Report

Date:	<b>04/04/2018</b>	Weather:		Coding:	<b>PACP 6.0</b>
Pipe Length (ft):	<b>266.4</b>	Owner:	<b>NA</b>	Pre Clean:	<b>No Pre-Cleaning</b>
P.O.#:		Surveyor:	<b>Jen Costello</b>	PSR:	<b>P-607-076-031</b>
Customer:		Clean Date:	<b>01/01/1900</b>	Shape:	<b>C</b>

Street:	<b>LAURA LN</b>	Flow Control:	<b>Not Controlled</b>
City:	<b>Hobart, IN</b>	Year Renewed:	
Location:	<b>Yard</b>	Tape/Media #:	
Purpose:	<b>Routine Assessment</b>	Dia/Height:	<b>8"</b>
Use:	<b>Sanitary</b>	Material:	<b>PVC</b>
Drain Area:	<b>NA</b>	Lining:	
Category:	<b>NA</b>		
Comment:	<b>P_C debris, flow direction marked wrong.</b>		
Location Details:		Direction of Survey:	<b>Upstream</b>
US MH:	<b>M-607-031</b>	DS MH:	<b>M-607-076</b>
		Total Length Surveyed (ft):	<b>259.5</b>

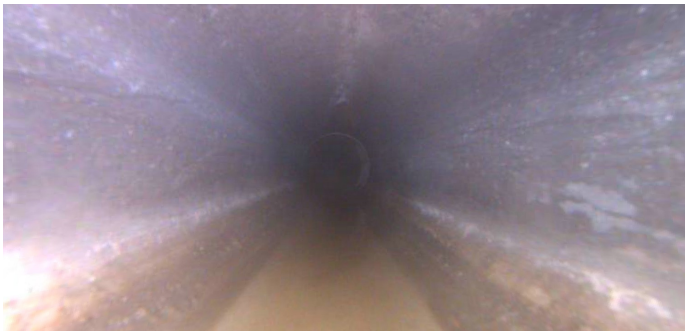
Code: **AMH**  
Description: **Manhole**

Distance (ft): **.0**  
Structural Grade: **0**  
O&M Grade: **0**  
Clock Start/From:  
Clock To:  
1st Value:  
2nd Value:  
Value Percent:  
Continuous Index:  
Within 8" of Joint: **NO**  
Remarks: **M-607-076**

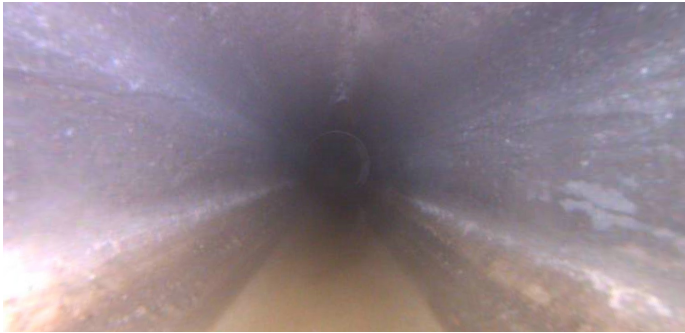
Code:	<b>MWL</b>
Description:	<b>Water Level</b>

Distance (ft):	<b>.0</b>
Structural Grade:	<b>0</b>
O&M Grade:	<b>0</b>
Clock Start/From:	
Clock To:	
1st Value:	
2nd Value:	
Value Percent:	<b>5.000</b>
Continuous Index:	
Within 8" of Joint:	<b>NO</b>
Remarks:

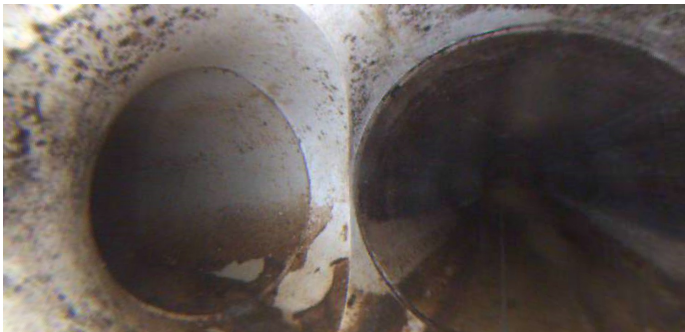
Code:	<b>TF</b>
Description:	<b>Tap Factory</b>

Distance (ft):	<b>3.7</b>
Structural Grade:	<b>0</b>
O&M Grade:	<b>0</b>
Clock Start/From:	<b>3</b>
Clock To:	
1st Value:	<b>4.000</b>
2nd Value:	
Value Percent:	
Continuous Index:	
Within 8" of Joint:	
Remarks:

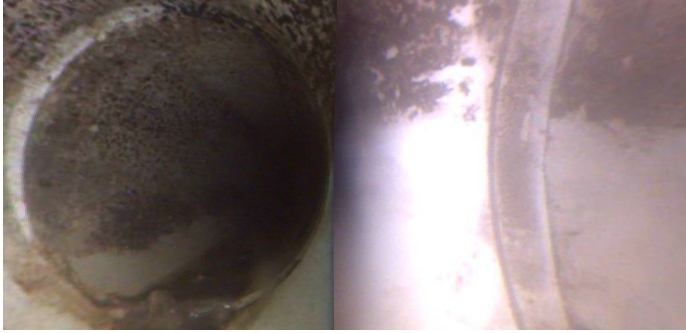
Code: **TF**  
Description: **Tap Factory**

Distance (ft): **16.8**  
Structural Grade: **0**  
O&M Grade: **0**  
Clock Start/From: **9**  
Clock To:  
1st Value: **4.000**  
2nd Value:  
Value Percent:  
Continuous Index:  
Within 8" of Joint:  
Remarks:

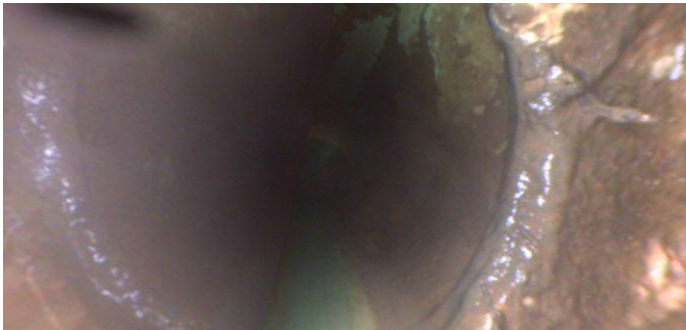
Code: **TB**  
Description: **Tap Break-in**

Distance (ft): **37.2**  
Structural Grade: **0**  
O&M Grade: **0**  
Clock Start/From: **2**  
Clock To:  
1st Value: **4.000**  
2nd Value:  
Value Percent:  
Continuous Index:  
Within 8" of Joint:  
Remarks:

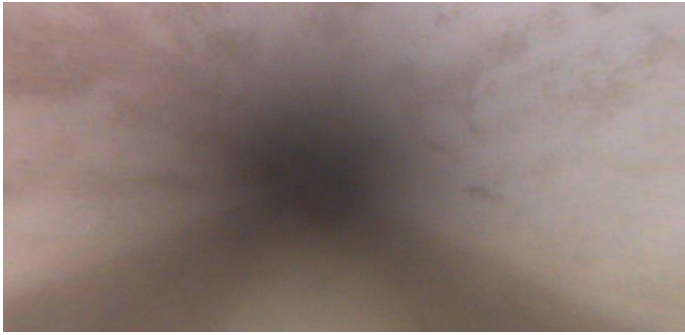
Code: **MWL**  
Description: **Water Level**

Distance (ft): **75.4**  
Structural Grade: **0**  
O&M Grade: **0**  
Clock Start/From:  
Clock To:  
1st Value:  
2nd Value:  
Value Percent: **30.000**  
Continuous Index:  
Within 8" of Joint: **NO**  
Remarks:

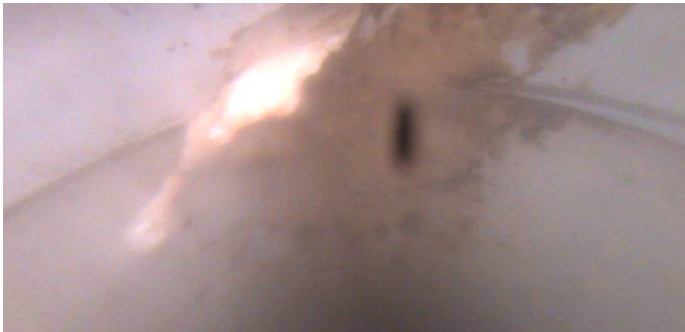
Code: **DAR**  
Description: **Deposits Attached Ragging**

Distance (ft): **97.8**  
Structural Grade: **0**  
O&M Grade: **2**  
Clock Start/From: **12**  
Clock To:  
1st Value:  
2nd Value:  
Value Percent: **5.000**  
Continuous Index:  
Within 8" of Joint: **YES**  
Remarks:

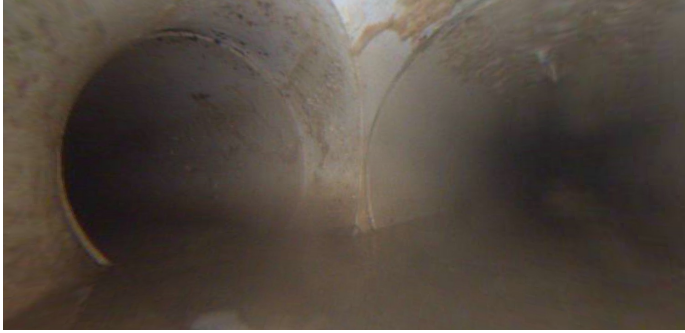
Code: **TFA**  
Description: **Tap Factory Active**

Distance (ft): **97.9**  
Structural Grade: **0**  
O&M Grade: **0**  
Clock Start/From: **3**  
Clock To:  
1st Value: **4.000**  
2nd Value:  
Value Percent:  
Continuous Index:  
Within 8" of Joint:  
Remarks:

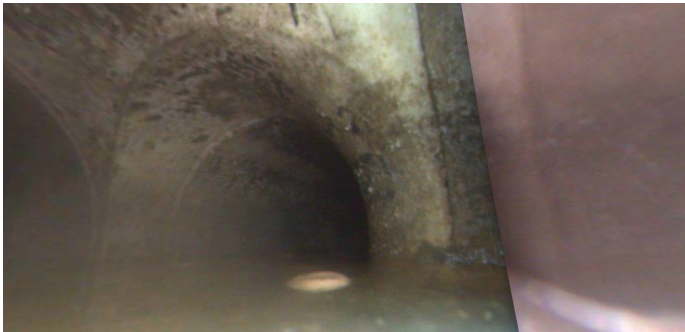
Code: **TFA**  
Description: **Tap Factory Active**

Distance (ft): **111.2**  
Structural Grade: **0**  
O&M Grade: **0**  
Clock Start/From: **9**  
Clock To:  
1st Value: **4.000**  
2nd Value:  
Value Percent:  
Continuous Index:  
Within 8" of Joint:  
Remarks:

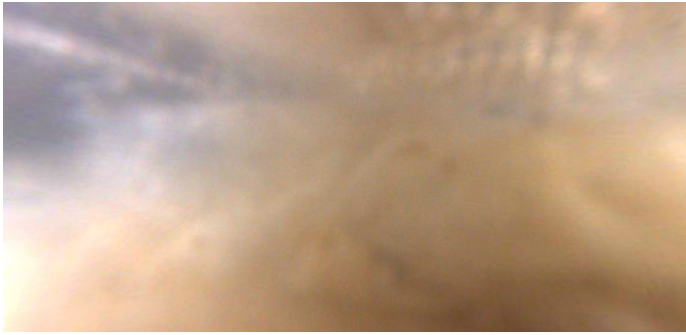
Code: **MWL**  
Description: **Water Level**

Distance (ft): **129.9**  
Structural Grade: **0**  
O&M Grade: **0**  
Clock Start/From:  
Clock To:  
1st Value:  
2nd Value:  
Value Percent: **60.000**  
Continuous Index:  
Within 8" of Joint: **NO**  
Remarks:

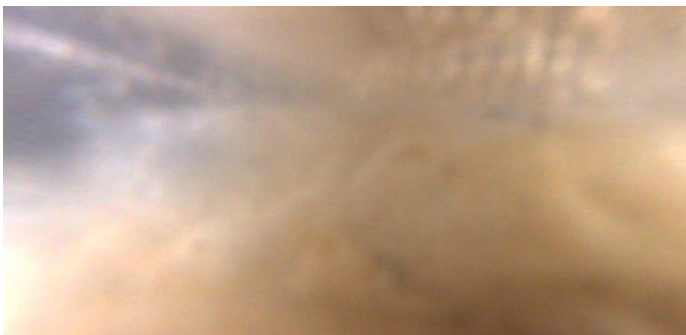
Code: **MCU**  
Description: **Camera Underwater**

Distance (ft): **129.9**  
Structural Grade: **0**  
O&M Grade: **4**  
Clock Start/From:  
Clock To:  
1st Value:  
2nd Value:  
Value Percent:  
Continuous Index: **S01**  
Within 8" of Joint: **NO**  
Remarks:
