Profile/Photo Observation Report

Date:	04/08/2018	Weather:		Coding:	PACP 6.0
Pipe Length (ft):		Owner:	City of Hobart	Pre Clean:	Not Known
P.O.#:	212	Surveyor:	B. Helbling	PSR:	P-608-004-033
Customer:	City of Hobart	Clean Date:		Shape:	C

Street:	South Wisconsin Street	Flow Control:	Not Controlled
City:	Hobart, IN	Year Renewed:	
Location:	Sidewalk	Tape/Media #:	DEP212
Purpose:	Routine Assessment	Dia/Height:	15"
Use:	Sanitary	Material:	PVC
Drain Area:		Lining:	
Category:	NA		
Comment:	YES501824 Submittal 2		
Location Details:		Direction of Survey:	Downstream
US MH:	M-607-033	DS MH:	M-608-004
		Total Length Surveyed (ft):	391.7

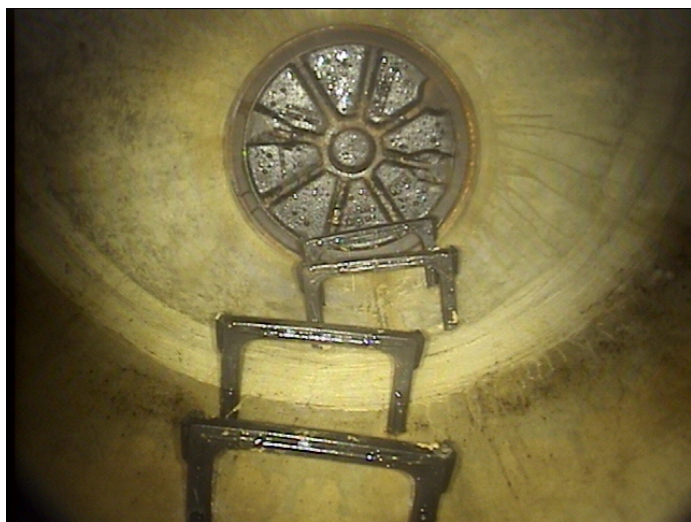
Code: **AMH**
Description: **Manhole**

Distance (ft): **.0**
Structural Grade: **0**
O&M Grade: **0**
Clock Start/From:
Clock To:
1st Value:
2nd Value:
Value Percent:
Continuous Index:
Within 8" of Joint: **NO**
Remarks: **M-607-033**

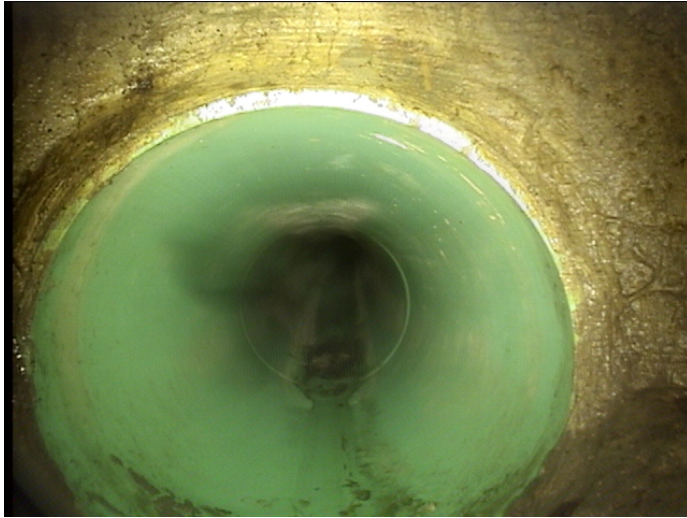
Code: **MWL**
Description: **Water Level**

Distance (ft): **.0**
Structural Grade: **0**
O&M Grade: **0**
Clock Start/From:
Clock To:
1st Value:
2nd Value:
Value Percent: **0.000**
Continuous Index:
Within 8" of Joint: **NO**
Remarks:

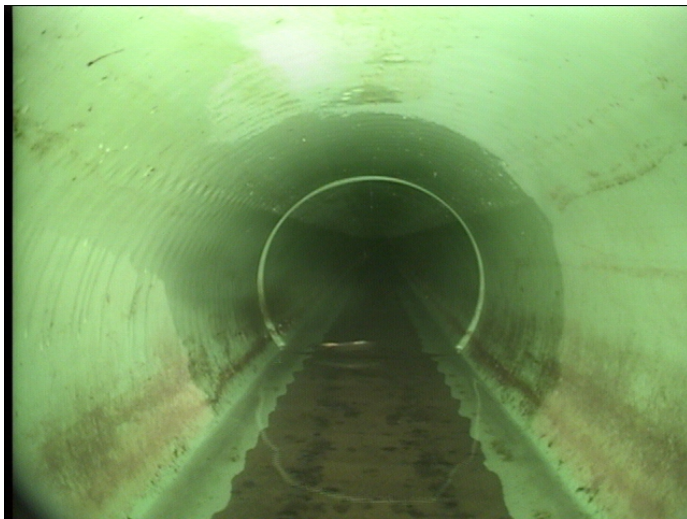
Code: **DSF**
Description: **Deposits Settled Fine**

Distance (ft): **93.6**
Structural Grade: **0**
O&M Grade: **2**
Clock Start/From: **5**
Clock To: **7**
1st Value:
2nd Value:
Value Percent: **5.000**
Continuous Index: **S01**
Within 8" of Joint: **NO**
Remarks:

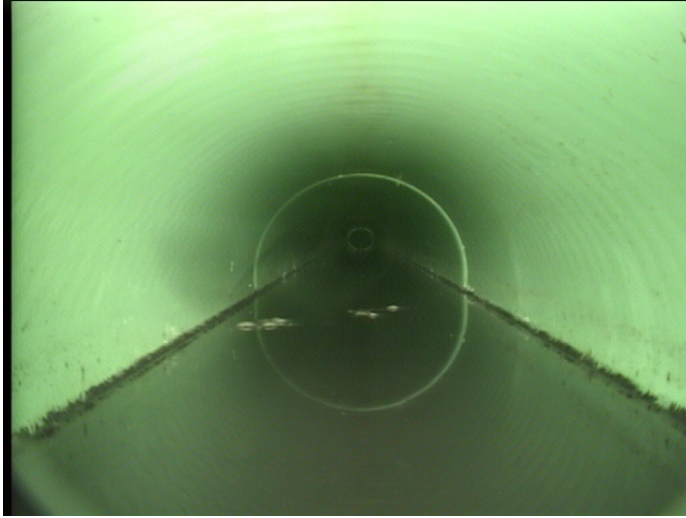
Code: **MWL**
Description: **Water Level**

Distance (ft): **342.0**
Structural Grade: **0**
O&M Grade: **0**
Clock Start/From:
Clock To:
1st Value:
2nd Value:
Value Percent: **20.000**
Continuous Index:
Within 8" of Joint: **NO**
Remarks:

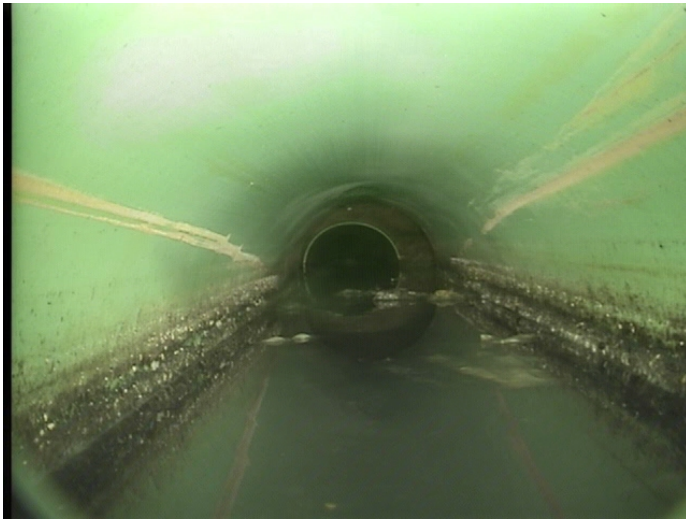
Code: **MSA**
Description: **Abandoned Survey**

Distance (ft): **391.7**
Structural Grade: **0**
O&M Grade: **0**
Clock Start/From:
Clock To:
1st Value:
2nd Value:
Value Percent:
Continuous Index:
Within 8" of Joint: **NO**
Remarks: **DSF**

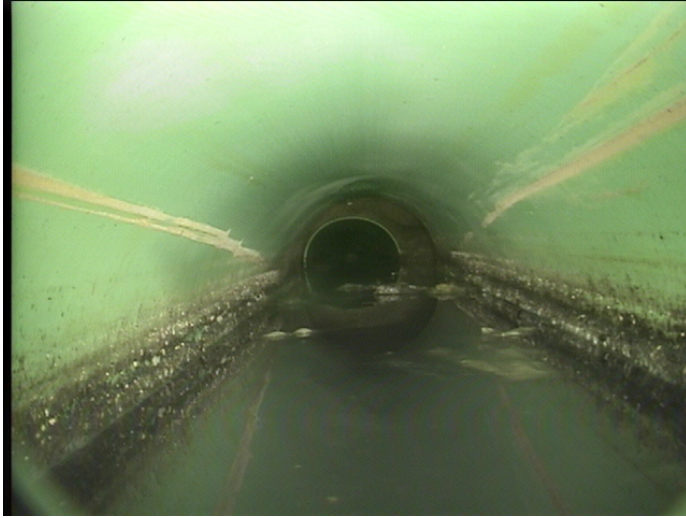
Code:	DSF
Description:	Deposits Settled Fine
Distance (ft):	391.7
Structural Grade:	0
O&M Grade:	2
Clock Start/From:	5
Clock To:	7
1st Value:	
2nd Value:	
Value Percent:	5.000
Continuous Index:	F01
Within 8" of Joint:	NO
Remarks:
