Profile/Photo Observation Report

Date:	04/08/2018	Weather:		Coding:	PACP 6.0
Pipe Length (ft):		Owner:	City of Hobart	Pre Clean:	No Pre-Cleaning
P.O.#:	211	Surveyor:	B. Helbling	PSR:	P-607-033-034
Customer:	City of Hobart	Clean Date:		Shape:	C

Street:	South Wisconsin Street	Flow Control:	Not Controlled
City:	Hobart, IN	Year Renewed:	
Location:	Light Highway	Tape/Media #:	DEP211
Purpose:	Routine Assessment	Dia/Height:	15"
Use:	Sanitary	Material:	PVC
Drain Area:		Lining:	
Category:	NA		
Comment:	YES501824 Submittal 2		
Location Details:		Direction of Survey:	Downstream
US MH:	M-607-034	DS MH:	M-607-033
		Total Length Surveyed (ft):	9.7

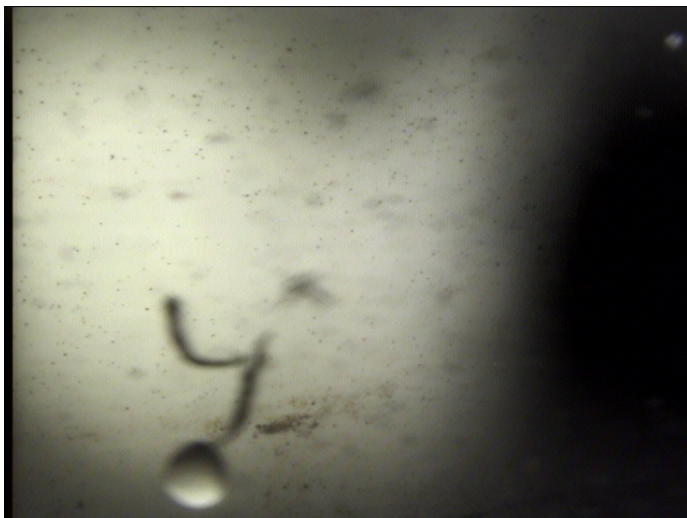
Code:	AMH
Description:	Manhole
Distance (ft):	.0
Structural Grade:	0
O&M Grade:	0
Clock Start/From:	
Clock To:	
1st Value:	
2nd Value:	
Value Percent:	
Continuous Index:	
Within 8" of Joint:	NO
Remarks:	M-607-033

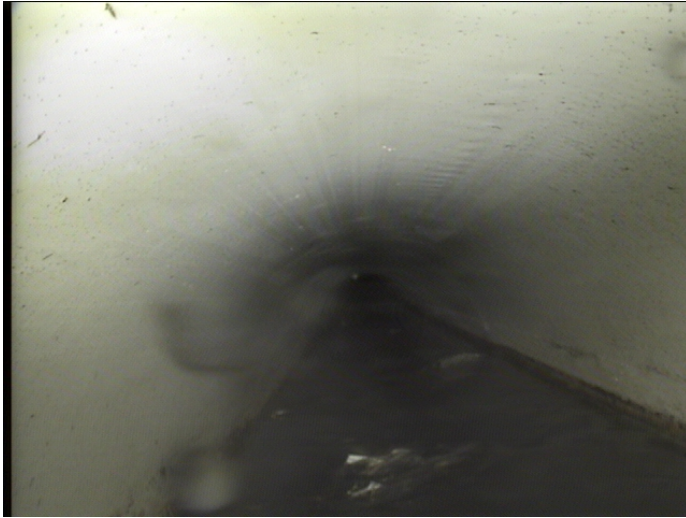
Code: **MWL**
Description: **Water Level**

Distance (ft): **.0**
Structural Grade: **0**
O&M Grade: **0**
Clock Start/From:
Clock To:
1st Value:
2nd Value:
Value Percent: **20.000**
Continuous Index:
Within 8" of Joint: **NO**
Remarks:

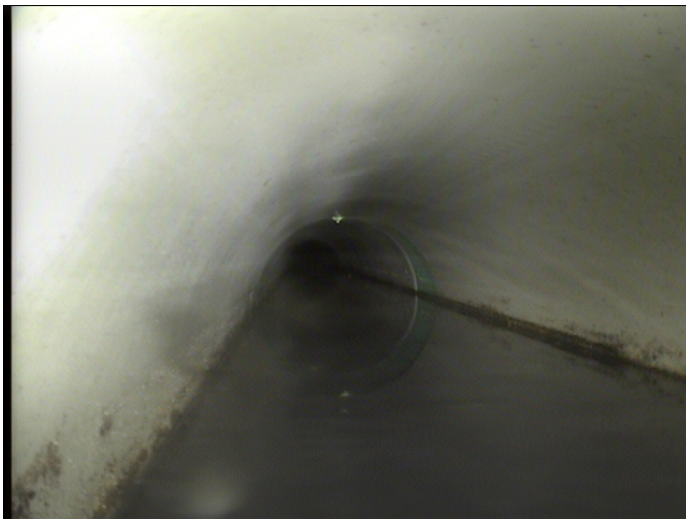
Code: **DSF**
Description: **Deposits Settled Fine**

Distance (ft): **7.3**
Structural Grade: **0**
O&M Grade: **3**
Clock Start/From: **4**
Clock To: **8**
1st Value:
2nd Value:
Value Percent: **20.000**
Continuous Index:
Within 8" of Joint: **NO**
Remarks:

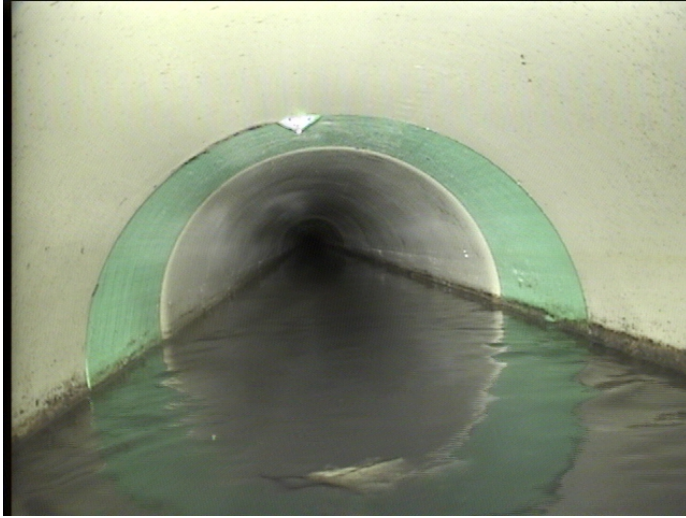
Code:	MSA
Description:	Abandoned Survey
Distance (ft):	9.3
Structural Grade:	0
O&M Grade:	0
Clock Start/From:	
Clock To:	
1st Value:	
2nd Value:	
Value Percent:	
Continuous Index:	
Within 8" of Joint:	NO
Remarks:	Heavy sediment
