## Profile/Photo Observation Report

Date:	<b>04/09/2018</b>	Weather:		Coding:	<b>PACP 6.0</b>
Pipe Length (ft):		Owner:	<b>City of Hobart</b>	Pre Clean:	<b>Not Known</b>
P.O.#:	<b>213</b>	Surveyor:	<b>B. Helbling</b>	PSR:	<b>P-607-033-034</b>
Customer:	<b>City of Hobart</b>	Clean Date:		Shape:	<b>C</b>

Street:	<b>West 14th Street</b>	Flow Control:	<b>Not Controlled</b>
City:	<b>Hobart, IN</b>	Year Renewed:	
Location:	<b>Light Highway</b>	Tape/Media #:	<b>DEP213</b>
Purpose:	<b>Routine Assessment</b>	Dia/Height:	<b>15"</b>
Use:	<b>Sanitary</b>	Material:	<b>PVC</b>
Drain Area:		Lining:	
Category:	<b>NA</b>		
Comment:	<b>YES501824 Submittal 2</b>		
Location Details:		Direction of Survey:	<b>Upstream</b>
US MH:	<b>M-607-034</b>	DS MH:	<b>M-607-033</b>
		Total Length Surveyed (ft):	<b>190.0</b>

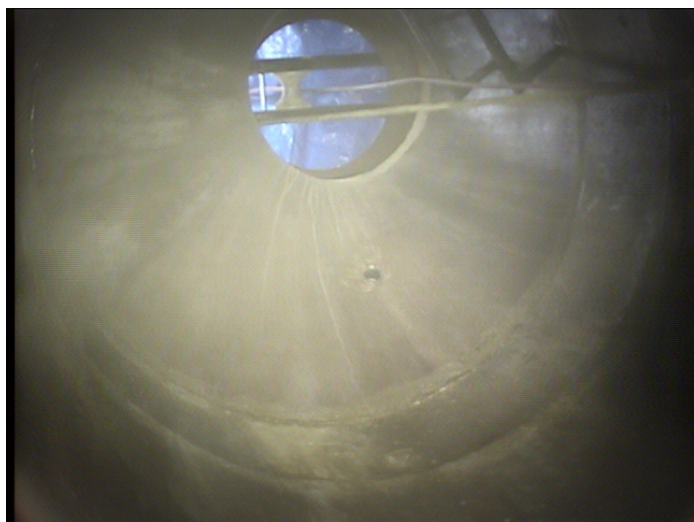
Code: **AMH**  
Description: **Manhole**

Distance (ft): **.0**  
Structural Grade: **0**  
O&M Grade: **0**  
Clock Start/From:  
Clock To:  
1st Value:  
2nd Value:  
Value Percent:  
Continuous Index:  
Within 8" of Joint: **NO**  
Remarks: **M-607-033**

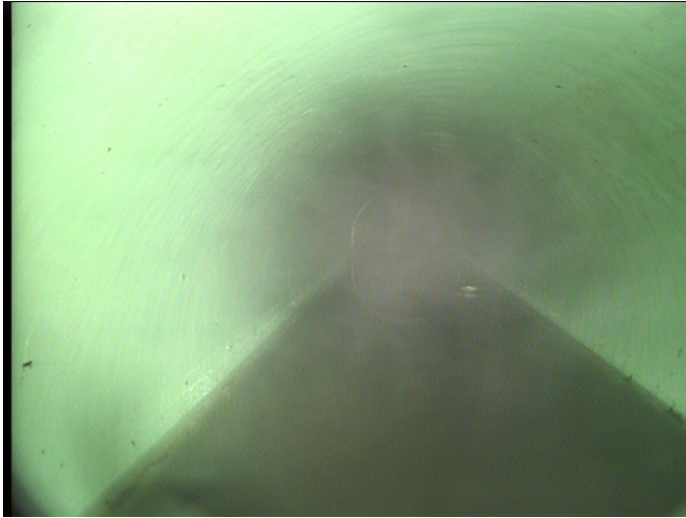
Code: **MWL**  
Description: **Water Level**

Distance (ft): **.0**  
Structural Grade: **0**  
O&M Grade: **0**  
Clock Start/From:  
Clock To:  
1st Value:  
2nd Value:  
Value Percent: **10.000**  
Continuous Index:  
Within 8" of Joint: **NO**  
Remarks:

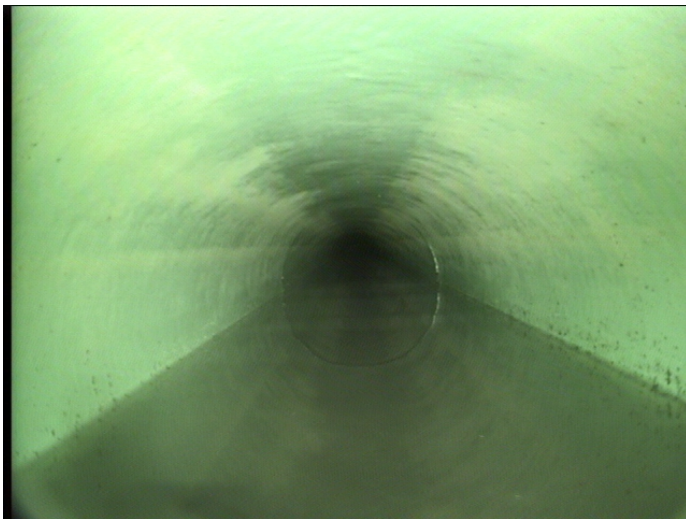
Code: **DSF**  
Description: **Deposits Settled Fine**

Distance (ft): **187.4**  
Structural Grade: **0**  
O&M Grade: **2**  
Clock Start/From: **5**  
Clock To: **7**  
1st Value:  
2nd Value:  
Value Percent: **10.000**  
Continuous Index:  
Within 8" of Joint: **NO**  
Remarks:

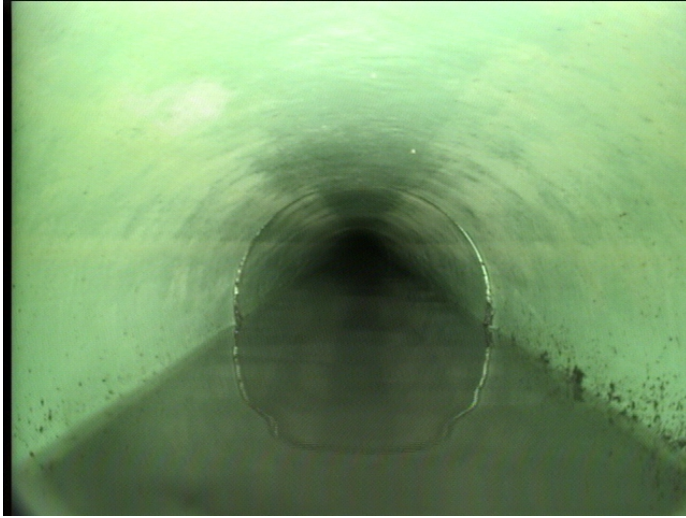
Code:	<b>MSA</b>
Description:	<b>Abandoned Survey</b>
Distance (ft):	<b>188.7</b>
Structural Grade:	<b>0</b>
O&M Grade:	<b>0</b>
Clock Start/From:	
Clock To:	
1st Value:	
2nd Value:	
Value Percent:	
Continuous Index:	
Within 8" of Joint:	<b>NO</b>
Remarks:	<b>Heavy sediment</b>
