Profile/Photo Observation Report

Date:	04/03/2018	Weather:		Coding:	PACP 6.0
Pipe Length (ft):	170.8	Owner:	NA	Pre Clean:	No Pre-Cleaning
P.O.#:		Surveyor:	Jen Costello	PSR:	P-607-035-036
Customer:		Clean Date:	01/01/1900	Shape:	C

Street:	DIANE CT	Flow Control:	Not Controlled
City:	Hobart, IN	Year Renewed:	
Location:	Yard	Tape/Media #:	
Purpose:	Routine Assessment	Dia/Height:	8"
Use:	Sanitary	Material:	PVC
Drain Area:	NA	Lining:	
Category:	NA		
Comment:	Flow direction is wrong.

Location Details:		Direction of Survey:	Upstream
US MH:	M-607-036	DS MH:	M-607-035
		Total Length Surveyed (ft):	170.0

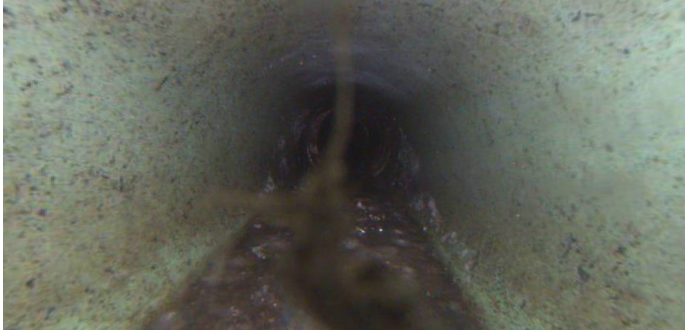
Code:	MWL
Description:	Water Level

Distance (ft):	.0
Structural Grade:	0
O&M Grade:	0
Clock Start/From:	
Clock To:	
1st Value:	
2nd Value:	
Value Percent:	10.000
Continuous Index:	
Within 8" of Joint:	NO
Remarks:

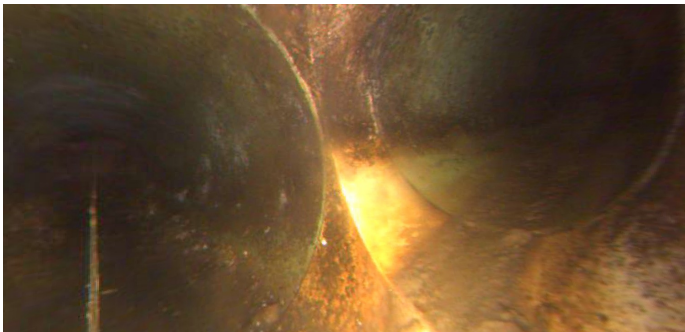
Code:	TF
Description:	Tap Factory

Distance (ft):	4.0
Structural Grade:	0
O&M Grade:	0
Clock Start/From:	9
Clock To:	
1st Value:	4.000
2nd Value:	
Value Percent:	
Continuous Index:	
Within 8" of Joint:	
Remarks:

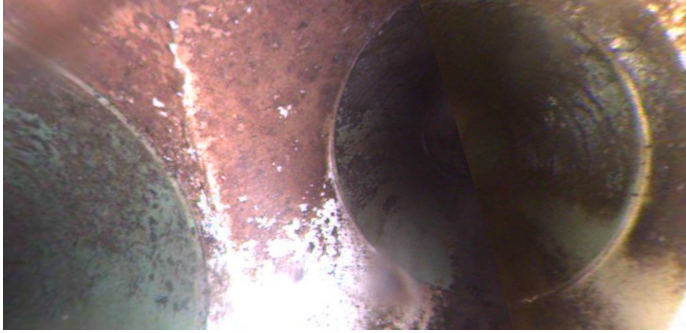
Code: **TF**
Description: **Tap Factory**

Distance (ft): **6.9**
Structural Grade: **0**
O&M Grade: **0**
Clock Start/From: **2**
Clock To:
1st Value: **4.000**
2nd Value:
Value Percent:
Continuous Index:
Within 8" of Joint:
Remarks:

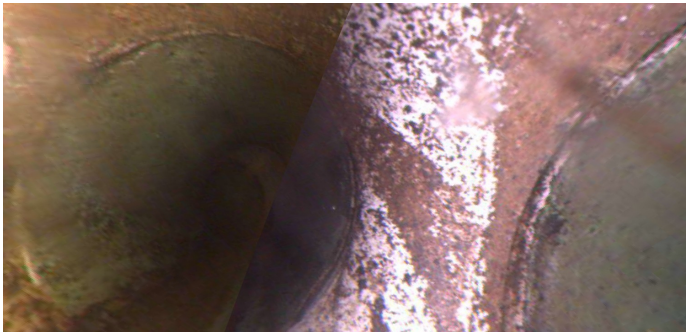
Code: **TF**
Description: **Tap Factory**

Distance (ft): **8.7**
Structural Grade: **0**
O&M Grade: **0**
Clock Start/From: **10**
Clock To:
1st Value: **4.000**
2nd Value:
Value Percent:
Continuous Index:
Within 8" of Joint:
Remarks:

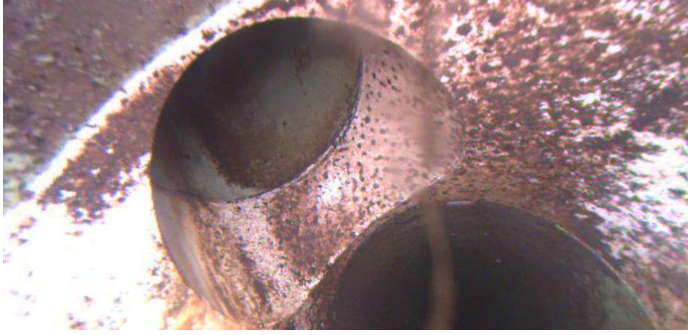
Code: **TF**
Description: **Tap Factory**

Distance (ft): **19.6**
Structural Grade: **0**
O&M Grade: **0**
Clock Start/From: **10**
Clock To:
1st Value: **4.000**
2nd Value:
Value Percent:
Continuous Index:
Within 8" of Joint:
Remarks:

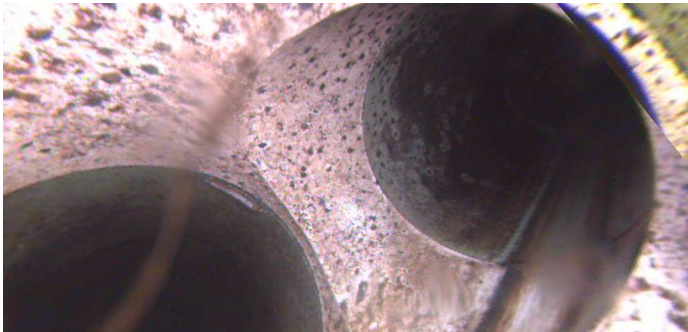
Code: **TF**
Description: **Tap Factory**

Distance (ft): **59.0**
Structural Grade: **0**
O&M Grade: **0**
Clock Start/From: **2**
Clock To:
1st Value: **4.000**
2nd Value:
Value Percent:
Continuous Index:
Within 8" of Joint:
Remarks:

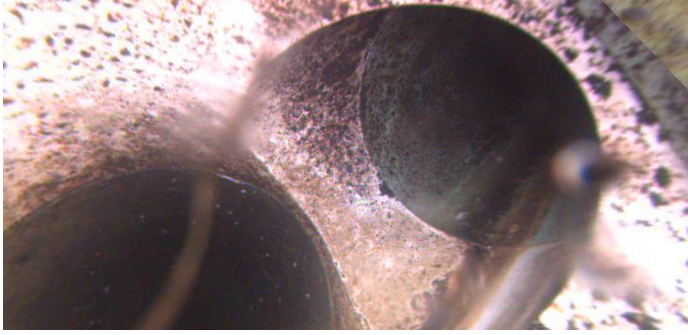
Code: **TF**
Description: **Tap Factory**

Distance (ft): **119.6**
Structural Grade: **0**
O&M Grade: **0**
Clock Start/From: **2**
Clock To:
1st Value: **4.000**
2nd Value:
Value Percent:
Continuous Index:
Within 8" of Joint:
Remarks:

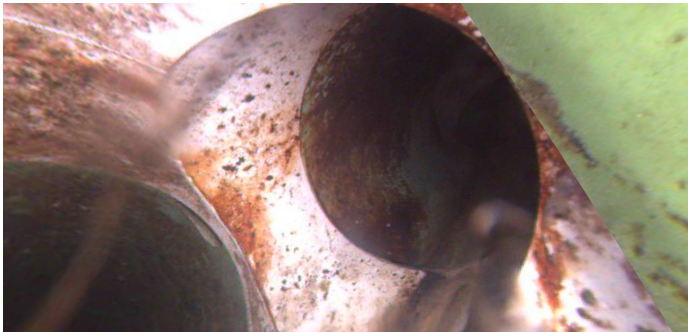
Code: **TF**
Description: **Tap Factory**

Distance (ft): **156.0**
Structural Grade: **0**
O&M Grade: **0**
Clock Start/From: **2**
Clock To:
1st Value: **4.000**
2nd Value:
Value Percent:
Continuous Index:
Within 8" of Joint:
Remarks:

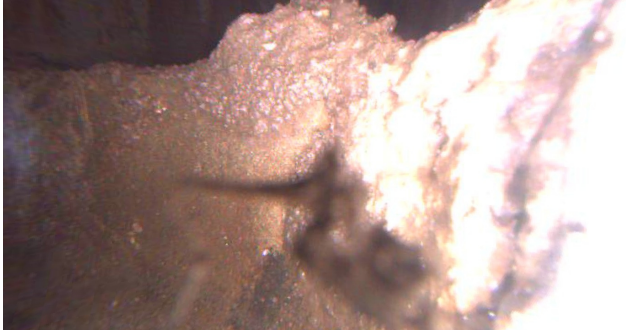
Code:	AMH
Description:	Manhole
Distance (ft):	170.0
Structural Grade:	0
O&M Grade:	0
Clock Start/From:	
Clock To:	
1st Value:	
2nd Value:	
Value Percent:	
Continuous Index:	
Within 8" of Joint:	NO
Remarks:	M-607-036
