Profile/Photo Observation Report

| Street: | MEDLEE DR | Flow Control: | Not Controlled |
| City: | Hobart, IN | Year Renewed: | |
| US MH: | M-607-039 | DS MH: | M-607-069 |

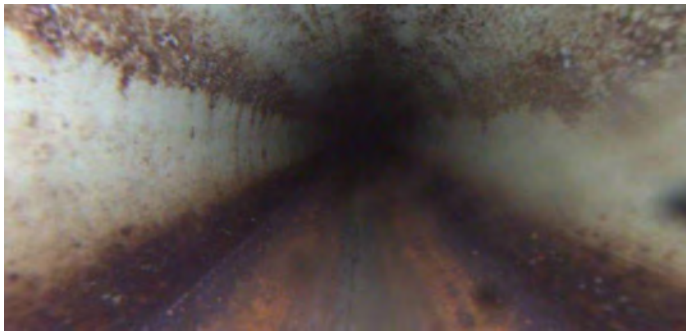
Code: **AMH**
Description: **Manhole**

Distance (ft): **.0**
Structural Grade: **0**
O&M Grade: **0**
Clock Start/From:
Clock To:
1st Value:
2nd Value:
Value Percent:
Continuous Index:
Within 8" of Joint: **NO**
Remarks: **M-607-069**

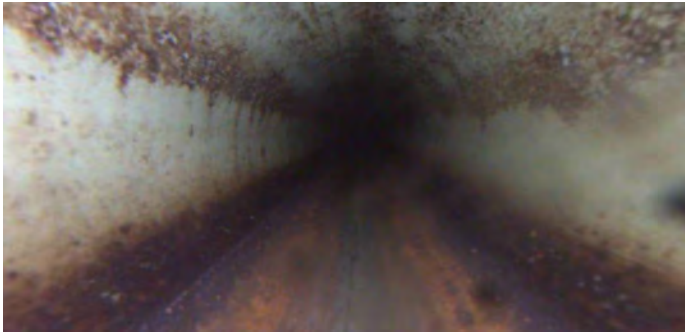
| Code: | MWL |
| Description: | Water Level |

| Distance (ft): | .0 |
| Value Percent: | 5.000 |

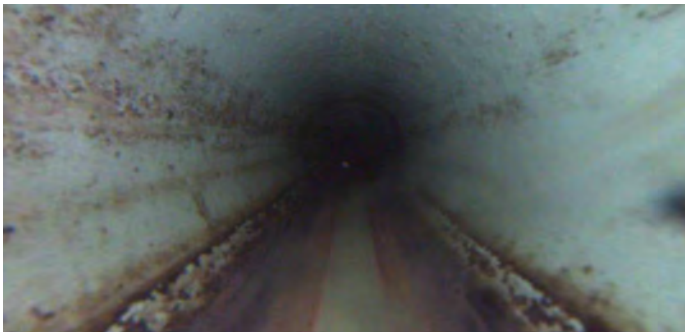
| Code: | MSA |
| Description: | Abandoned Survey |

| Distance (ft): | 22.9 |
| Remarks: | UNKNOWN |
