Profile/Photo Observation Report

Date:	04/03/2018	Weather:		Coding:	PACP 6.0
Pipe Length (ft):	73.0	Owner:	NA	Pre Clean:	No Pre-Cleaning
P.O.#:		Surveyor:	Jen Costello	PSR:	P-607-039-069
Customer:		Clean Date:	01/01/1900	Shape:	C

Street:	MEDLEE DR	Flow Control:	Not Controlled
City:	Hobart, IN	Year Renewed:	
Location:	Yard	Tape/Media #:	
Purpose:	Routine Assessment	Dia/Height:	8"
Use:	Sanitary	Material:	PVC
Drain Area:	NA	Lining:	
Category:	NA		
Comment:			
Location Details:		Direction of Survey:	Upstream
US MH:	M-607-039	DS MH:	M-607-069
		Total Length Surveyed (ft):	72.2

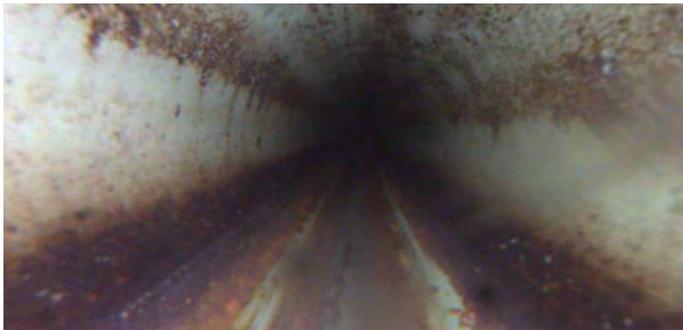
Code: **AMH**
Description: **Manhole**

Distance (ft): **.0**
Structural Grade: **0**
O&M Grade: **0**
Clock Start/From:
Clock To:
1st Value:
2nd Value:
Value Percent:
Continuous Index:
Within 8" of Joint: **NO**
Remarks: **M-607-069**

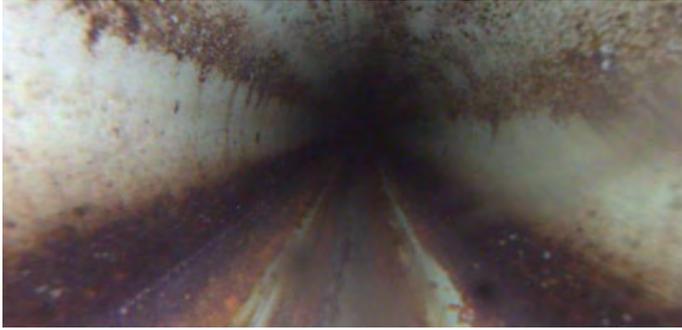
Code: **MWL**
Description: **Water Level**

Distance (ft): **.0**
Structural Grade: **0**
O&M Grade: **0**
Clock Start/From:
Clock To:
1st Value:
2nd Value:
Value Percent: **5.000**
Continuous Index:
Within 8" of Joint: **NO**
Remarks:

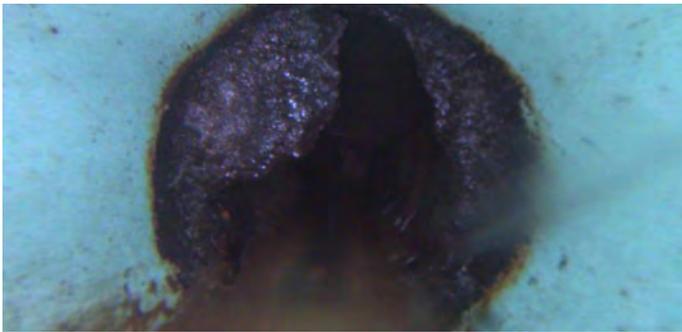
Code: **DAE**
Description: **Deposits Attached Encrustation**

Distance (ft): **69.8**
Structural Grade: **0**
O&M Grade: **4**
Clock Start/From: **8**
Clock To: **4**
1st Value:
2nd Value:
Value Percent: **30.000**
Continuous Index:
Within 8" of Joint: **NO**
Remarks: **from MH**

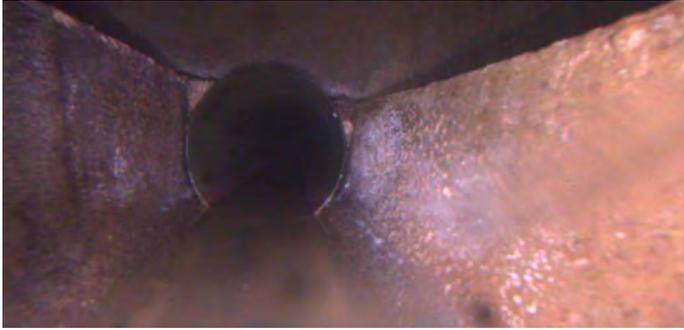
Code:	AMH
Description:	Manhole
Distance (ft):	72.2
Structural Grade:	0
O&M Grade:	0
Clock Start/From:	
Clock To:	
1st Value:	
2nd Value:	
Value Percent:	
Continuous Index:	
Within 8" of Joint:	NO
Remarks:	M-607-039
