Profile/Ph	oto Observatio	n Report			RedZon
Date:	04/03/2018	Weather:		Coding:	PACP 6.0
Pipe Length (ft	:): 117.7	Owner:	NA	Pre Clean:	No Pre-Cleaning
P.O.#:		Surveyor:	Jen Costello	PSR:	P-607-047-048
Customer:		Clean Date:	01/01/1900	Shape:	С
Street:	MEDLEE DR		Flow Control:	Not Controlled	
City:	Hobart, IN		Year Renewed:		
Location:	Yard		Tape/Media #:		
Purpose:	Routine Assessme	ent	Dia/Height:	8"	
Use:	Sanitary		Material:	PVC	
Drain Area:	NA		Lining:		
Category:	NA				
Comment:	Flow direction is	marked wrong.			
Location Detai	ls:		Direction of Surve	ey: Downstream	
US MH:	M-607-048	DS MH:	M-607-047	Total Length Surveyed (ft)	: 115.7
0&M Index:	0.00	O&M Quick:	0000	O&M Rating:	0.00
Structural Index:	0.00	Structural Qu	uick: 0000	Structural Rating:	0.00
Overall Index:	0.00	Overall Quick	<: 0000	Overall Rating:	0.00

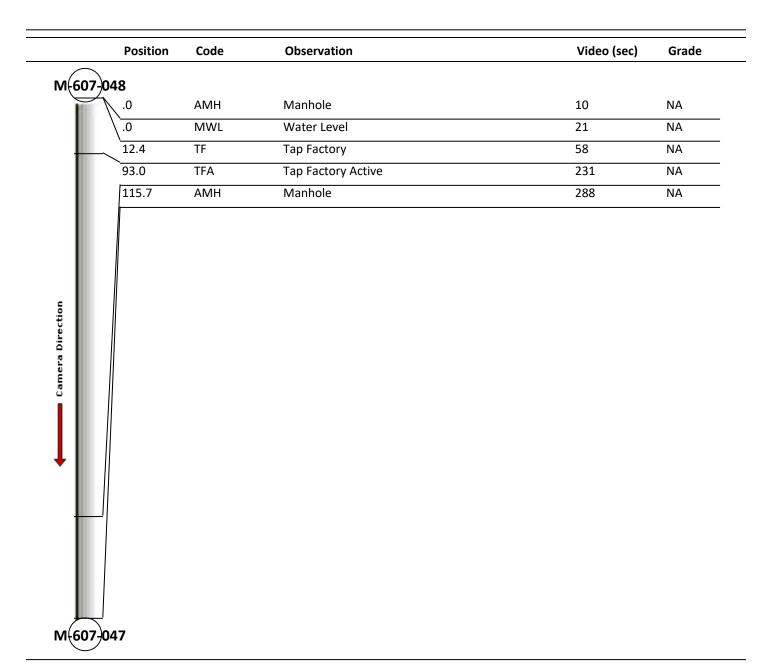
Code:	AMH	
Description:	Manhole	
Distance (ft):	.0	
Structural Grade:	0	
O&M Grade:	0	
Clock Start/From:		
Clock To:		
1st Value:		
2nd Value:		
Value Percent:		
Continuous Index:		
Within 8" of Joint:	NO	
Remarks:	M-607-048
