Profile/Photo Observation Report

Street:	FOXCROFT STREET	Flow Control:	Not Controlled
City:	Hobart, IN	Year Renewed:	
Location:	Yard	Tape/Media #:	
Purpose:	Routine Assessment	Dia/Height:	10"
Use:	Sanitary	Material:	PVC
Drain Area:	NA	Lining:	
Category:	NA		
Comment:

Location Details:		Direction of Survey:	Upstream
US MH:	M-607-053	DS MH:	M-607-054
		Total Length Surveyed (ft):	215.2

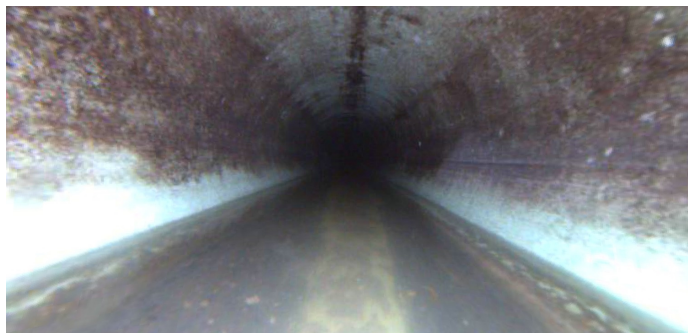
Code: **AMH**
 Description: **Manhole**

Distance (ft): **.0**
 Structural Grade: **0**
 O&M Grade: **0**
 Clock Start/From:
 Clock To:
 1st Value:
 2nd Value:
 Value Percent:
 Continuous Index:
 Within 8" of Joint: **NO**
 Remarks: **M-607-054**

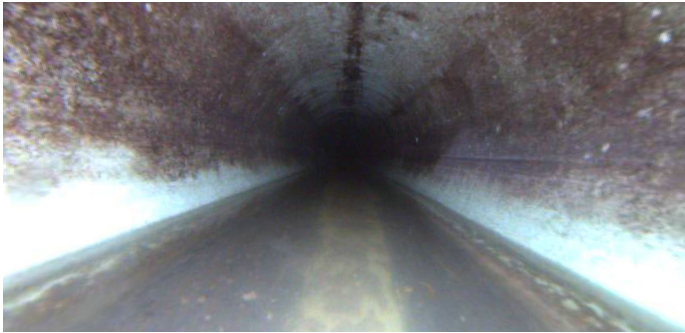
Code: **MWL**
Description: **Water Level**

Distance (ft): **.0**
Structural Grade: **0**
O&M Grade: **0**
Clock Start/From:
Clock To:
1st Value:
2nd Value:
Value Percent: **20.000**
Continuous Index:
Within 8" of Joint: **NO**
Remarks:

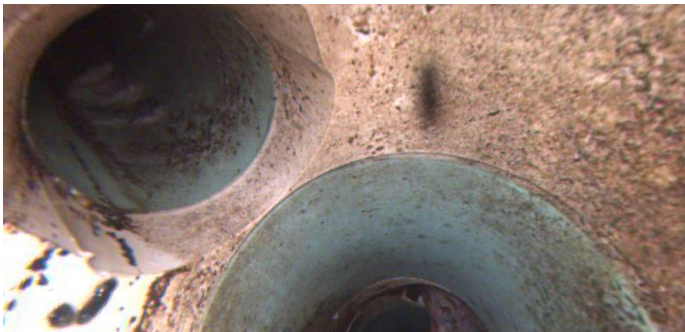
Code: **TFA**
Description: **Tap Factory Active**

Distance (ft): **137.6**
Structural Grade: **0**
O&M Grade: **0**
Clock Start/From: **10**
Clock To:
1st Value: **4.000**
2nd Value:
Value Percent:
Continuous Index:
Within 8" of Joint:
Remarks:

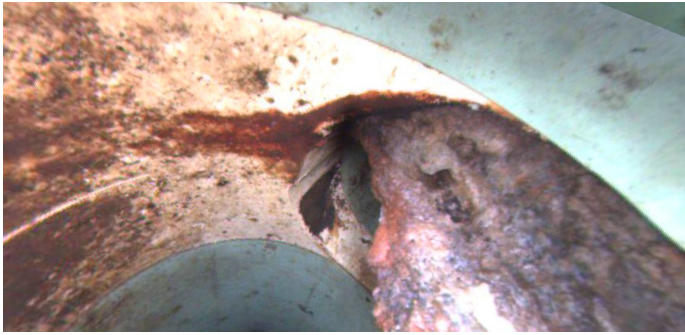
Code: **TFD**
Description: **Tap Factory Defective**

Distance (ft): **139.1**
Structural Grade: **0**
O&M Grade: **2**
Clock Start/From: **1**
Clock To:
1st Value: **4.000**
2nd Value:
Value Percent:
Continuous Index:
Within 8" of Joint:
Remarks: **dae**

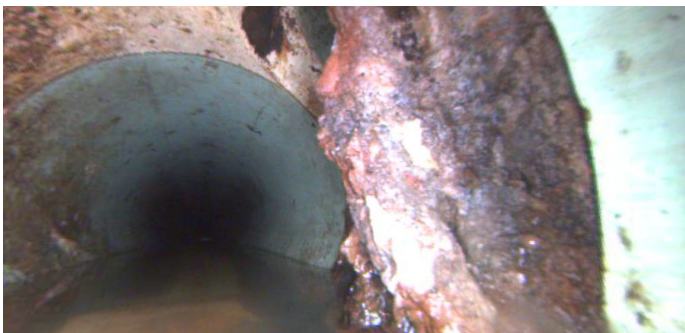
Code: **DAE**
Description: **Deposits Attached Encrustation**

Distance (ft): **139.1**
Structural Grade: **0**
O&M Grade: **3**
Clock Start/From: **1**
Clock To: **4**
1st Value:
2nd Value:
Value Percent: **15.000**
Continuous Index:
Within 8" of Joint: **YES**
Remarks:

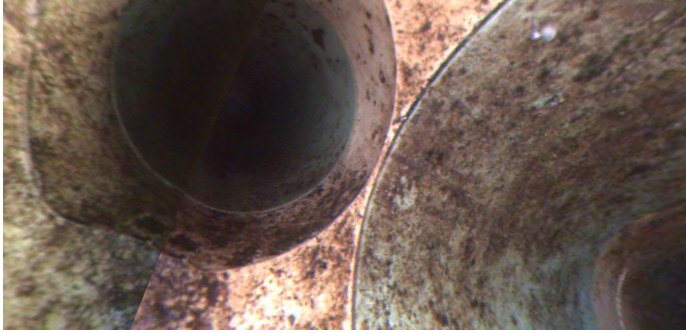
Code: **TF**
Description: **Tap Factory**

Distance (ft): **175.3**
Structural Grade: **0**
O&M Grade: **0**
Clock Start/From: **10**
Clock To:
1st Value: **4.000**
2nd Value:
Value Percent:
Continuous Index:
Within 8" of Joint:
Remarks:

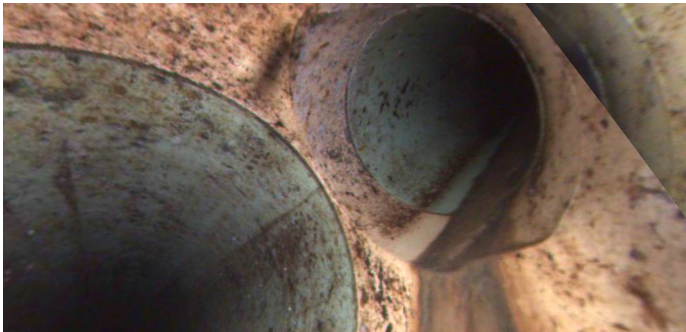
Code: **TF**
Description: **Tap Factory**

Distance (ft): **177.0**
Structural Grade: **0**
O&M Grade: **0**
Clock Start/From: **2**
Clock To:
1st Value: **4.000**
2nd Value:
Value Percent:
Continuous Index:
Within 8" of Joint:
Remarks:

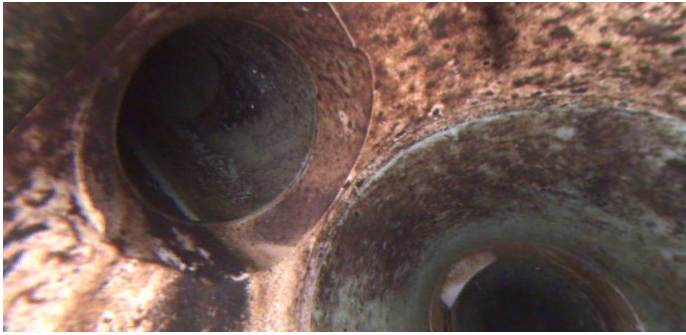
Code: **TF**
Description: **Tap Factory**

Distance (ft): **205.6**
Structural Grade: **0**
O&M Grade: **0**
Clock Start/From: **10**
Clock To:
1st Value: **4.000**
2nd Value:
Value Percent:
Continuous Index:
Within 8" of Joint:
Remarks:

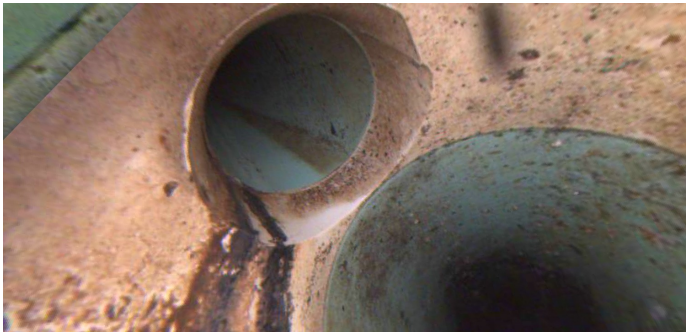
Code: **TF**
Description: **Tap Factory**

Distance (ft): **207.3**
Structural Grade: **0**
O&M Grade: **0**
Clock Start/From: **10**
Clock To:
1st Value: **4.000**
2nd Value:
Value Percent:
Continuous Index:
Within 8" of Joint:
Remarks:

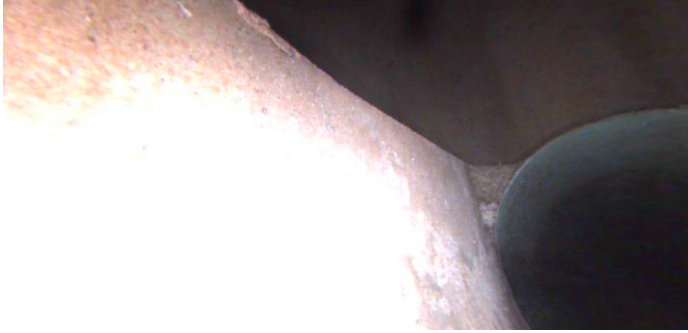
Code:	AMH
Description:	Manhole
Distance (ft):	215.2
Structural Grade:	0
O&M Grade:	0
Clock Start/From:	
Clock To:	
1st Value:	
2nd Value:	
Value Percent:	
Continuous Index:	
Within 8" of Joint:	NO
Remarks:	M-607-053
