Profile/Photo Observation Report

Date:	04/08/2018	Weather:		Coding:	PACP 6.0
Pipe Length (ft):		Owner:	City of Hobart	Pre Clean:	Not Known
P.O.#:	210	Surveyor:	B. Helbling	PSR:	P-607-055-033
Customer:	City of Hobart	Clean Date:		Shape:	C

Street:	South Wisconsin Street	Flow Control:	Not Controlled
City:	Hobart, IN	Year Renewed:	
Location:	Sidewalk	Tape/Media #:	DEP210
Purpose:	Routine Assessment	Dia/Height:	15"
Use:	Sanitary	Material:	PVC
Drain Area:		Lining:	
Category:	NA		
Comment:	YES501824 Submittal 2		
Location Details:		Direction of Survey:	Downstream
US MH:	M-607-055	DS MH:	M-607-033
		Total Length Surveyed (ft):	82.6

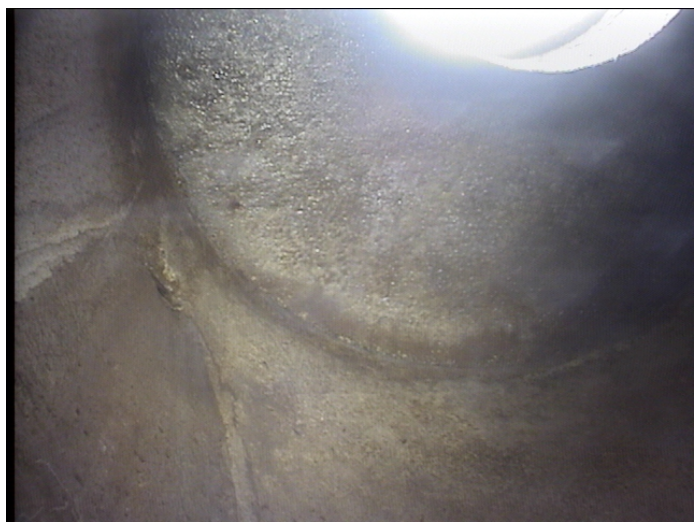
Code: **AMH**
Description: **Manhole**

Distance (ft): **.0**
Structural Grade: **0**
O&M Grade: **0**
Clock Start/From:
Clock To:
1st Value:
2nd Value:
Value Percent:
Continuous Index:
Within 8" of Joint: **NO**
Remarks: **M-607-055**

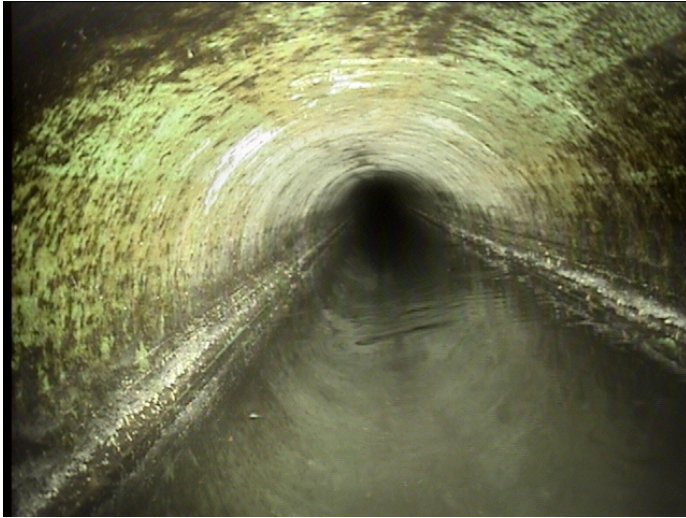
Code: **MWL**
Description: **Water Level**

Distance (ft): **.0**
Structural Grade: **0**
O&M Grade: **0**
Clock Start/From:
Clock To:
1st Value:
2nd Value:
Value Percent: **15.000**
Continuous Index:
Within 8" of Joint: **NO**
Remarks:

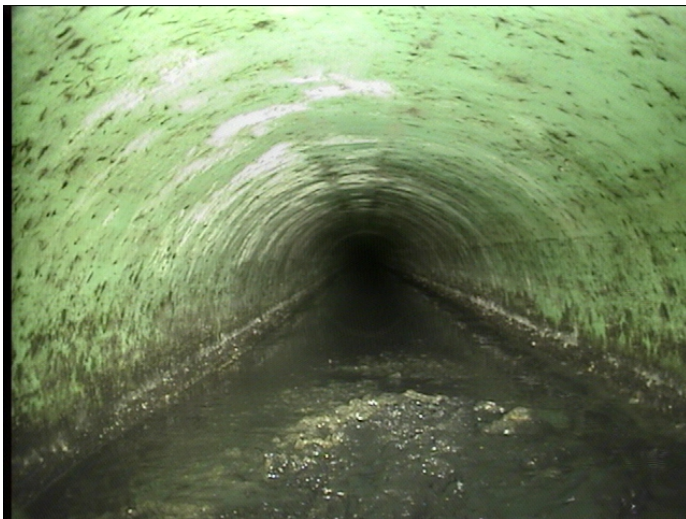
Code: **DSF**
Description: **Deposits Settled Fine**

Distance (ft): **8.0**
Structural Grade: **0**
O&M Grade: **3**
Clock Start/From: **4**
Clock To: **8**
1st Value:
2nd Value:
Value Percent: **15.000**
Continuous Index: **S01**
Within 8" of Joint: **NO**
Remarks:

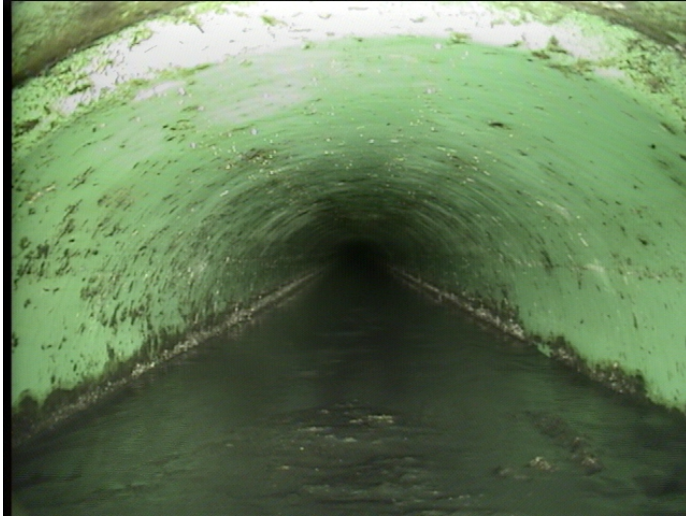
Code:	DSF
Description:	Deposits Settled Fine
Distance (ft):	82.6
Structural Grade:	0
O&M Grade:	3
Clock Start/From:	4
Clock To:	8
1st Value:	
2nd Value:	
Value Percent:	15.000
Continuous Index:	F01
Within 8" of Joint:	NO
Remarks:

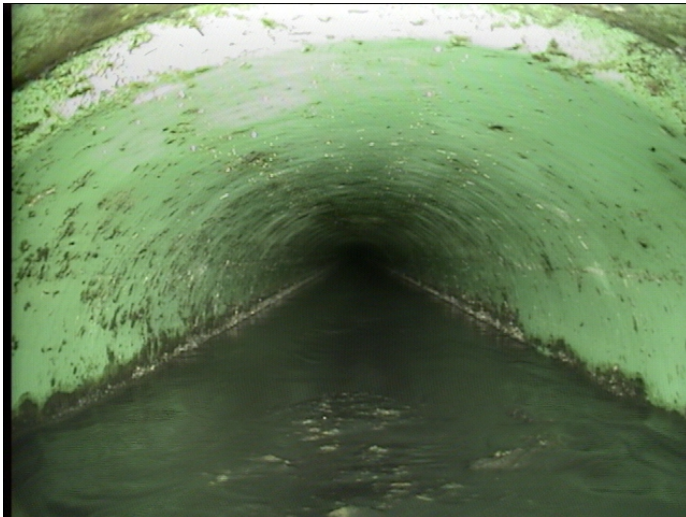
Code:	MSA
Description:	Abandoned Survey
Distance (ft):	82.6
Structural Grade:	0
O&M Grade:	0
Clock Start/From:	
Clock To:	
1st Value:	
2nd Value:	
Value Percent:	
Continuous Index:	
Within 8" of Joint:	NO
Remarks:	Heavy sediment
