Date:	04/08/2018	Weather:		Coding:	PACP 6.0
Pipe Length (f	t):	Owner:	City of Hobart	Pre Clean:	Not Known
P.O.#:	209	Surveyor:	B. Helbling	PSR:	P-607-056-055
Customer:	City of Hobart	Clean Date:		Shape:	С
Street:	South Wisconsin Street		Flow Control:	Not Controlled	1
City:	Hobart, IN		Year Renewed:		
Location:	Sidewalk		Tape/Media #:	DEP209	
Purpose:	Routine Assessme	nt	Dia/Height:	15"	
Use:	Sanitary		Material:	PVC	
Drain Area:			Lining:		
Category:	NA				
Comment:	nment: YES501824 Submital 2				
Location Deta	ils:		Direction of Survey	y: Downstream	
US MH:	M-607-056	DS MH:	M-607-055	Total Length Surveyed (ft	): <b>369.0</b>
D&M Index:	2.00	O&M Quick:	2M00	O&M Rating:	148.00
Structural Index		Structural Qu	uick: 0000	Structural Rating:	0.00
Overall Index: 2.00		Overall Quick			148.00

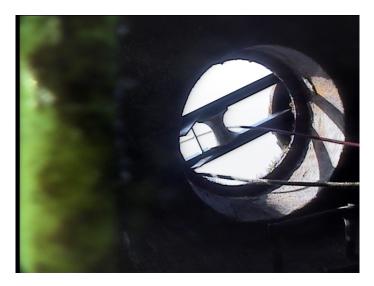
Code: Description:	AMH Manhole
Distance (ft):	.0
Structural Grade:	0
O&M Grade:	0
Clock Start/From:	
Clock To:	
1st Value:	
2nd Value:	
Value Percent:	
Continuous Index:	
Within 8" of Joint:	NO
Remarks:	M-607-056

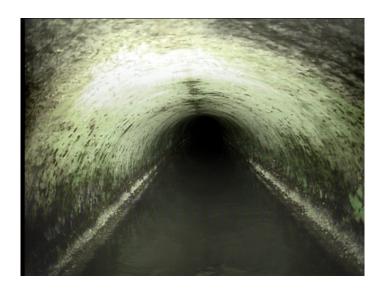
Code: Description:	DSF Deposits Settled Fine
Distance (ft): Structural Grade: O&M Grade: Clock Start/From: Clock To: 1st Value: 2nd Value: Value Percent: Continuous Index: Within 8" of Joint: Remarks:	.2 0 2 5 7 5.000 501 NO

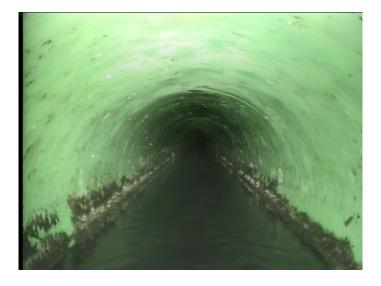
Code:	DSF
Description:	<b>Deposits Settled Fine</b>
Distance (ft):	369.0
Structural Grade:	0
O&M Grade:	2
Clock Start/From:	5
Clock To:	7
1st Value:	
2nd Value:	
Value Percent:	10.000
Continuous Index:	F01
Within 8" of Joint:	NO

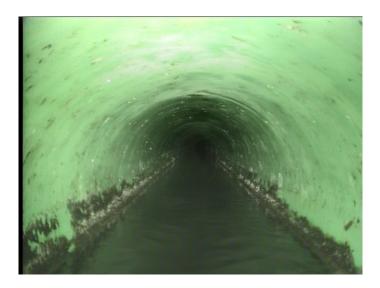
Code: Description:	MSA Abandoned Survey
Distance (ft):	369.0
Structural Grade:	0
O&M Grade:	0
Clock Start/From:	
Clock To:	
1st Value:	
2nd Value:	
Value Percent:	
Continuous Index:	
Within 8" of Joint:	NO
Remarks:	Thick sediment
