Profile/Photo Observation Report

Date:	04/08/2018	Weather:		Coding:	PACP 6.0
Pipe Length (ft):		Owner:	City of Hobart	Pre Clean:	Not Known
P.O.#:	210	Surveyor:	B. Helbling	PSR:	P-607-056-055
Customer:	City of Hobart	Clean Date:		Shape:	C

Street:	South Wisconsin Street	Flow Control:	Not Controlled
City:	Hobart, IN	Year Renewed:	
Location:	Sidewalk	Tape/Media #:	DEP210
Purpose:	Routine Assessment	Dia/Height:	15"
Use:	Sanitary	Material:	PVC
Drain Area:		Lining:	
Category:	NA		
Comment:	YES501824 Submittal 2		
Location Details:		Direction of Survey:	Upstream
US MH:	M-607-056	DS MH:	M-607-055
		Total Length Surveyed (ft):	112.9

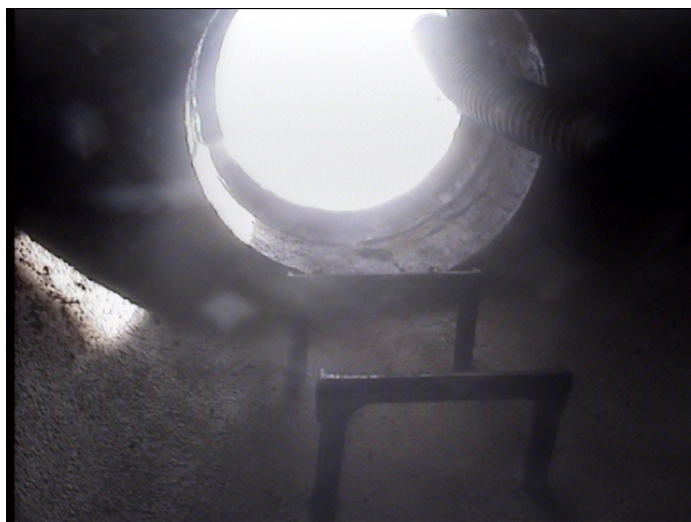
Code: **AMH**
Description: **Manhole**

Distance (ft): **.0**
Structural Grade: **0**
O&M Grade: **0**
Clock Start/From:
Clock To:
1st Value:
2nd Value:
Value Percent:
Continuous Index:
Within 8" of Joint: **NO**
Remarks: **M-607-055**

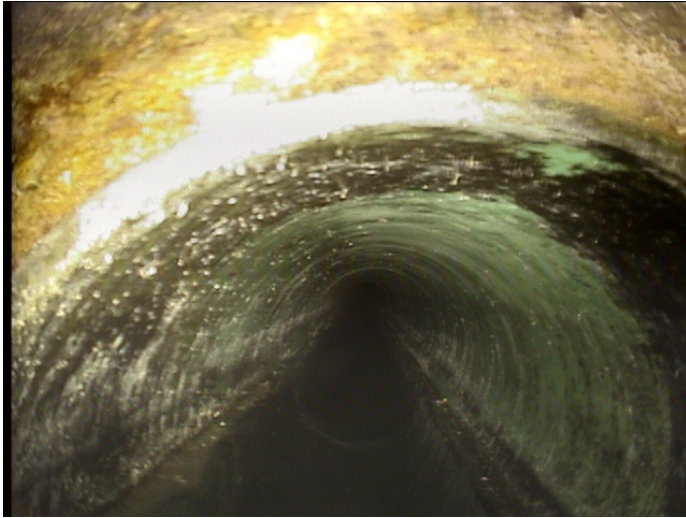
Code: **MWL**
Description: **Water Level**

Distance (ft): **.0**
Structural Grade: **0**
O&M Grade: **0**
Clock Start/From:
Clock To:
1st Value:
2nd Value:
Value Percent: **10.000**
Continuous Index:
Within 8" of Joint: **NO**
Remarks:

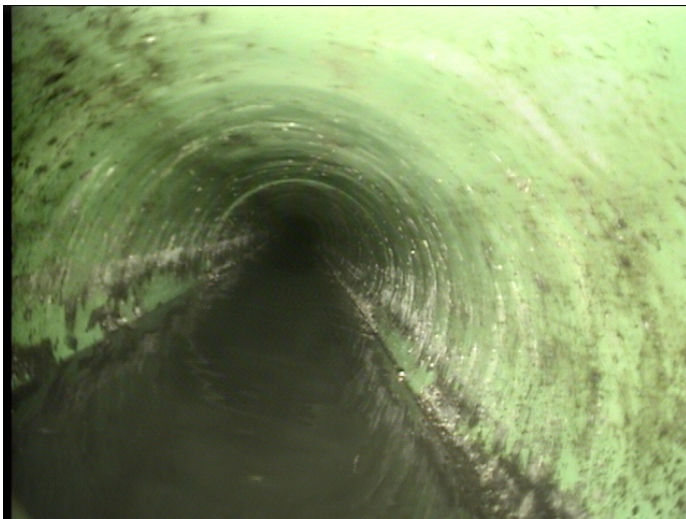
Code: **DSF**
Description: **Deposits Settled Fine**

Distance (ft): **.0**
Structural Grade: **0**
O&M Grade: **2**
Clock Start/From: **5**
Clock To: **7**
1st Value:
2nd Value:
Value Percent: **5.000**
Continuous Index: **S01**
Within 8" of Joint: **NO**
Remarks:

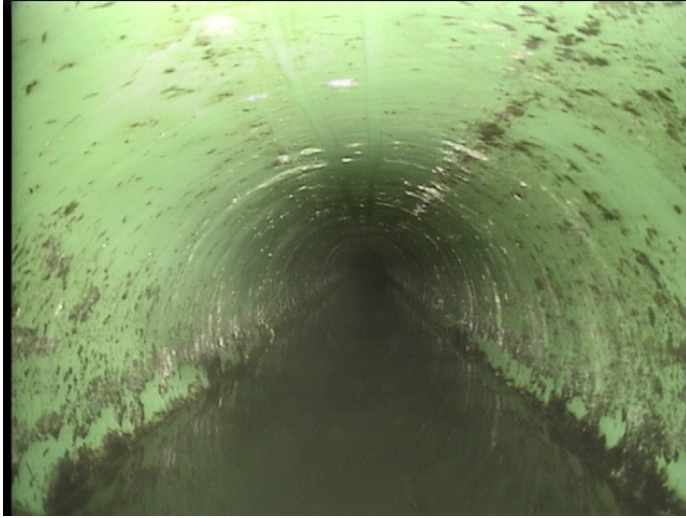
Code: **DSF**
Description: **Deposits Settled Fine**

Distance (ft): **112.9**
Structural Grade: **0**
O&M Grade: **2**
Clock Start/From: **5**
Clock To: **7**
1st Value:
2nd Value:
Value Percent: **5.000**
Continuous Index: **F01**
Within 8" of Joint: **NO**
Remarks:

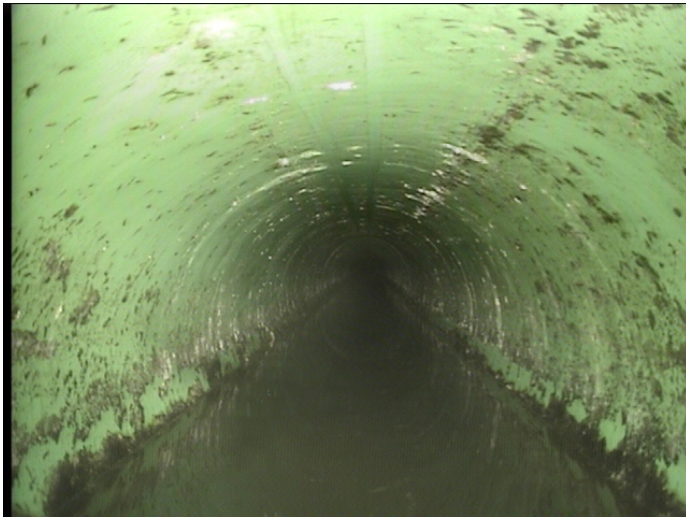
Code: **MSA**
Description: **Abandoned Survey**

Distance (ft): **112.9**
Structural Grade: **0**
O&M Grade: **0**
Clock Start/From:
Clock To:
1st Value:
2nd Value:
Value Percent:
Continuous Index:
Within 8" of Joint: **NO**
Remarks: **Sediment. Dots connected**
