Profile/Photo Observation Report

Date:	04/08/2018	Weather:		Coding:	PACP 6.0
Pipe Length (ft):		Owner:	City of Hobart	Pre Clean:	Not Known
P.O.#:	207	Surveyor:	B. Helbling	PSR:	P-607-057-056
Customer:	City of Hobart	Clean Date:		Shape:	C

Street:	South Wisconsin Street	Flow Control:	Not Controlled
City:	Hobart, IN	Year Renewed:	
Location:	Sidewalk	Tape/Media #:	DEP207
Purpose:	Routine Assessment	Dia/Height:	15"
Use:	Sanitary	Material:	PVC
Drain Area:		Lining:	
Category:	NA		
Comment:	YES501824 Submittal 2		
Location Details:		Direction of Survey:	Downstream
US MH:	M-607-057	DS MH:	M-607-056
		Total Length Surveyed (ft):	5.4

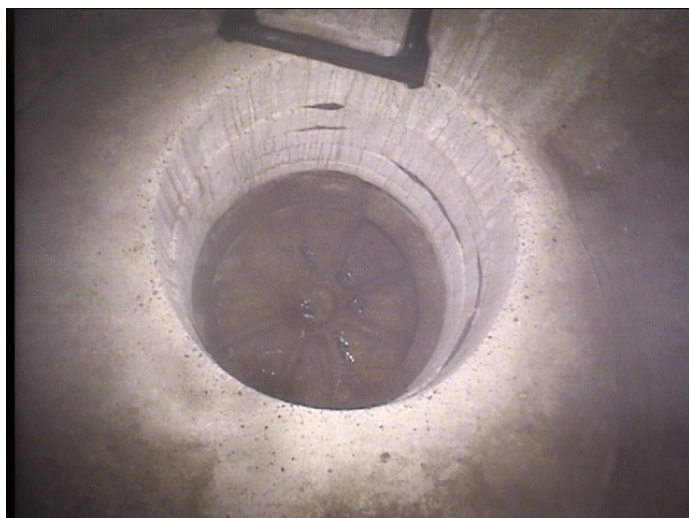
Code: **AMH**
Description: **Manhole**

Distance (ft): **.0**
Structural Grade: **0**
O&M Grade: **0**
Clock Start/From:
Clock To:
1st Value:
2nd Value:
Value Percent:
Continuous Index:
Within 8" of Joint: **NO**
Remarks: **M-607-057**

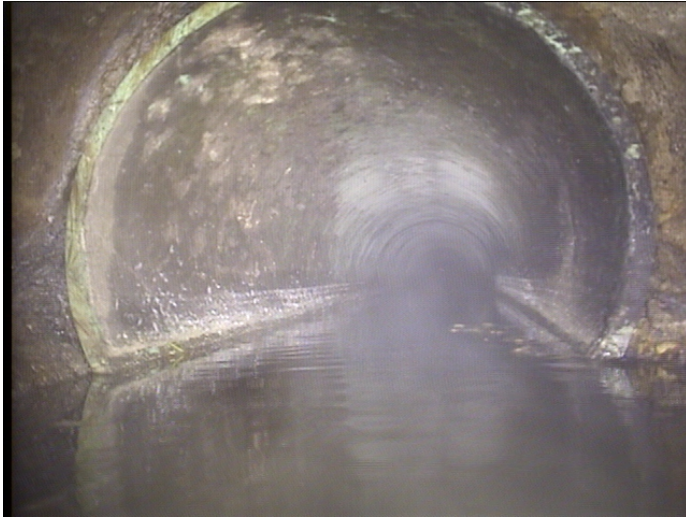
Code: **MWL**
Description: **Water Level**

Distance (ft): **.0**
Structural Grade: **0**
O&M Grade: **0**
Clock Start/From:
Clock To:
1st Value:
2nd Value:
Value Percent: **10.000**
Continuous Index:
Within 8" of Joint: **NO**
Remarks:

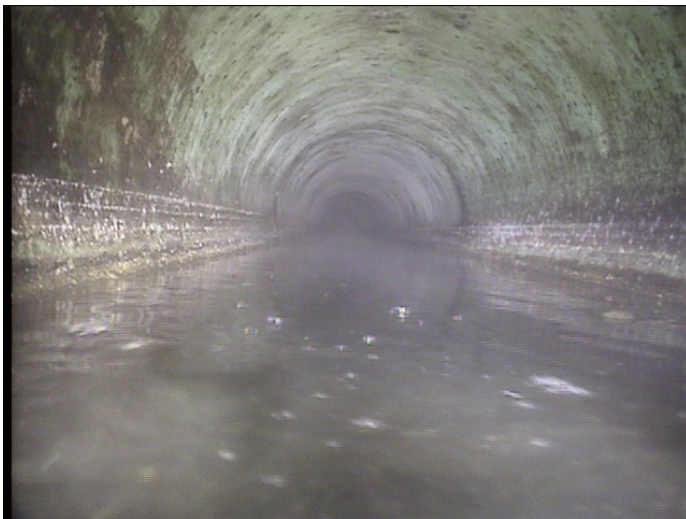
Code: **DSF**
Description: **Deposits Settled Fine**

Distance (ft): **2.2**
Structural Grade: **0**
O&M Grade: **2**
Clock Start/From: **4**
Clock To: **8**
1st Value:
2nd Value:
Value Percent: **5.000**
Continuous Index:
Within 8" of Joint: **NO**
Remarks:

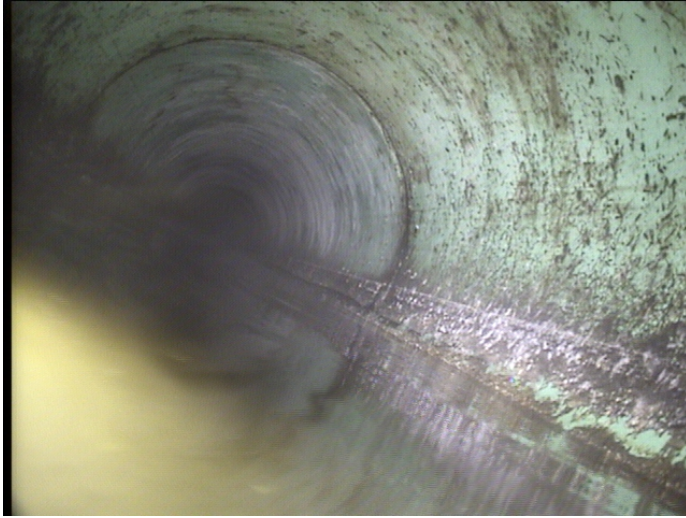
Code: **OBZ**
Description: **Obstacle Other**

Distance (ft): **5.4**
Structural Grade: **0**
O&M Grade: **2**
Clock Start/From: **5**
Clock To: **7**
1st Value:
2nd Value:
Value Percent: **5.000**
Continuous Index:
Within 8" of Joint: **NO**
Remarks: **Debris under flow**

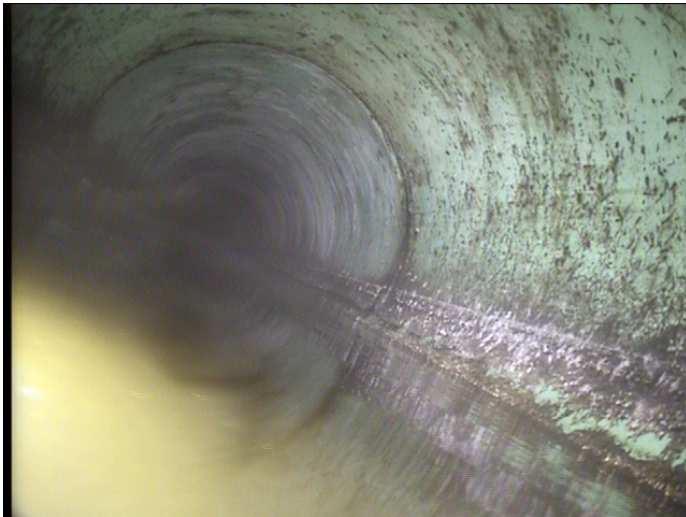
Code: **MSA**
Description: **Abandoned Survey**

Distance (ft): **5.4**
Structural Grade: **0**
O&M Grade: **0**
Clock Start/From:
Clock To:
1st Value:
2nd Value:
Value Percent:
Continuous Index:
Within 8" of Joint: **NO**
Remarks: **Cannot pass debris under flow**
