## Profile/Photo Observation Report

Date:	<b>04/08/2018</b>	Weather:		Coding:	<b>PACP 6.0</b>
Pipe Length (ft):		Owner:	<b>City of Hobart</b>	Pre Clean:	<b>Not Known</b>
P.O.#:	<b>208</b>	Surveyor:	<b>B. Helbling</b>	PSR:	<b>P-607-057-056</b>
Customer:	<b>City of Hobart</b>	Clean Date:		Shape:	<b>C</b>

Street:	<b>South Wisconsin Street</b>	Flow Control:	<b>Not Controlled</b>
City:	<b>Hobart, IN</b>	Year Renewed:	
Location:	<b>Sidewalk</b>	Tape/Media #:	<b>DEP208</b>
Purpose:	<b>Routine Assessment</b>	Dia/Height:	<b>15"</b>
Use:	<b>Sanitary</b>	Material:	<b>PVC</b>
Drain Area:		Lining:	
Category:	<b>NA</b>		
Comment:	<b>YES501824 Submittal 2</b>		
Location Details:		Direction of Survey:	<b>Upstream</b>
US MH:	<b>M-607-057</b>	DS MH:	<b>M-607-056</b>
		Total Length Surveyed (ft):	<b>260.9</b>

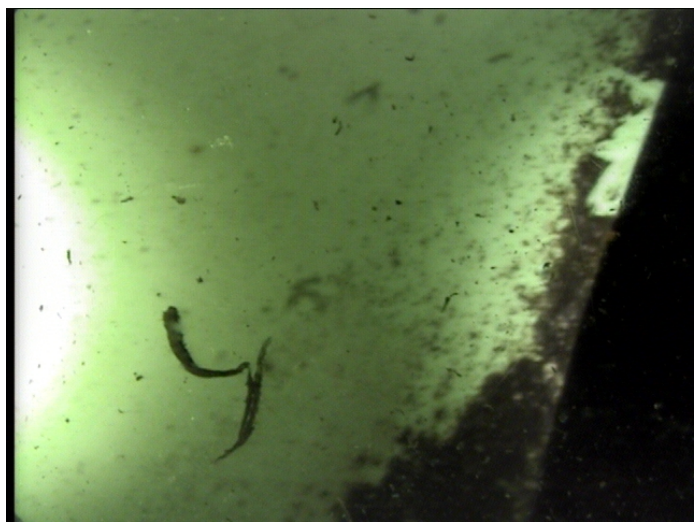
Code: **AMH**  
Description: **Manhole**

Distance (ft): **.0**  
Structural Grade: **0**  
O&M Grade: **0**  
Clock Start/From:  
Clock To:  
1st Value:  
2nd Value:  
Value Percent:  
Continuous Index:  
Within 8" of Joint: **NO**  
Remarks: **M-607-056**

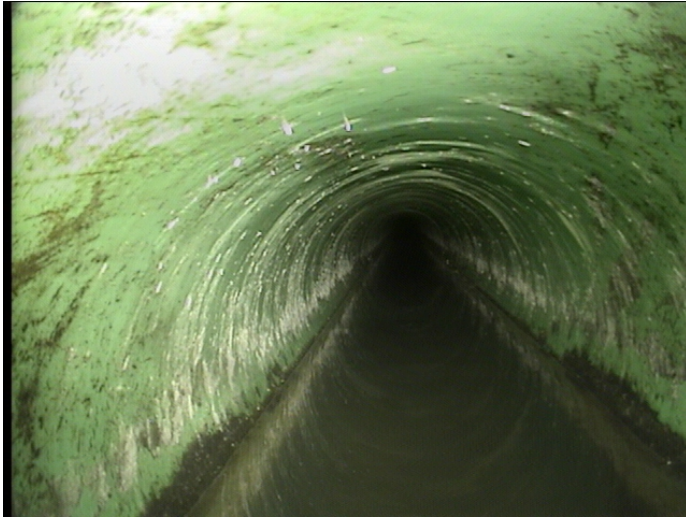
Code: **MWL**  
Description: **Water Level**

Distance (ft): **.0**  
Structural Grade: **0**  
O&M Grade: **0**  
Clock Start/From:  
Clock To:  
1st Value:  
2nd Value:  
Value Percent: **10.000**  
Continuous Index:  
Within 8" of Joint: **NO**  
Remarks:

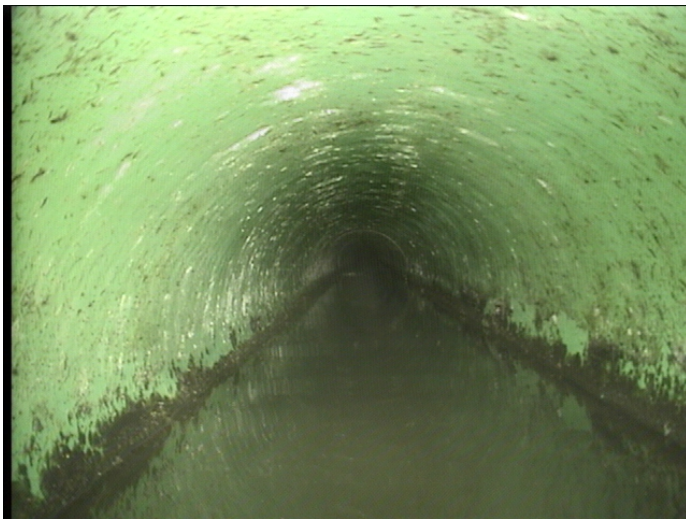
Code: **DSF**  
Description: **Deposits Settled Fine**

Distance (ft): **259.6**  
Structural Grade: **0**  
O&M Grade: **2**  
Clock Start/From: **5**  
Clock To: **7**  
1st Value:  
2nd Value:  
Value Percent: **10.000**  
Continuous Index:  
Within 8" of Joint: **NO**  
Remarks:

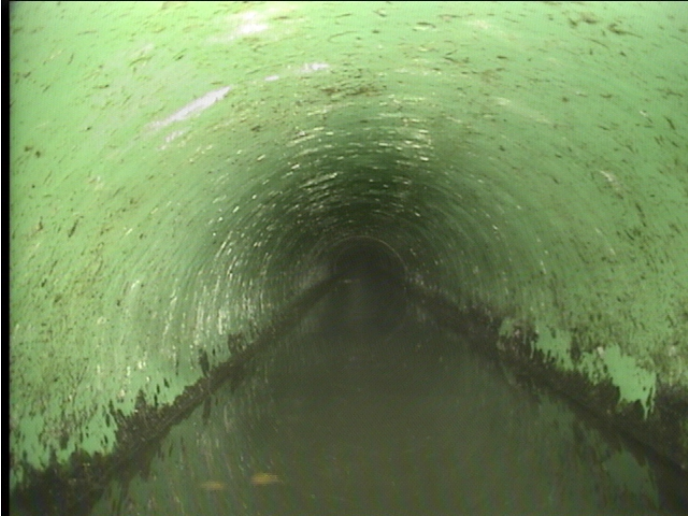
Code:	MSA
Description:	Abandoned Survey
Distance (ft):	260.7
Structural Grade:	0
O&M Grade:	0
Clock Start/From:	
Clock To:	
1st Value:	
2nd Value:	
Value Percent:	
Continuous Index:	
Within 8" of Joint:	NO
Remarks:	Thick sediment
