Profile/Photo Observation Report

Street:	South Wisconsin Street	Flow Control:	Not Controlled
City:	Hobart, IN	Year Renewed:	
Location:	Sidewalk	Tape/Media #:	DEP207
Purpose:	Routine Assessment	Dia/Height:	15"
Use:	Sanitary	Material:	PVC
Drain Area:		Lining:	
Category:	NA		
Comment:	YES501824 Submittal 2		
Location Details:		Direction of Survey:	Downstream
US MH:	M-607-058	DS MH:	M-607-057
		Total Length Surveyed (ft):	399.3

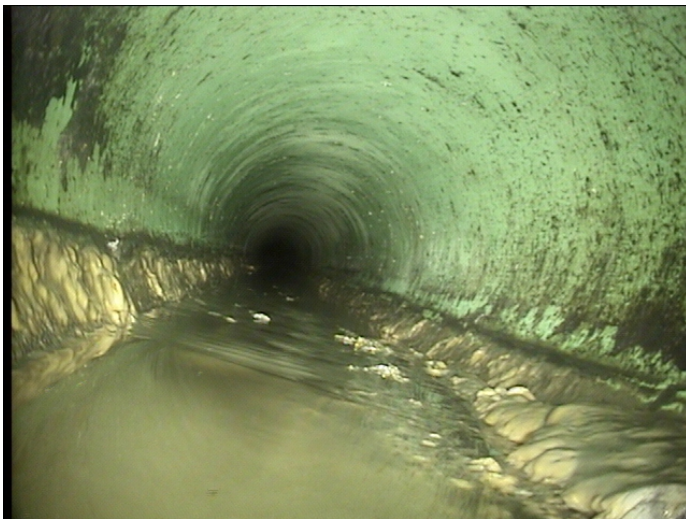
Code: **DAE**
Description: **Deposits Attached Encrustation**

Distance (ft): **3.0**
Structural Grade: **0**
O&M Grade: **2**
Clock Start/From: **4**
Clock To: **8**
1st Value:
2nd Value:
Value Percent: **10.000**
Continuous Index: **S01**
Within 8" of Joint: **NO**
Remarks:

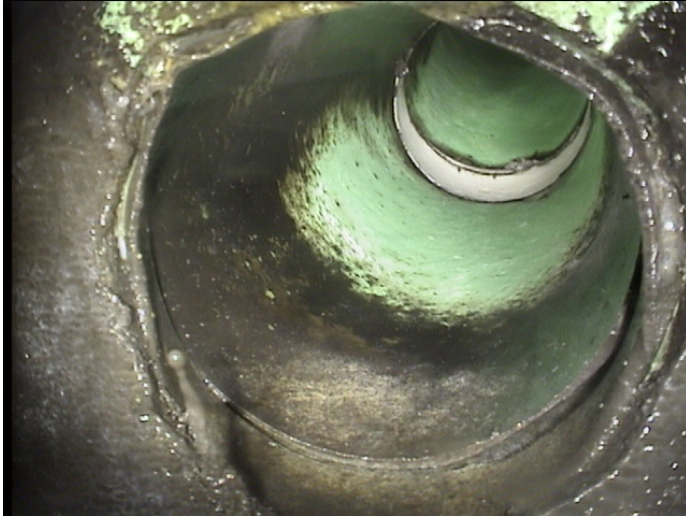
Code: **TB**
Description: **Tap Break-in**

Distance (ft): **45.3**
Structural Grade: **0**
O&M Grade: **0**
Clock Start/From: **10**
Clock To:
1st Value: **4.000**
2nd Value:
Value Percent:
Continuous Index:
Within 8" of Joint: **NO**
Remarks:

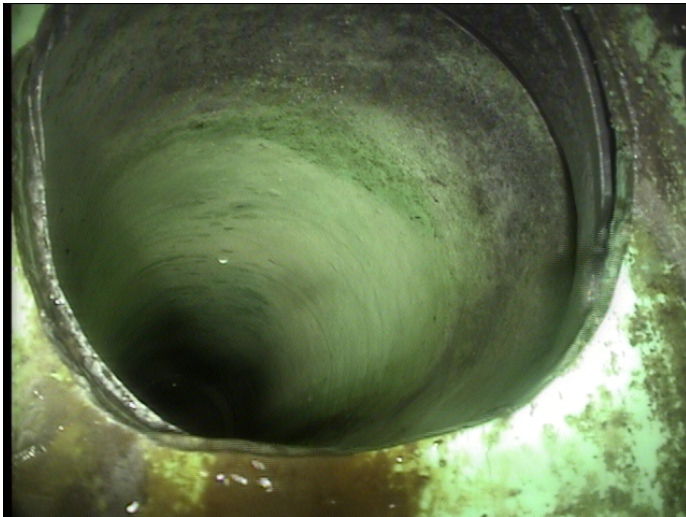
Code: **TBD**
Description: **Tap Break-in Defective**

Distance (ft): **168.8**
Structural Grade: **0**
O&M Grade: **3**
Clock Start/From: **9**
Clock To:
1st Value: **4.000**
2nd Value:
Value Percent:
Continuous Index:
Within 8" of Joint: **NO**
Remarks: **Defective**

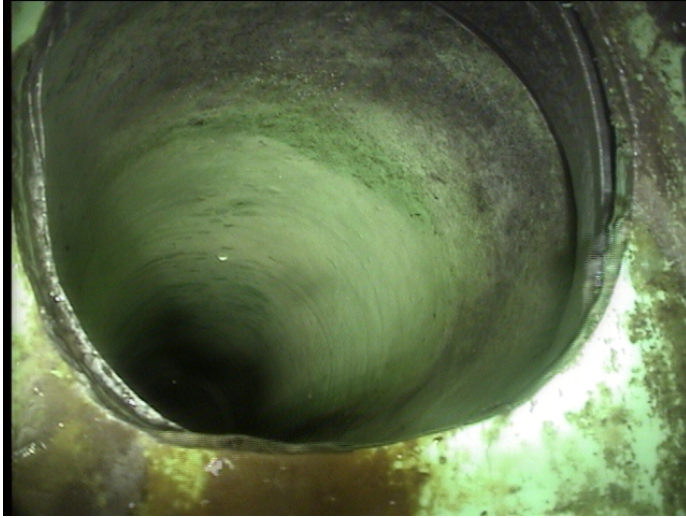
Code: **IR**
Description: **Infil Runner**

Distance (ft): **168.9**
Structural Grade: **0**
O&M Grade: **4**
Clock Start/From: **10**
Clock To:
1st Value:
2nd Value:
Value Percent:
Continuous Index:
Within 8" of Joint: **NO**
Remarks:

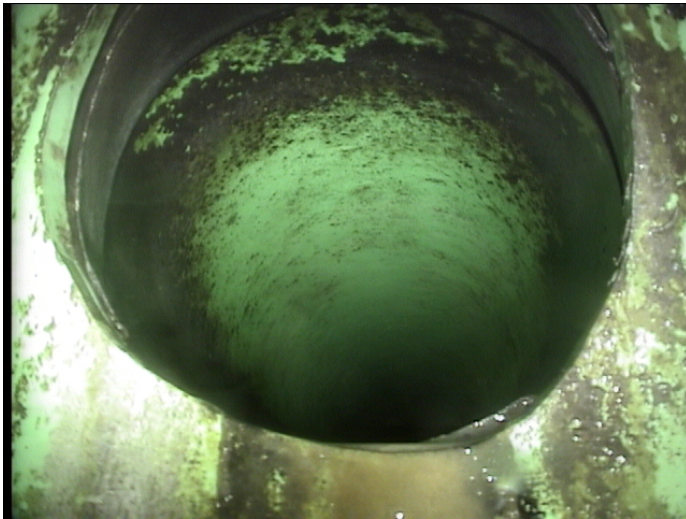
Code: **TB**
Description: **Tap Break-in**

Distance (ft): **211.6**
Structural Grade: **0**
O&M Grade: **0**
Clock Start/From: **10**
Clock To:
1st Value: **4.000**
2nd Value:
Value Percent:
Continuous Index:
Within 8" of Joint: **NO**
Remarks:

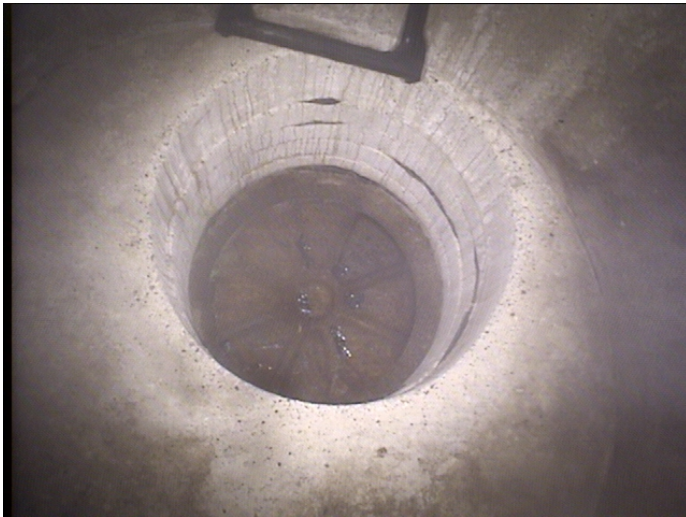
Code: **DAGS**
Description: **Deposits Attached Grease**

Distance (ft): **399.3**
Structural Grade: **0**
O&M Grade: **2**
Clock Start/From: **4**
Clock To: **8**
1st Value:
2nd Value:
Value Percent: **10.000**
Continuous Index: **F01**
Within 8" of Joint: **NO**
Remarks:
