Profile/Photo Observation Report

| Street: | S WISCONSIN ST | Flow Control: | Not Controlled |
| City: | Hobart, IN | Year Renewed: | |
| US MH: | M-607-059 | DS MH: | M-607-058 |

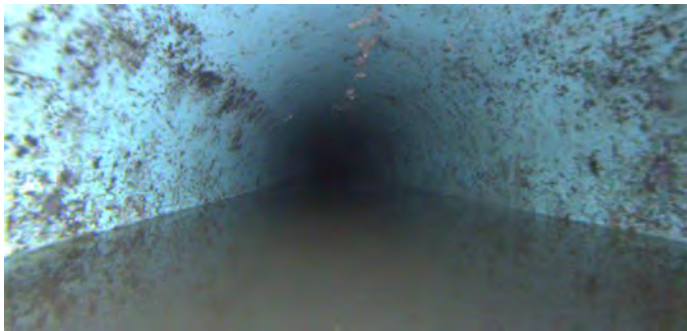
Code: **AMH**
Description: **Manhole**

Distance (ft): **.0**
Structural Grade: **0**
O&M Grade: **0**
Clock Start/From:
Clock To:
1st Value:
2nd Value:
Value Percent:
Continuous Index:
Within 8" of Joint: **NO**
Remarks: **M-607-058**

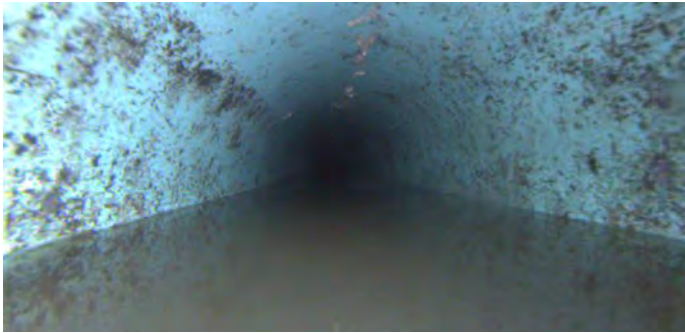
| Code: | MWL |
| Description: | Water Level |

| Value Percent: | 40.000 |

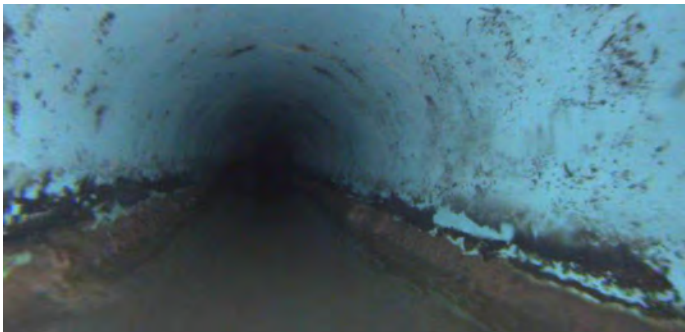
| Code: | DAGS |
| Description: | Deposits Attached Grease |

| Distance (ft): | 5.5 |
| O&M Grade: | 2 |
| Clock Start/From: | 8 |
| Clock To: | 4 |
| Value Percent: | 5.000 |
| Continuous Index: | S01 |

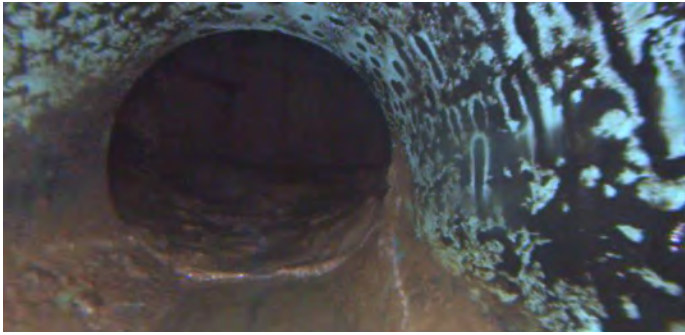
Code: **DAGS**
Description: **Deposits Attached Grease**

Distance (ft): **69.0**
Structural Grade: **0**
O&M Grade: **2**
Clock Start/From: **8**
Clock To: **4**
1st Value:
2nd Value:
Value Percent: **5.000**
Continuous Index: **F01**
Within 8" of Joint: **NO**
Remarks:

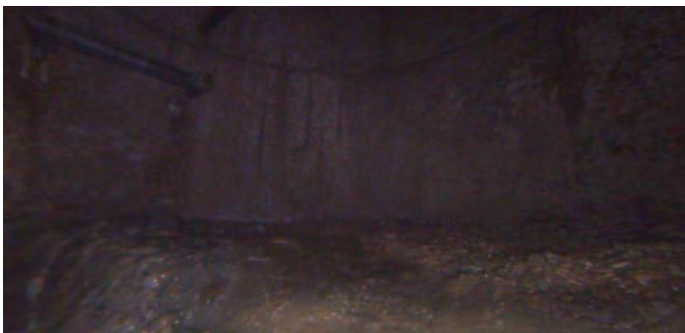
Code: **AMH**
Description: **Manhole**

Distance (ft): **71.0**
Structural Grade: **0**
O&M Grade: **0**
Clock Start/From:
Clock To:
1st Value:
2nd Value:
Value Percent:
Continuous Index:
Within 8" of Joint: **NO**
Remarks: **M-607-059**
