Profile/Photo Observation Report

Street:	West 14th Street	Flow Control:	Not Controlled
City:	Hobart, IN	Year Renewed:	
Location:	Light Highway	Tape/Media #:	DEP215
Purpose:	Routine Assessment	Dia/Height:	15"
Use:	Sanitary	Material:	PVC
Drain Area:		Lining:	
Category:	NA		
Comment:	YES501824 Submittal 2		
Location Details:		Direction of Survey:	Upstream
US MH:	M-607-060	DS MH:	M-607-061
		Total Length Surveyed (ft):	15.3

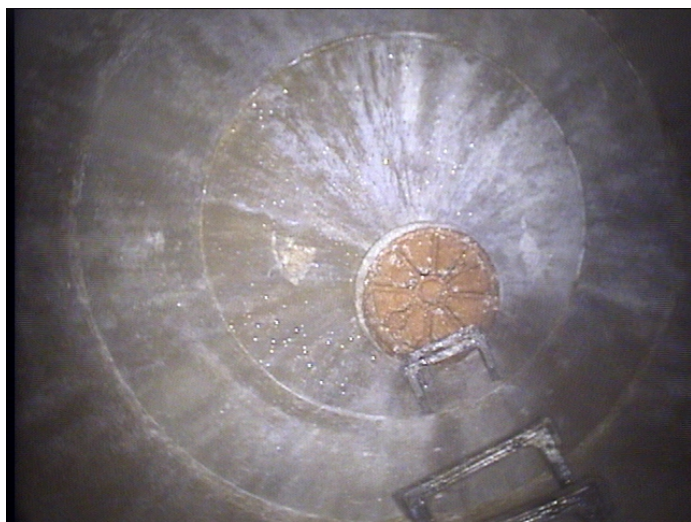
Code: **AMH**
Description: **Manhole**

Distance (ft): **.0**
Structural Grade: **0**
O&M Grade: **0**
Clock Start/From:
Clock To:
1st Value:
2nd Value:
Value Percent:
Continuous Index:
Within 8" of Joint: **NO**
Remarks: **M-607-061**

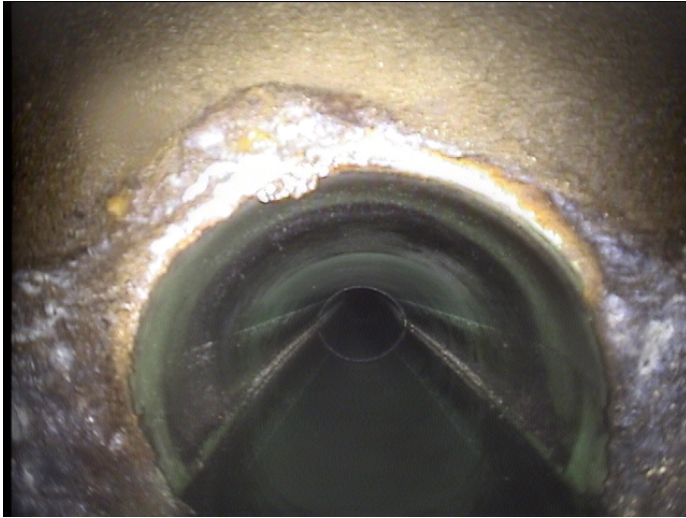
Code:	MWL
Description:	Water Level
Distance (ft):	.0
Structural Grade:	0
O&M Grade:	0
Clock Start/From:	
Clock To:	
1st Value:	
2nd Value:	
Value Percent:	20.000
Continuous Index:	
Within 8" of Joint:	NO
Remarks:

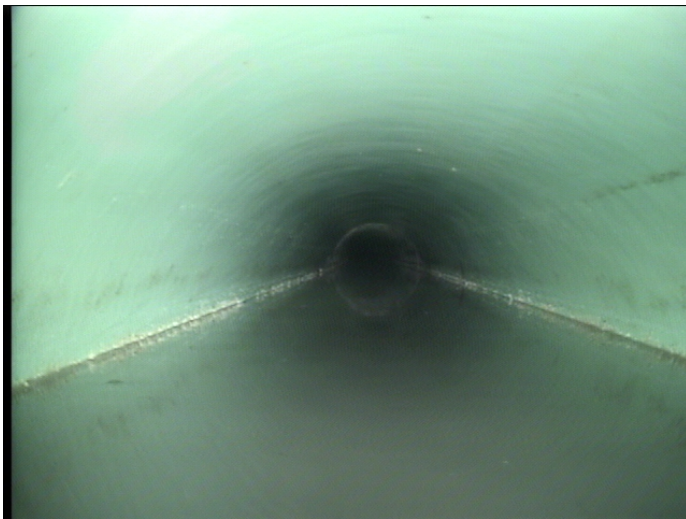
Code:	MWL
Description:	Water Level
Distance (ft):	13.3
Structural Grade:	0
O&M Grade:	0
Clock Start/From:	
Clock To:	
1st Value:	
2nd Value:	
Value Percent:	50.000
Continuous Index:	
Within 8" of Joint:	NO
Remarks:

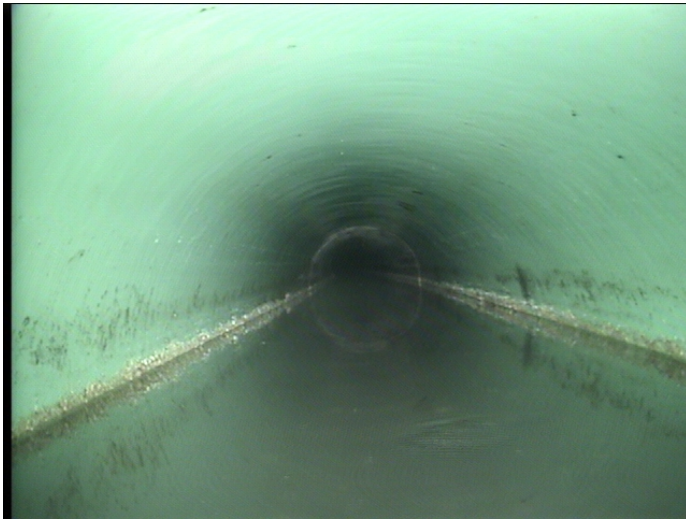
Code:	MSA
Description:	Abandoned Survey
Distance (ft):	15.3
Structural Grade:	0
O&M Grade:	0
Clock Start/From:	
Clock To:	
1st Value:	
2nd Value:	
Value Percent:	
Continuous Index:	
Within 8" of Joint:	NO
Remarks:	Sediment
