## **Profile/Photo Observation Report**

Date:	04/09/2018	Weather:		Coding:	PACP 6.0
Pipe Length (f	t):	Owner:	City of Hobart	Pre Clean:	Not Known
P.O.#:	214	Surveyor:	B. Helbling	PSR:	P-607-060-061
Customer:	City of Hobart	Clean Date:	:	Shape:	С
Street:	West 14th Street		Flow Control:	Not Controll	ed
City:	Hobart, IN		Year Renewed:		
Location:	<b>Light Highway</b>		Tape/Media #:	DEP214	
Purpose:	Routine Assessmen	nt	Dia/Height:	15"	
Use:	Sanitary		Material:	PVC	
Drain Area:			Lining:		
Category:	NA				
Comment:	YES501824 Submital 2				
Location Details:		Direction of Sur	vey: <b>Downstream</b>	ı	
US MH:	M-607-060	DS MH:	M-607-061	Total Length Surveyed	(ft): <b>8.0</b>
0&M Index:	3.00	O&M Quick:	. 31	00 O&M Rating:	3.00

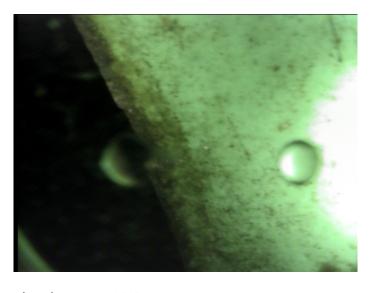
Description: Manhole Distance (ft): .0 Structural Grade: 0 O&M Grade: 0 Clock Start/From: Clock To: 1st Value: 2nd Value: Value Percent: Continuous Index: Within 8" of Joint: NO Remarks: M-607-060

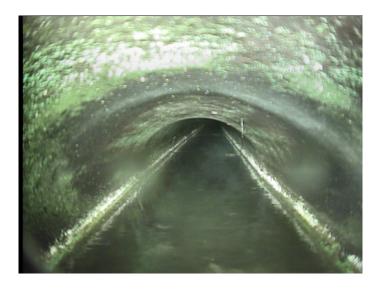
Code: MWL
Description: Water Level

Distance (ft): .0
Structural Grade: 0
O&M Grade: 0

Value Percent: 15.000

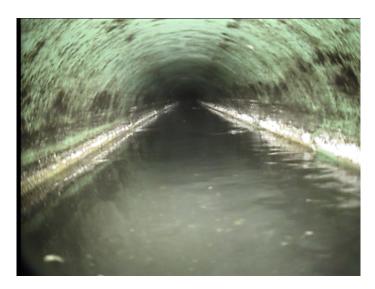
Code: **DSF**

Description: Deposits Settled Fine

Distance (ft): 4.0
Structural Grade: 0
O&M Grade: 3
Clock Start/From: 4
Clock To: 8
1st Value:

Value Percent: 15.000
