Profile/Photo Observation Report

Date:	04/09/2018	Weather:		Coding:	PACP 6.0
Pipe Length (ft):		Owner:	City of Hobart	Pre Clean:	Not Known
P.O.#:	216	Surveyor:	B. Helbling	PSR:	P-607-066-068
Customer:	City of Hobart	Clean Date:		Shape:	C

Street:	West 14th Street	Flow Control:	Not Controlled
City:	Hobart, IN	Year Renewed:	
Location:	Light Highway	Tape/Media #:	DEP216
Purpose:	Routine Assessment	Dia/Height:	15"
Use:	Sanitary	Material:	PVC
Drain Area:		Lining:	
Category:	NA		
Comment:	YES501824 Submittal 2		
Location Details:		Direction of Survey:	Downstream
US MH:	M-607-066	DS MH:	M-607-068
		Total Length Surveyed (ft):	163.1

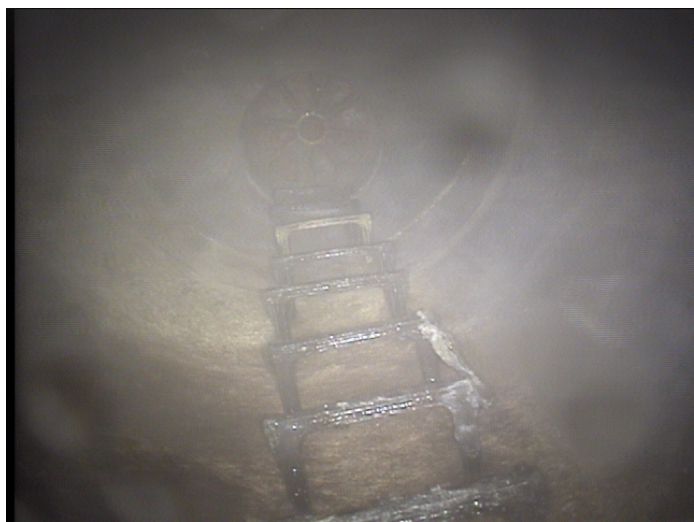
Code: **AMH**
Description: **Manhole**

Distance (ft): **.0**
Structural Grade: **0**
O&M Grade: **0**
Clock Start/From:
Clock To:
1st Value:
2nd Value:
Value Percent:
Continuous Index:
Within 8" of Joint: **NO**
Remarks: **M-607-066**

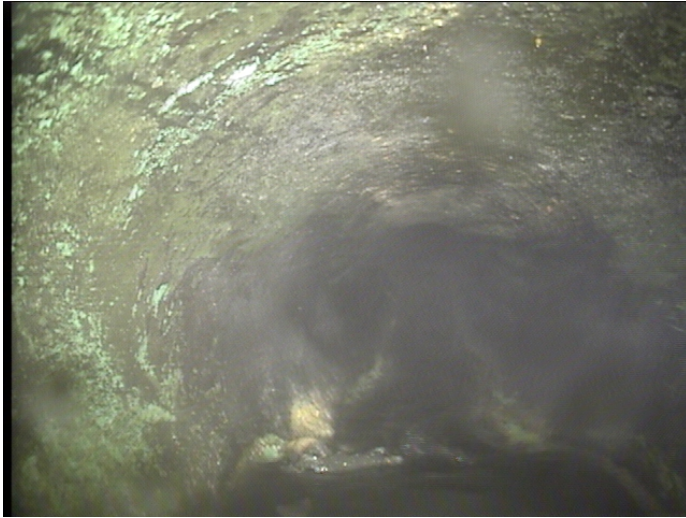
Code: **MWL**
Description: **Water Level**

Distance (ft): **.0**
Structural Grade: **0**
O&M Grade: **0**
Clock Start/From:
Clock To:
1st Value:
2nd Value:
Value Percent: **5.000**
Continuous Index:
Within 8" of Joint: **NO**
Remarks:

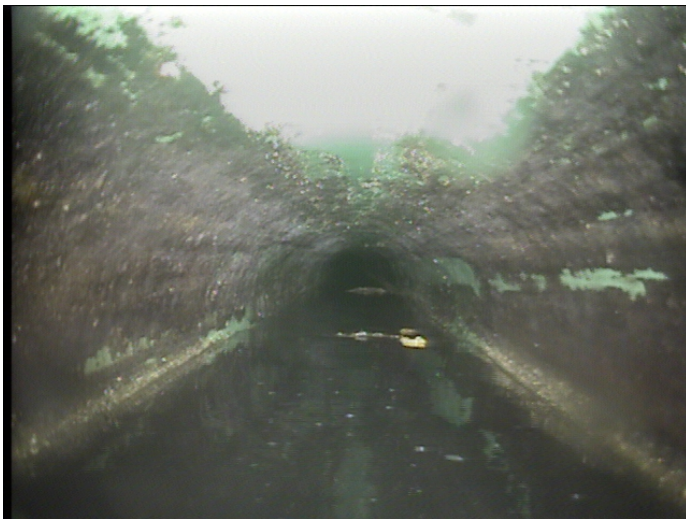
Code: **DSF**
Description: **Deposits Settled Fine**

Distance (ft): **156.1**
Structural Grade: **0**
O&M Grade: **2**
Clock Start/From: **4**
Clock To: **8**
1st Value:
2nd Value:
Value Percent: **10.000**
Continuous Index: **S01**
Within 8" of Joint: **NO**
Remarks:

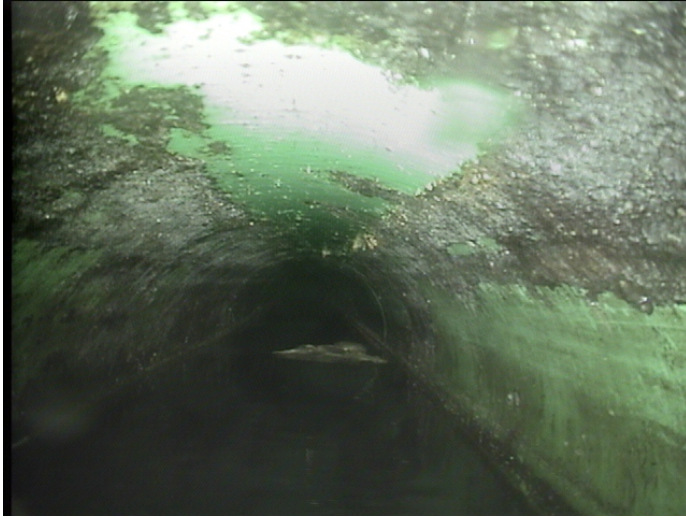
Code:	DSF
Description:	Deposits Settled Fine
Distance (ft):	162.8
Structural Grade:	0
O&M Grade:	2
Clock Start/From:	4
Clock To:	8
1st Value:	
2nd Value:	
Value Percent:	10.000
Continuous Index:	F01
Within 8" of Joint:	NO
Remarks:

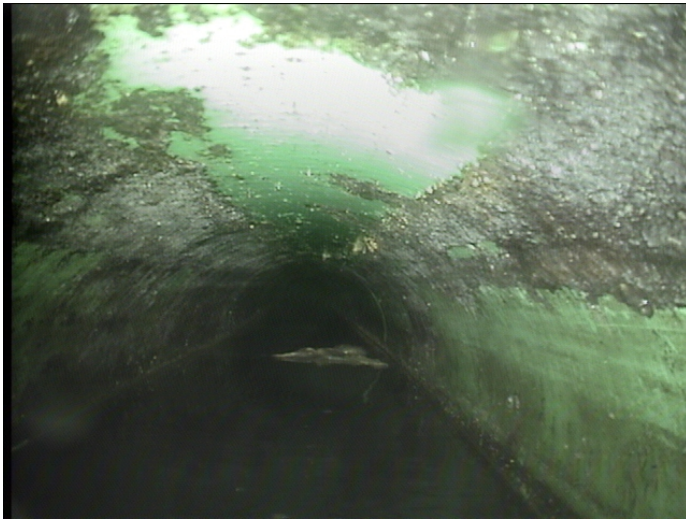
Code:	MSA
Description:	Abandoned Survey
Distance (ft):	162.8
Structural Grade:	0
O&M Grade:	0
Clock Start/From:	
Clock To:	
1st Value:	
2nd Value:	
Value Percent:	
Continuous Index:	
Within 8" of Joint:	NO
Remarks:	Cannot pass debris under flow
