Profile/Photo Observation Report

| Street: | West 14th Street | Flow Control: | Not Controlled |
| Purpose: | Routine Assessment | Dia/Height: | 15" |
| US MH: | M-607-066 | DS MH: | M-607-068 |

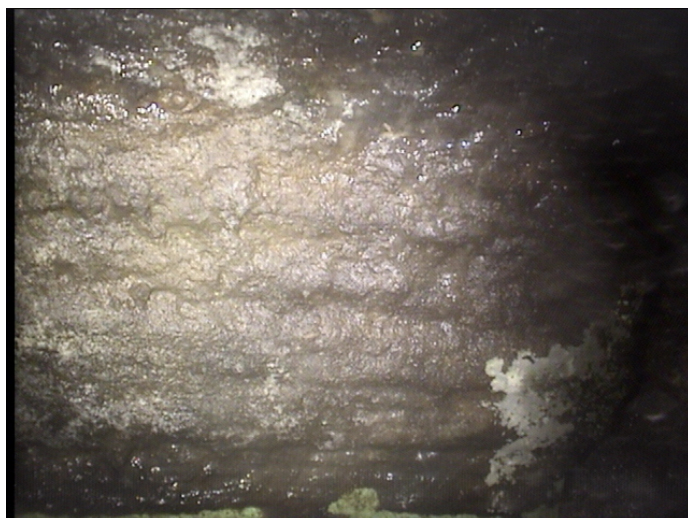
Code: **AMH**
Description: **Manhole**

Distance (ft): **.0**
Structural Grade: **0**
O&M Grade: **0**
Clock Start/From:
Clock To:
1st Value:
2nd Value:
Value Percent:
Continuous Index:
Within 8" of Joint: **NO**
Remarks: **M-607-068**

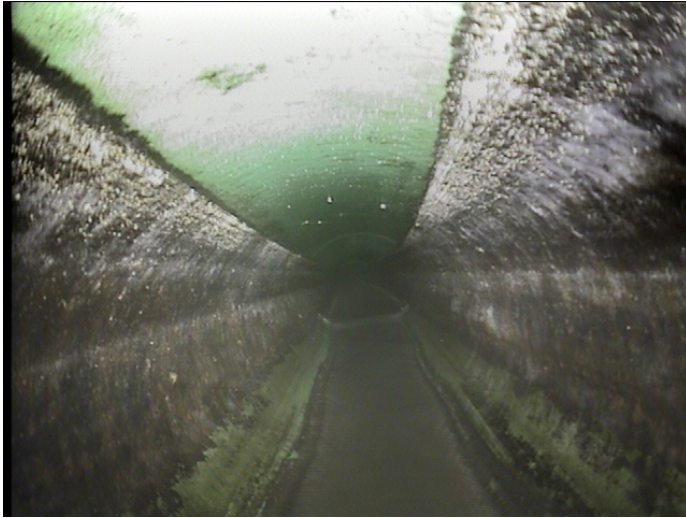
Code: **MWL**
Description: **Water Level**

Distance (ft): **.0**
Structural Grade: **0**
O&M Grade: **0**
Clock Start/From:
Clock To:
1st Value:
2nd Value:
Value Percent: **5.000**
Continuous Index:
Within 8" of Joint: **NO**
Remarks:

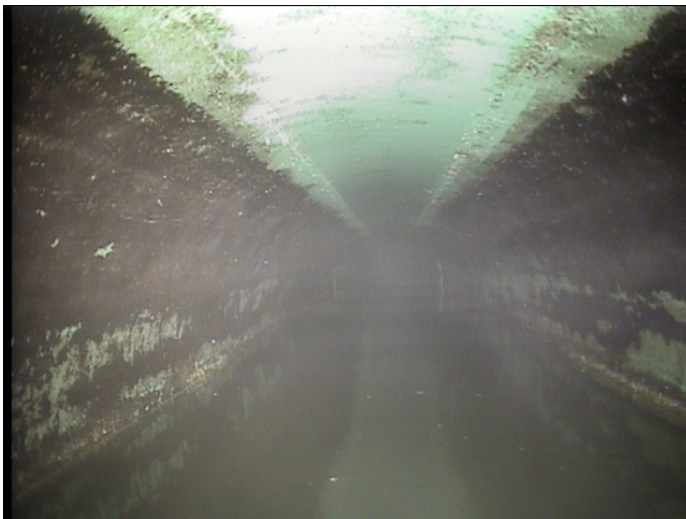
| | Position | Code | Observation | Video (sec) | Grade |
|--|---|---|---|---|---|
| | 68.0 | DSF(S01) | Deposits Settled Fine | 257 | M 2 |

Code: **DSF**
Description: **Deposits Settled Fine**

Distance (ft): **68.0**
Structural Grade: **0**
O&M Grade: **2**
Clock Start/From: **5**
Clock To: **7**
1st Value:
2nd Value:
Value Percent: **5.000**
Continuous Index: **S01**
Within 8" of Joint: **NO**
Remarks:

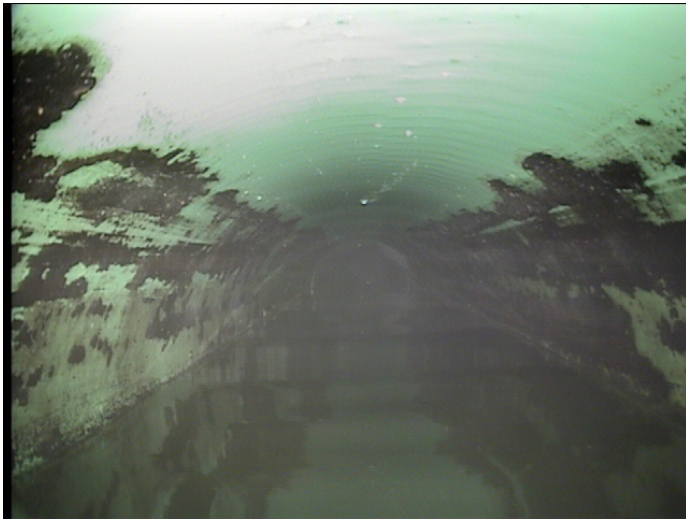
Code: **MWL**
Description: **Water Level**

Distance (ft): **107.1**
Structural Grade: **0**
O&M Grade: **0**
Clock Start/From:
Clock To:
1st Value:
2nd Value:
Value Percent: **25.000**
Continuous Index:
Within 8" of Joint: **NO**
Remarks:

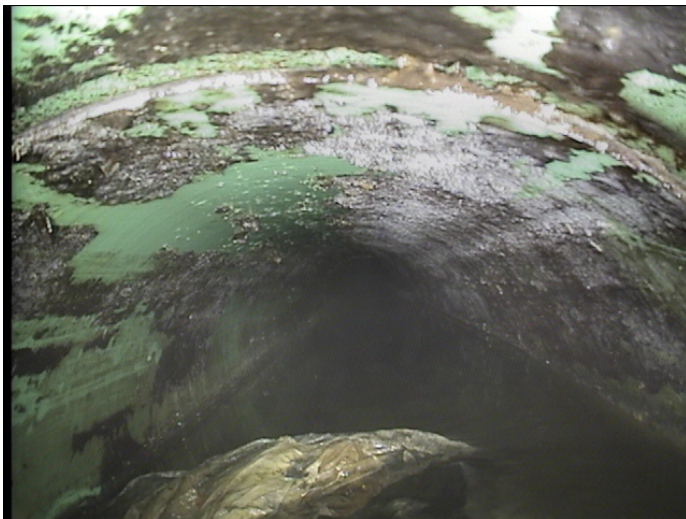
| | Position | Code | Observation | Video (sec) | Grade |
|--|---|---|---|---|---|
| | 129.5 | DSF(F01) | Deposits Settled Fine | 640 | M 2 |

Code: **DSF**
Description: **Deposits Settled Fine**

Distance (ft): **129.5**
Structural Grade: **0**
O&M Grade: **2**
Clock Start/From: **5**
Clock To: **7**
1st Value:
2nd Value:
Value Percent: **5.000**
Continuous Index: **F01**
Within 8" of Joint: **NO**
Remarks:

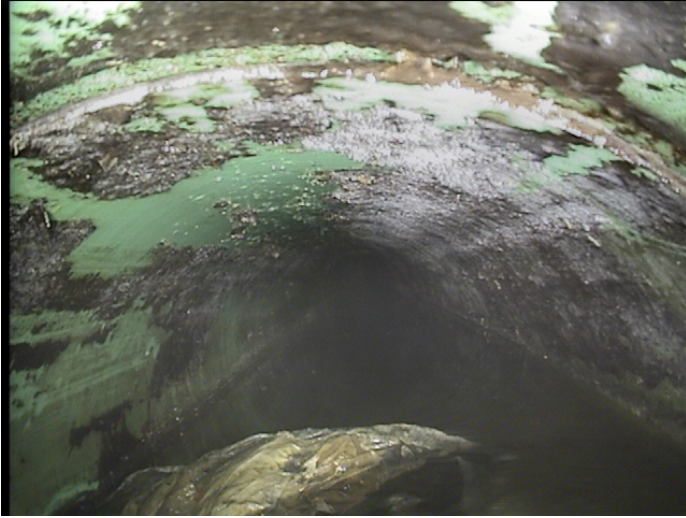
| Code: | MSA |
| Description: | Abandoned Survey |
| Remarks: | Heavy sediment |
