Profile/Photo Observation Report

Date:	04/04/2018	Weather:		Coding:	PACP 6.0
Pipe Length (ft):	78.2	Owner:	NA	Pre Clean:	No Pre-Cleaning
P.O.#:		Surveyor:	Jen Costello	PSR:	P-608-022-066
Customer:		Clean Date:	01/01/1900	Shape:	C

Street:	W 14TH ST	Flow Control:	Not Controlled
City:	Hobart, IN	Year Renewed:	
Location:	Yard	Tape/Media #:	
Purpose:	Routine Assessment	Dia/Height:	8"
Use:	Sanitary	Material:	PVC
Drain Area:	NA	Lining:	
Category:	NA		
Comment:

Location Details:		Direction of Survey:	Upstream
US MH:	M-607-066	DS MH:	M-608-022
		Total Length Surveyed (ft):	74.4

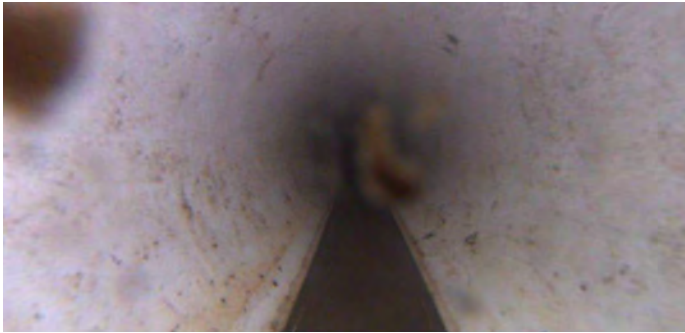
Code:	MWL
Description:	Water Level

Distance (ft):	.0
Structural Grade:	0
O&M Grade:	0
Clock Start/From:	
Clock To:	
1st Value:	
2nd Value:	
Value Percent:	5.000
Continuous Index:	
Within 8" of Joint:	NO
Remarks:

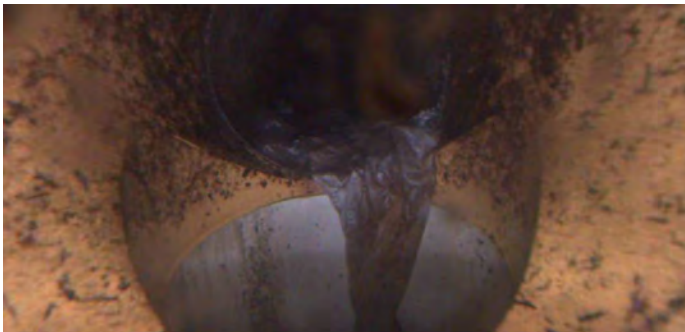
Code:	TF
Description:	Tap Factory

Distance (ft):	72.0
Structural Grade:	0
O&M Grade:	0
Clock Start/From:	6
Clock To:	
1st Value:	6.000
2nd Value:	
Value Percent:	
Continuous Index:	
Within 8" of Joint:	
Remarks:	drop connection

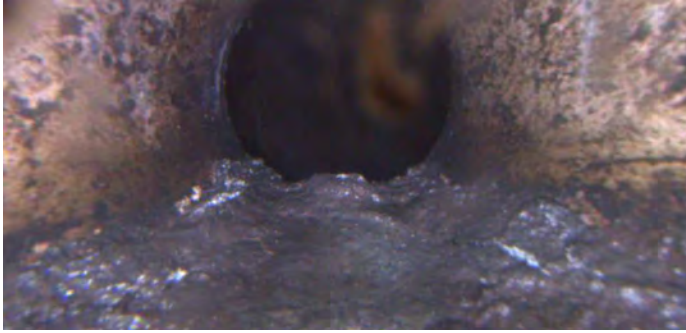
Code: **DSF**
Description: **Deposits Settled Fine**

Distance (ft): **73.0**
Structural Grade: **0**
O&M Grade: **3**
Clock Start/From: **4**
Clock To: **8**
1st Value:
2nd Value:
Value Percent: **20.000**
Continuous Index:
Within 8" of Joint: **NO**
Remarks:
