Profile/Photo Observation Report

Street:	W 14TH ST	Flow Control:	Not Controlled
City:	Hobart, IN	Year Renewed:	
Location:	Yard	Tape/Media #:	
Purpose:	Routine Assessment	Dia/Height:	12"
Use:	Sanitary	Material:	PVC
Drain Area:	NA	Lining:	
Category:	NA		
Comment:	Flow direction is marked wrong.		
Location Details:		Direction of Survey:	Upstream
US MH:	M-607-066	DS MH:	M-608-027
		Total Length Surveyed (ft):	14.7

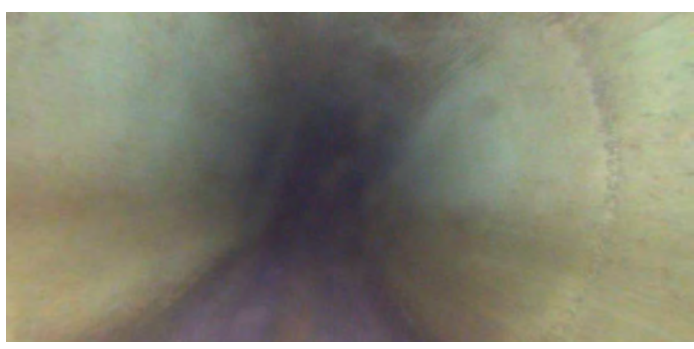
Code: **AMH**
Description: **Manhole**

Distance (ft): **.0**
Structural Grade: **0**
O&M Grade: **0**
Clock Start/From:
Clock To:
1st Value:
2nd Value:
Value Percent:
Continuous Index:
Within 8" of Joint: **NO**
Remarks: **M-608-027**

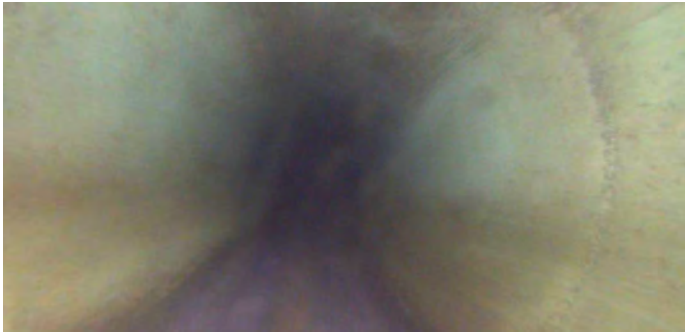
Code:	MWL
Description:	Water Level

Distance (ft):	.0
Structural Grade:	0
O&M Grade:	0
Clock Start/From:	
Clock To:	
1st Value:	
2nd Value:	
Value Percent:	5.000
Continuous Index:	
Within 8" of Joint:	NO
Remarks:
