## Profile/Photo Observation Report

Street:	<b>FOXCROFT STREET</b>	Flow Control:	<b>Not Controlled</b>
City:	<b>Hobart, IN</b>	Year Renewed:	
Location:	<b>Yard</b>	Tape/Media #:	
Purpose:	<b>Routine Assessment</b>	Dia/Height:	<b>12"</b>
Use:	<b>Sanitary</b>	Material:	<b>PVC</b>
Drain Area:	<b>NA</b>	Lining:	
Category:	<b>NA</b>		
Comment:	<b>Flow direction is marked wrong.</b>		
Location Details:		Direction of Survey:	<b>Upstream</b>
US MH:	<b>M-607-066</b>	DS MH:	<b>M-608-027</b>
		Total Length Surveyed (ft):	<b>14.7</b>

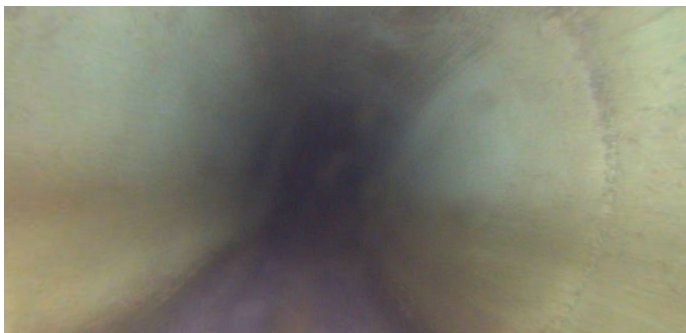
Code: **AMH**  
Description: **Manhole**

Distance (ft): **.0**  
Structural Grade: **0**  
O&M Grade: **0**  
Clock Start/From:  
Clock To:  
1st Value:  
2nd Value:  
Value Percent:  
Continuous Index:  
Within 8" of Joint: **NO**  
Remarks: **M-608-027**

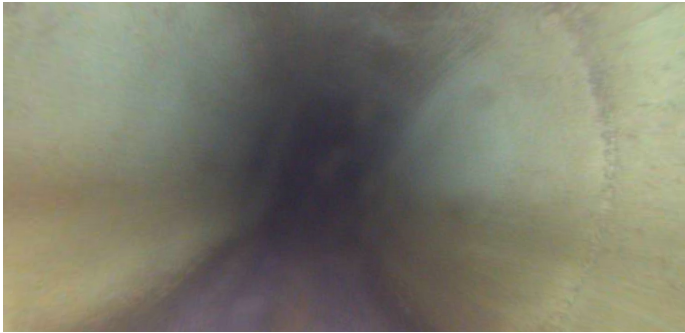
Code:	<b>MWL</b>
Description:	<b>Water Level</b>

Distance (ft):	<b>.0</b>
Structural Grade:	<b>0</b>
O&M Grade:	<b>0</b>
Clock Start/From:	
Clock To:	
1st Value:	
2nd Value:	
Value Percent:	<b>5.000</b>
Continuous Index:	
Within 8" of Joint:	<b>NO</b>
Remarks:
