## Profile/Photo Observation Report

Street:	<b>FOXCROFT STREET</b>	Flow Control:	<b>Not Controlled</b>
City:	<b>Hobart, IN</b>	Year Renewed:	
Location:	<b>Yard</b>	Tape/Media #:	
Purpose:	<b>Routine Assessment</b>	Dia/Height:	<b>10"</b>
Use:	<b>Sanitary</b>	Material:	<b>PVC</b>
Drain Area:	<b>NA</b>	Lining:	
Category:	<b>NA</b>		
Comment:

Location Details:		Direction of Survey:	<b>Downstream</b>
US MH:	<b>M-607-071</b>	DS MH:	<b>M-607-022</b>
		Total Length Surveyed (ft):	<b>35.0</b>

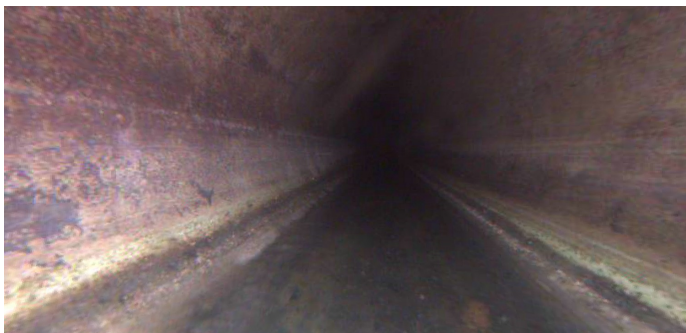
Code: **AMH**  
Description: **Manhole**

Distance (ft): **.0**  
Structural Grade: **0**  
O&M Grade: **0**  
Clock Start/From:  
Clock To:  
1st Value:  
2nd Value:  
Value Percent:  
Continuous Index:  
Within 8" of Joint: **NO**  
Remarks: **M-607-071**

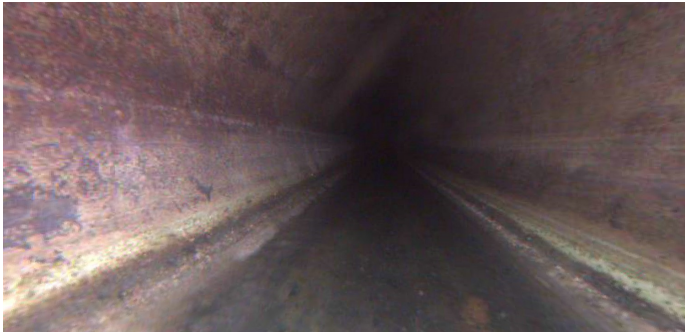
Code:	<b>MWL</b>
Description:	<b>Water Level</b>

Distance (ft):	<b>.0</b>
Structural Grade:	<b>0</b>
O&M Grade:	<b>0</b>
Clock Start/From:	
Clock To:	
1st Value:	
2nd Value:	
Value Percent:	<b>5.000</b>
Continuous Index:	
Within 8" of Joint:	<b>NO</b>
Remarks:

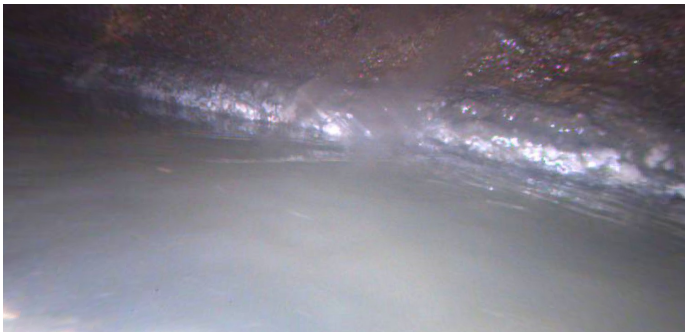
Code:	<b>AMH</b>
Description:	<b>Manhole</b>

Distance (ft):	<b>35.0</b>
Structural Grade:	<b>0</b>
O&M Grade:	<b>0</b>
Clock Start/From:	
Clock To:	
1st Value:	
2nd Value:	
Value Percent:	
Continuous Index:	
Within 8" of Joint:	<b>NO</b>
Remarks:	<b>M-607-022</b>
