Profile/Photo Observation Report

Date:	04/03/2018	Weather:		Coding:	PACP 6.0
Pipe Length (ft):	158.8	Owner:	NA	Pre Clean:	No Pre-Cleaning
P.O.#:		Surveyor:	Jen Costello	PSR:	P-607-072-074
Customer:		Clean Date:	01/01/1900	Shape:	C

Street:	S ASH ST	Flow Control:	Not Controlled
City:	Hobart, IN	Year Renewed:	
Location:	Yard	Tape/Media #:	
Purpose:	Routine Assessment	Dia/Height:	10"
Use:	Sanitary	Material:	PVC
Drain Area:	NA	Lining:	
Category:	NA		
Comment:

Location Details:		Direction of Survey:	Upstream
US MH:	M-607-072	DS MH:	M-607-074
		Total Length Surveyed (ft):	80.1

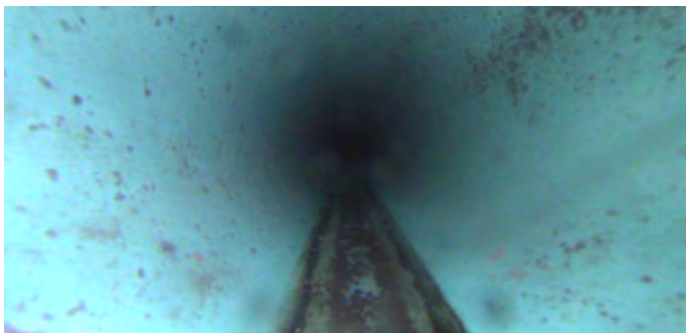
Code: **AMH**
Description: **Manhole**

Distance (ft): **.0**
Structural Grade: **0**
O&M Grade: **0**
Clock Start/From:
Clock To:
1st Value:
2nd Value:
Value Percent:
Continuous Index:
Within 8" of Joint: **NO**
Remarks: **M-607-074**

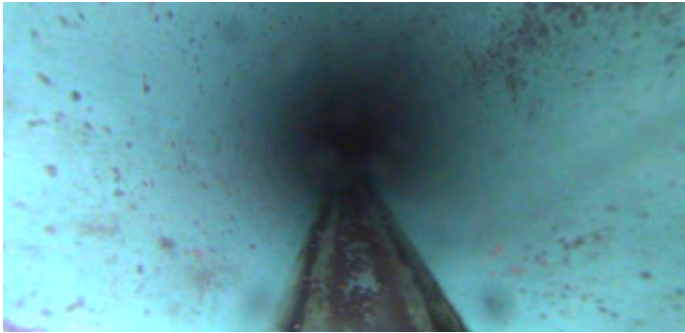
Code:	MWL
Description:	Water Level

Distance (ft):	.0
Structural Grade:	0
O&M Grade:	0
Clock Start/From:	
Clock To:	
1st Value:	
2nd Value:	
Value Percent:	5.000
Continuous Index:	
Within 8" of Joint:	NO
Remarks:

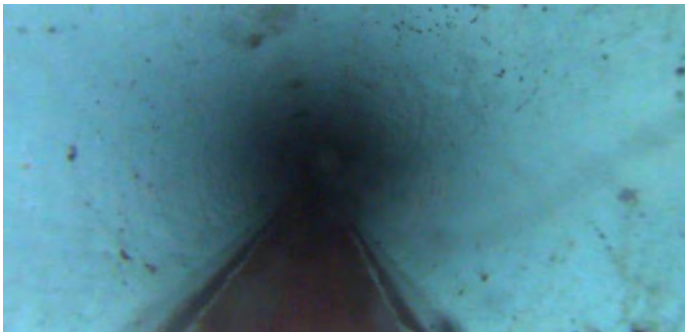
Code:	MSA
Description:	Abandoned Survey

Distance (ft):	80.1
Structural Grade:	0
O&M Grade:	0
Clock Start/From:	
Clock To:	
1st Value:	
2nd Value:	
Value Percent:	
Continuous Index:	
Within 8" of Joint:	NO
Remarks:	DEBRIS UNDER WATER
