## Profile/Photo Observation Report

Street:	<b>FOXCROFT STREET</b>	Flow Control:	<b>Not Controlled</b>
City:	<b>Hobart, IN</b>	Year Renewed:	
Location:	<b>Yard</b>	Tape/Media #:	
Purpose:	<b>Routine Assessment</b>	Dia/Height:	<b>10"</b>
Use:	<b>Sanitary</b>	Material:	<b>PVC</b>
Drain Area:	<b>NA</b>	Lining:	
Category:	<b>NA</b>		
Comment:

Location Details:		Direction of Survey:	<b>Upstream</b>
US MH:	<b>M-607-072</b>	DS MH:	<b>M-607-074</b>
		Total Length Surveyed (ft):	<b>80.1</b>

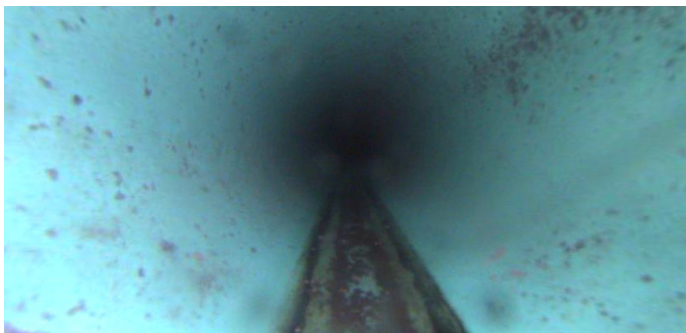
Code: **AMH**  
Description: **Manhole**

Distance (ft): **.0**  
Structural Grade: **0**  
O&M Grade: **0**  
Clock Start/From:  
Clock To:  
1st Value:  
2nd Value:  
Value Percent:  
Continuous Index:  
Within 8" of Joint: **NO**  
Remarks: **M-607-074**

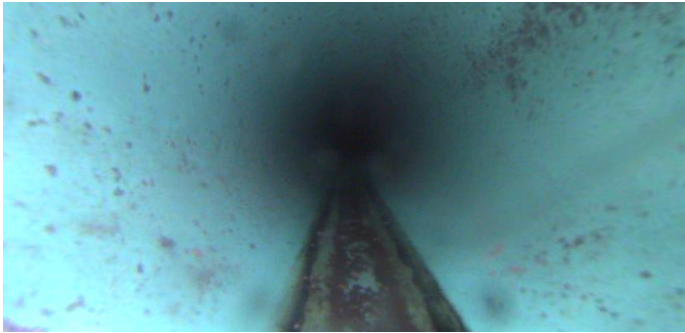
Code:	<b>MWL</b>
Description:	<b>Water Level</b>

Distance (ft):	<b>.0</b>
Structural Grade:	<b>0</b>
O&M Grade:	<b>0</b>
Clock Start/From:	
Clock To:	
1st Value:	
2nd Value:	
Value Percent:	<b>5.000</b>
Continuous Index:	
Within 8" of Joint:	<b>NO</b>
Remarks:

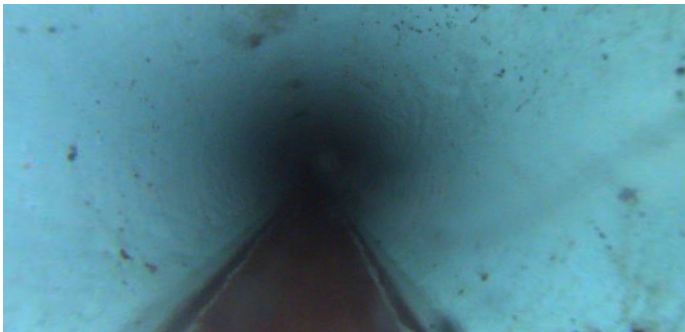
Code:	<b>MSA</b>
Description:	<b>Abandoned Survey</b>

Distance (ft):	<b>80.1</b>
Structural Grade:	<b>0</b>
O&M Grade:	<b>0</b>
Clock Start/From:	
Clock To:	
1st Value:	
2nd Value:	
Value Percent:	
Continuous Index:	
Within 8" of Joint:	<b>NO</b>
Remarks:	<b>DEBRIS UNDER WATER</b>
