## Profile/Photo Observation Report

Date:	<b>04/03/2018</b>	Weather:		Coding:	<b>PACP 6.0</b>
Pipe Length (ft):	<b>158.8</b>	Owner:	<b>NA</b>	Pre Clean:	<b>No Pre-Cleaning</b>
P.O.#:		Surveyor:	<b>Jen Costello</b>	PSR:	<b>P-607-072-074</b>
Customer:		Clean Date:	<b>01/01/1900</b>	Shape:	<b>C</b>

Street:	<b>S ASH ST</b>	Flow Control:	<b>Not Controlled</b>
City:	<b>Hobart, IN</b>	Year Renewed:	
Location:	<b>Yard</b>	Tape/Media #:	
Purpose:	<b>Routine Assessment</b>	Dia/Height:	<b>12"</b>
Use:	<b>Sanitary</b>	Material:	<b>PVC</b>
Drain Area:	<b>NA</b>	Lining:	
Category:	<b>NA</b>		
Comment:			
Location Details:		Direction of Survey:	<b>Upstream</b>
US MH:	<b>M-607-072</b>	DS MH:	<b>M-607-074</b>
		Total Length Surveyed (ft):	<b>42.5</b>

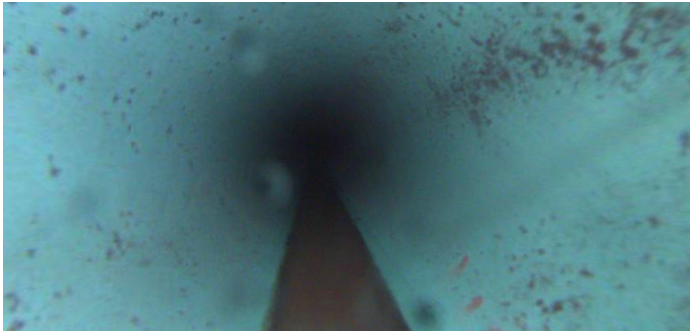
Code: AMH

Description: Manhole

Remarks: M-607-074

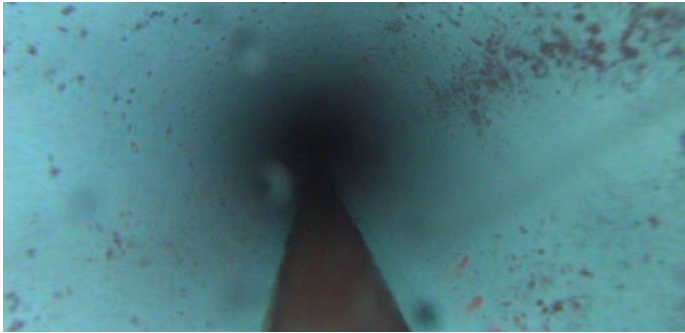
Code:	<b>MWL</b>
Description:	<b>Water Level</b>

Distance (ft):	<b>.0</b>
Structural Grade:	<b>0</b>
O&M Grade:	<b>0</b>
Clock Start/From:	
Clock To:	
1st Value:	
2nd Value:	
Value Percent:	<b>5.000</b>
Continuous Index:	
Within 8" of Joint:	<b>NO</b>
Remarks:

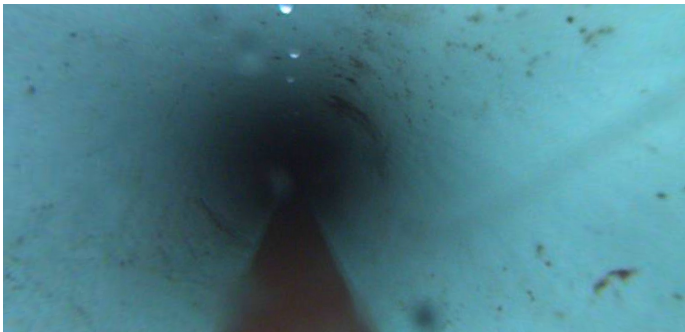
Code:	<b>MSA</b>
Description:	<b>Abandoned Survey</b>

Distance (ft):	<b>42.5</b>
Structural Grade:	<b>0</b>
O&M Grade:	<b>0</b>
Clock Start/From:	
Clock To:	
1st Value:	
2nd Value:	
Value Percent:	
Continuous Index:	
Within 8" of Joint:	<b>NO</b>
Remarks:	<b>debris</b>
