## Profile/Photo Observation Report

Street:	<b>FOXCROFT STREET</b>	Flow Control:	<b>Not Controlled</b>
City:	<b>Hobart, IN</b>	Year Renewed:	
Location:	<b>Yard</b>	Tape/Media #:	
Purpose:	<b>Routine Assessment</b>	Dia/Height:	<b>12"</b>
Use:	<b>Sanitary</b>	Material:	<b>PVC</b>
Drain Area:	<b>NA</b>	Lining:	
Category:	<b>NA</b>		
Comment:

Location Details:		Direction of Survey:	<b>Upstream</b>
US MH:	<b>M-607-072</b>	DS MH:	<b>M-607-074</b>
		Total Length Surveyed (ft):	<b>42.5</b>

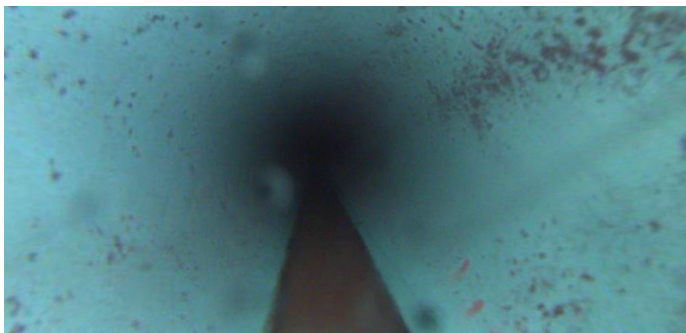
Code: **AMH**  
Description: **Manhole**

Distance (ft): **.0**  
Structural Grade: **0**  
O&M Grade: **0**  
Clock Start/From:  
Clock To:  
1st Value:  
2nd Value:  
Value Percent:  
Continuous Index:  
Within 8" of Joint: **NO**  
Remarks: **M-607-074**

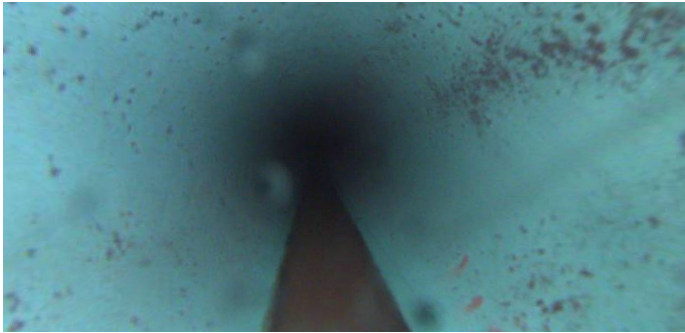
Code:	<b>MWL</b>
Description:	<b>Water Level</b>

Distance (ft):	<b>.0</b>
Structural Grade:	<b>0</b>
O&M Grade:	<b>0</b>
Clock Start/From:	
Clock To:	
1st Value:	
2nd Value:	
Value Percent:	<b>5.000</b>
Continuous Index:	
Within 8" of Joint:	<b>NO</b>
Remarks:

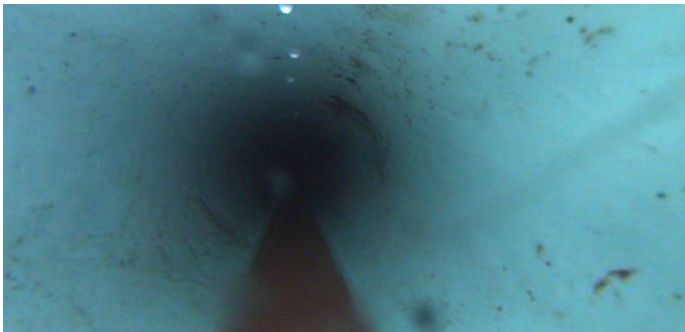
Code:	<b>MSA</b>
Description:	<b>Abandoned Survey</b>

Distance (ft):	<b>42.5</b>
Structural Grade:	<b>0</b>
O&M Grade:	<b>0</b>
Clock Start/From:	
Clock To:	
1st Value:	
2nd Value:	
Value Percent:	
Continuous Index:	
Within 8" of Joint:	<b>NO</b>
Remarks:	<b>debris</b>
