Profile/Photo Observation Report

Street:	S ASH ST	Flow Control:	Not Controlled
City:	Hobart, IN	Year Renewed:	
Location:	Yard	Tape/Media #:	
Purpose:	Routine Assessment	Dia/Height:	12"
Use:	Sanitary	Material:	PVC
Drain Area:	NA	Lining:	
Category:	NA		
Comment:

Location Details:		Direction of Survey:	Downstream
US MH:	M-607-072	DS MH:	M-607-074
		Total Length Surveyed (ft):	27.5

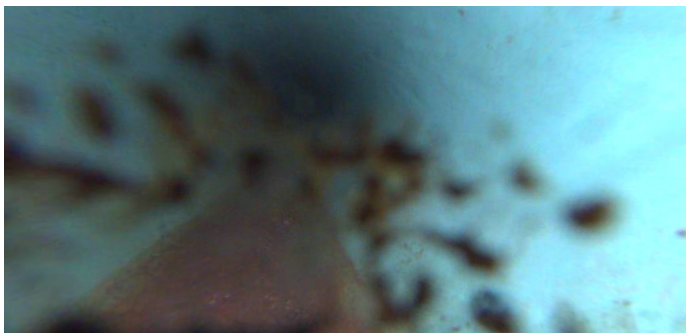
Code: **AMH**
Description: **Manhole**

Distance (ft): **.0**
Structural Grade: **0**
O&M Grade: **0**
Clock Start/From:
Clock To:
1st Value:
2nd Value:
Value Percent:
Continuous Index:
Within 8" of Joint: **NO**
Remarks: **M-607-072**

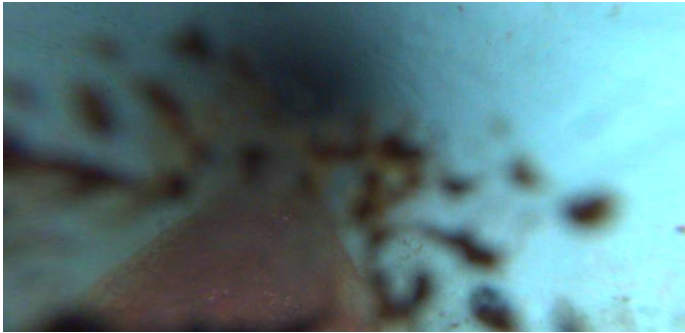
Code:	MWL
Description:	Water Level

Distance (ft):	.0
Structural Grade:	0
O&M Grade:	0
Clock Start/From:	
Clock To:	
1st Value:	
2nd Value:	
Value Percent:	5.000
Continuous Index:	
Within 8" of Joint:	NO
Remarks:

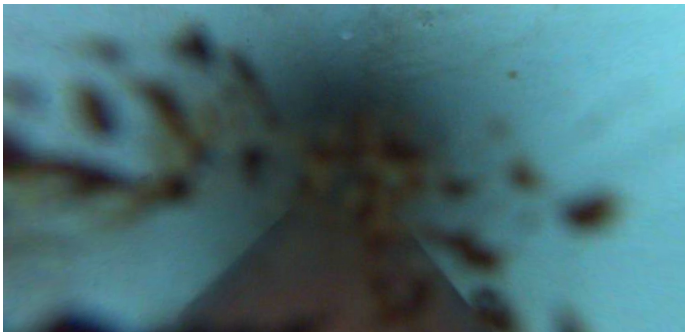
Code:	MSA
Description:	Abandoned Survey

Distance (ft):	27.5
Structural Grade:	0
O&M Grade:	0
Clock Start/From:	
Clock To:	
1st Value:	
2nd Value:	
Value Percent:	
Continuous Index:	
Within 8" of Joint:	NO
Remarks:	debris
