## Profile/Photo Observation Report

Street:	<b>FOXCROFT STREET</b>	Flow Control:	<b>Not Controlled</b>
City:	<b>Hobart, IN</b>	Year Renewed:	
Location:	<b>Yard</b>	Tape/Media #:	
Purpose:	<b>Routine Assessment</b>	Dia/Height:	<b>12"</b>
Use:	<b>Sanitary</b>	Material:	<b>PVC</b>
Drain Area:	<b>NA</b>	Lining:	
Category:	<b>NA</b>		
Comment:

Location Details:		Direction of Survey:	<b>Downstream</b>
US MH:	<b>M-607-072</b>	DS MH:	<b>M-607-074</b>
		Total Length Surveyed (ft):	<b>27.5</b>

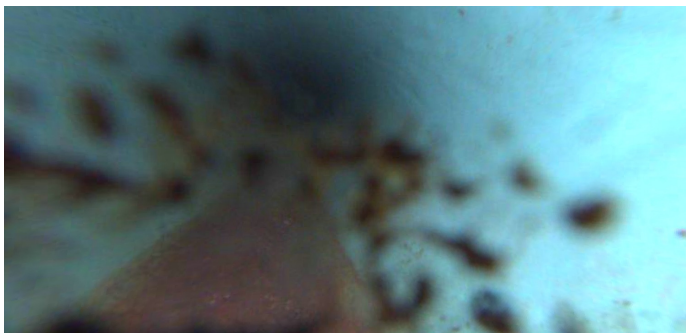
Code: **AMH**  
Description: **Manhole**

Distance (ft): **.0**  
Structural Grade: **0**  
O&M Grade: **0**  
Clock Start/From:  
Clock To:  
1st Value:  
2nd Value:  
Value Percent:  
Continuous Index:  
Within 8" of Joint: **NO**  
Remarks: **M-607-072**

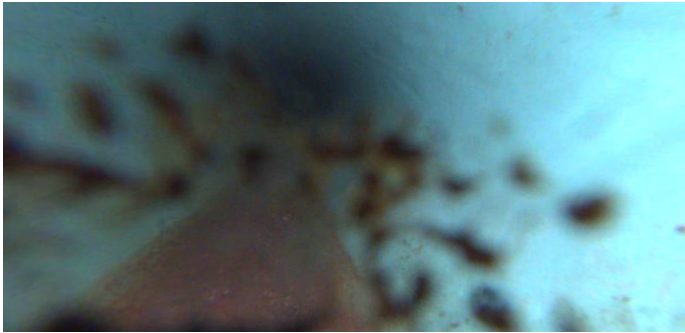
Code:	<b>MWL</b>
Description:	<b>Water Level</b>

Distance (ft):	<b>.0</b>
Structural Grade:	<b>0</b>
O&M Grade:	<b>0</b>
Clock Start/From:	
Clock To:	
1st Value:	
2nd Value:	
Value Percent:	<b>5.000</b>
Continuous Index:	
Within 8" of Joint:	<b>NO</b>
Remarks:

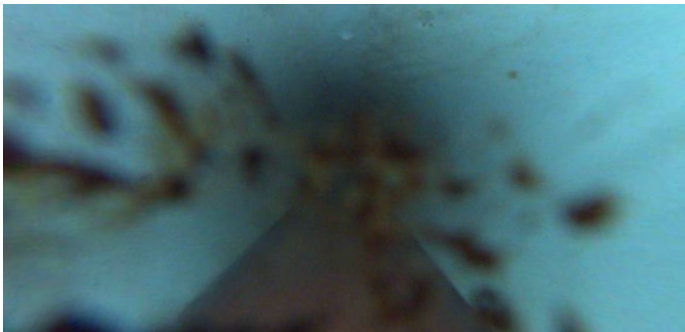
Code:	<b>MSA</b>
Description:	<b>Abandoned Survey</b>

Distance (ft):	<b>27.5</b>
Structural Grade:	<b>0</b>
O&M Grade:	<b>0</b>
Clock Start/From:	
Clock To:	
1st Value:	
2nd Value:	
Value Percent:	
Continuous Index:	
Within 8" of Joint:	<b>NO</b>
Remarks:	<b>debris</b>
