Profile/Photo Observation Report

| Street: | FOXCROFT STREET | Flow Control: | Not Controlled |
| City: | Hobart, IN | Year Renewed: | |
| US MH: | M-607-074 | DS MH: | M-607-073 |

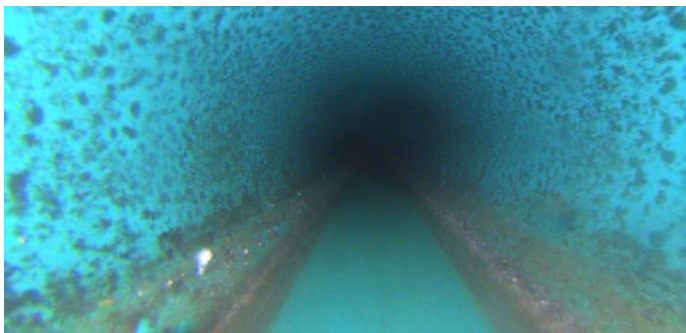
Code: **AMH**
Description: **Manhole**

Distance (ft): **.0**
Structural Grade: **0**
O&M Grade: **0**
Clock Start/From:
Clock To:
1st Value:
2nd Value:
Value Percent:
Continuous Index:
Within 8" of Joint: **NO**
Remarks: **M-607-074**

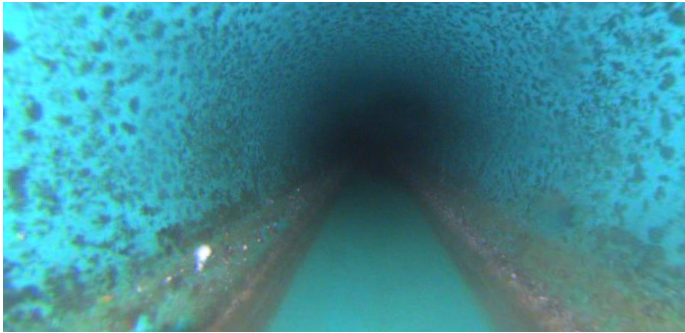
| Code: | MWL |

| Description: | Water Level |

| Distance (ft): | .0 |
| Value Percent: | 5.000 |

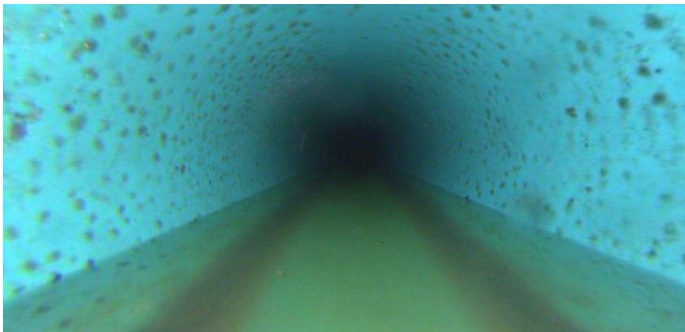
| Code: | MWL |

| Description: | Water Level |

| Distance (ft): | 142.1 |
| Value Percent: | 30.000 |

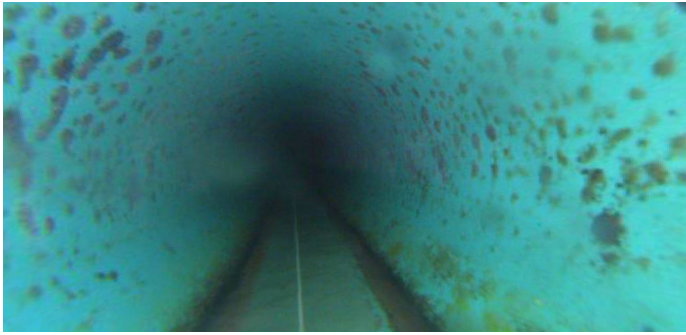
Code: **MGO**
Description: **General Observation**

Distance (ft): **241.8**
Structural Grade: **0**
O&M Grade: **0**
Clock Start/From:
Clock To:
1st Value:
2nd Value:
Value Percent:
Continuous Index:
Within 8" of Joint: **NO**
Remarks: **REAR CAMERA**

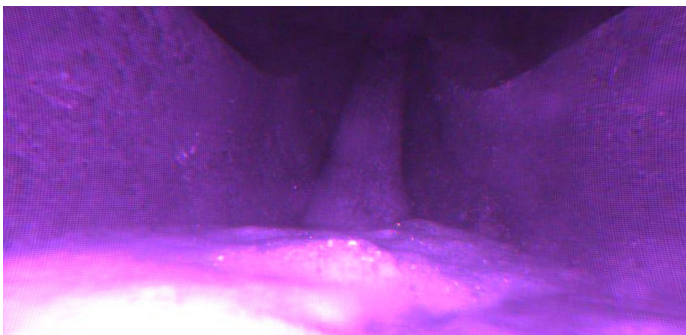
Code: **AMH**
Description: **Manhole**

Distance (ft): **255.2**
Structural Grade: **0**
O&M Grade: **0**
Clock Start/From:
Clock To:
1st Value:
2nd Value:
Value Percent:
Continuous Index:
Within 8" of Joint: **NO**
Remarks: **M-607-073**
