Profile/Photo Observation Report

| Street: | W 14TH ST | Flow Control: | Not Controlled |
| City: | Hobart, IN | Year Renewed: | |
| US MH: | M-607-074 | DS MH: | M-607-075 |

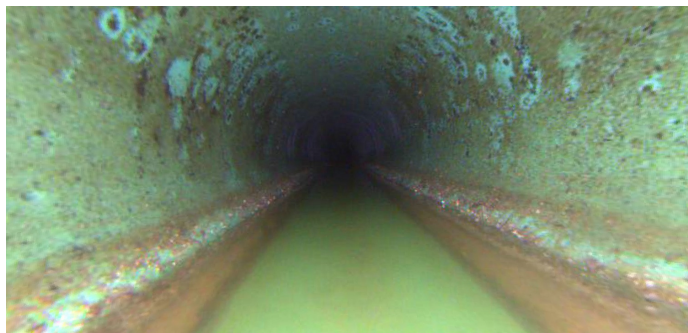
Code: **AMH**
 Description: **Manhole**
 Distance (ft): **.0**
 Structural Grade: **0**
 O&M Grade: **0**
 Clock Start/From:
 Clock To:
 1st Value:
 2nd Value:
 Value Percent:
 Continuous Index:
 Within 8" of Joint: **NO**
 Remarks: **M-607-075**

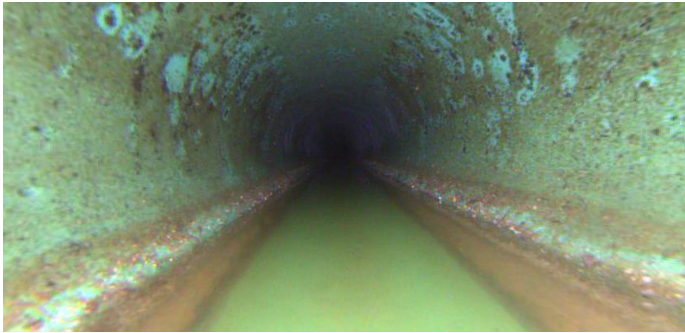
| Code: | MWL |
| Description: | Water Level |

| Distance (ft): | .0 |
| Value Percent: | 10.000 |

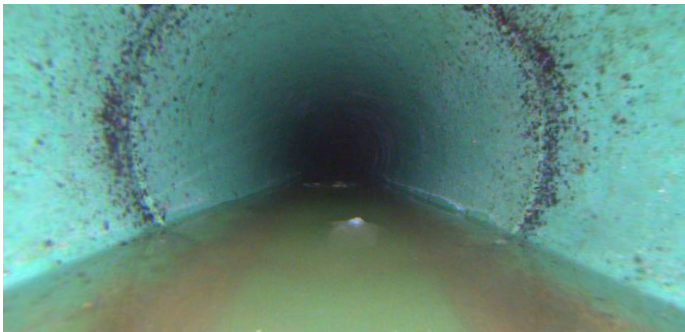
| Code: | MWL |
| Description: | Water Level |

| Distance (ft): | 141.0 |
| Value Percent: | 20.000 |

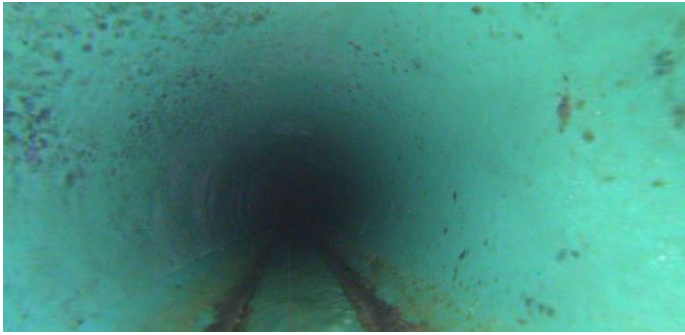
Code: **MGO**
Description: **General Observation**

Distance (ft): **149.6**
Structural Grade: **0**
O&M Grade: **0**
Clock Start/From:
Clock To:
1st Value:
2nd Value:
Value Percent:
Continuous Index:
Within 8" of Joint: **NO**
Remarks: **rear camera**

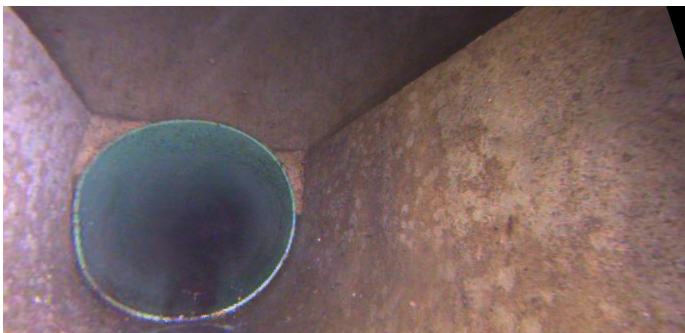
Code: **AMH**
Description: **Manhole**

Distance (ft): **205.1**
Structural Grade: **0**
O&M Grade: **0**
Clock Start/From:
Clock To:
1st Value:
2nd Value:
Value Percent:
Continuous Index:
Within 8" of Joint: **NO**
Remarks: **M-607-074**
