## Profile/Photo Observation Report

Date:	<b>04/11/2018</b>	Weather:		Coding:	<b>PACP 6.0</b>
Pipe Length (ft):	<b>124.5</b>	Owner:	<b>NA</b>	Pre Clean:	<b>No Pre-Cleaning</b>
P.O.#:		Surveyor:	<b>Jen Costello</b>	PSR:	<b>P-607-032-076</b>
Customer:		Clean Date:	<b>01/01/1900</b>	Shape:	<b>C</b>

Street:	<b>LAURA CT</b>	Flow Control:	<b>Not Controlled</b>
City:	<b>Hobart, IN</b>	Year Renewed:	
Location:	<b>Yard</b>	Tape/Media #:	
Purpose:	<b>Routine Assessment</b>	Dia/Height:	<b>8"</b>
Use:	<b>Sanitary</b>	Material:	<b>PVC</b>
Drain Area:	<b>NA</b>	Lining:	
Category:	<b>NA</b>		
Comment:	<b>Drove through MH, flow direction is marked wrong.</b>		
Location Details:		Direction of Survey:	<b>Upstream</b>
US MH:	<b>M-607-076</b>	DS MH:	<b>M-607-032</b>
		Total Length Surveyed (ft):	<b>308.7</b>

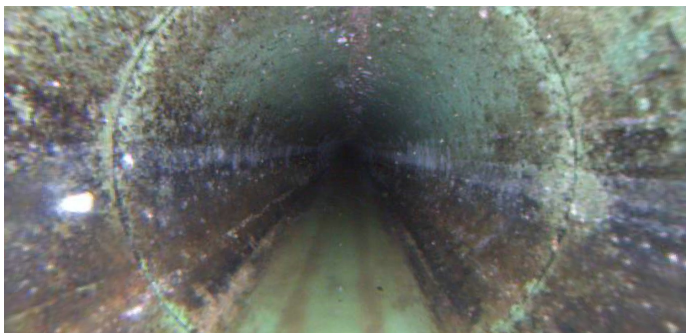
Code: **AMH**  
Description: **Manhole**

Distance (ft): **.0**  
Structural Grade: **0**  
O&M Grade: **0**  
Clock Start/From:  
Clock To:  
1st Value:  
2nd Value:  
Value Percent:  
Continuous Index:  
Within 8" of Joint: **NO**  
Remarks: **M-607-032**

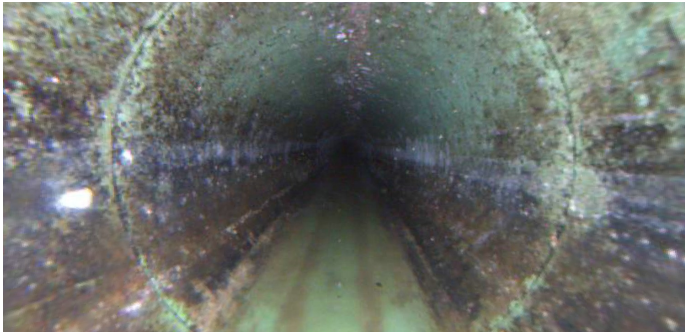
Code:	<b>MWL</b>
Description:	<b>Water Level</b>

Distance (ft):	<b>.0</b>
Structural Grade:	<b>0</b>
O&M Grade:	<b>0</b>
Clock Start/From:	
Clock To:	
1st Value:	
2nd Value:	
Value Percent:	<b>5.000</b>
Continuous Index:	
Within 8" of Joint:	<b>NO</b>
Remarks:

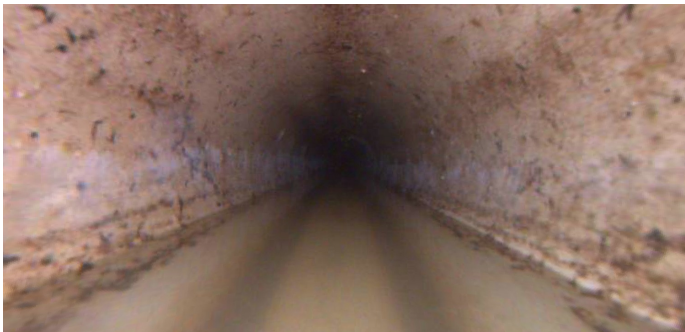
Code:	<b>MWL</b>
Description:	<b>Water Level</b>

Distance (ft):	<b>24.2</b>
Structural Grade:	<b>0</b>
O&M Grade:	<b>0</b>
Clock Start/From:	
Clock To:	
1st Value:	
2nd Value:	
Value Percent:	<b>20.000</b>
Continuous Index:	
Within 8" of Joint:	<b>NO</b>
Remarks:

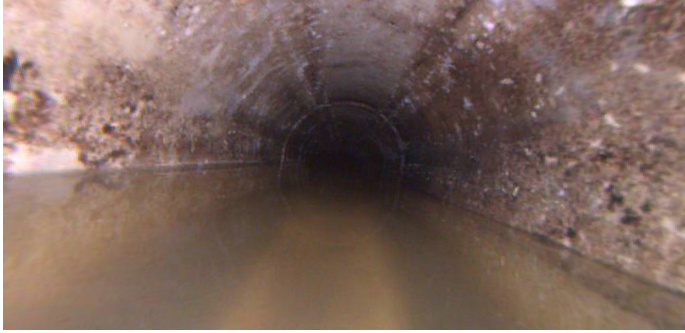
Code: **MWL**  
Description: **Water Level**

Distance (ft): **50.7**  
Structural Grade: **0**  
O&M Grade: **0**  
Clock Start/From:  
Clock To:  
1st Value:  
2nd Value:  
Value Percent: **40.000**  
Continuous Index:  
Within 8" of Joint: **NO**  
Remarks:

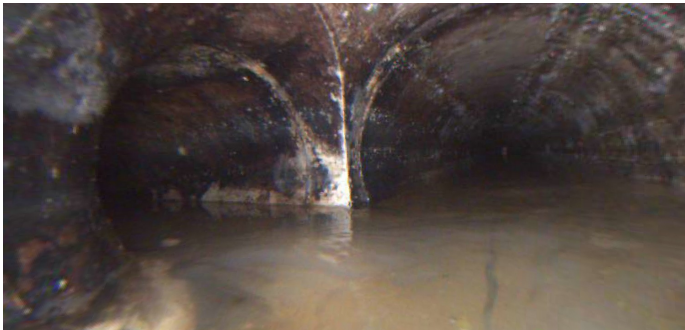
Code: **TFA**  
Description: **Tap Factory Active**

Distance (ft): **52.9**  
Structural Grade: **0**  
O&M Grade: **0**  
Clock Start/From: **3**  
Clock To:  
1st Value: **4.000**  
2nd Value:  
Value Percent:  
Continuous Index:  
Within 8" of Joint:  
Remarks:

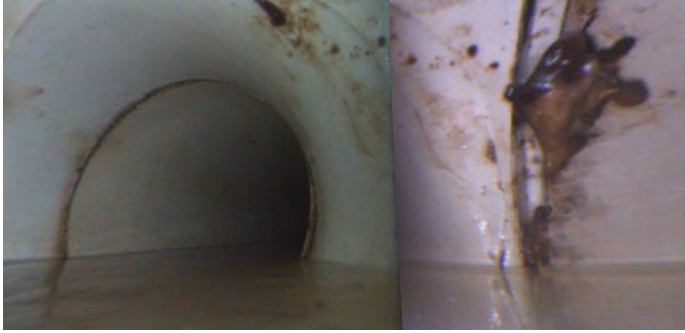
Code: **TFA**  
Description: **Tap Factory Active**

Distance (ft): **66.1**  
Structural Grade: **0**  
O&M Grade: **0**  
Clock Start/From: **9**  
Clock To:  
1st Value: **4.000**  
2nd Value:  
Value Percent:  
Continuous Index:  
Within 8" of Joint:  
Remarks:
