Profile/Photo Observation Report

Date:	04/11/2018	Weather:		Coding:	PACP 6.0
Pipe Length (ft):	124.5	Owner:	NA	Pre Clean:	No Pre-Cleaning
P.O.#:		Surveyor:	Jen Costello	PSR:	P-607-032-076
Customer:		Clean Date:	01/01/1900	Shape:	C

Street:	FOXCROFT STREET	Flow Control:	Not Controlled
City:	Hobart, IN	Year Renewed:	
Location:	Yard	Tape/Media #:	
Purpose:	Routine Assessment	Dia/Height:	8"
Use:	Sanitary	Material:	PVC
Drain Area:	NA	Lining:	
Category:	NA		
Comment:	Drove through MH, flow direction is marked wrong.		
Location Details:		Direction of Survey:	Upstream
US MH:	M-607-076	DS MH:	M-607-032
		Total Length Surveyed (ft):	308.7

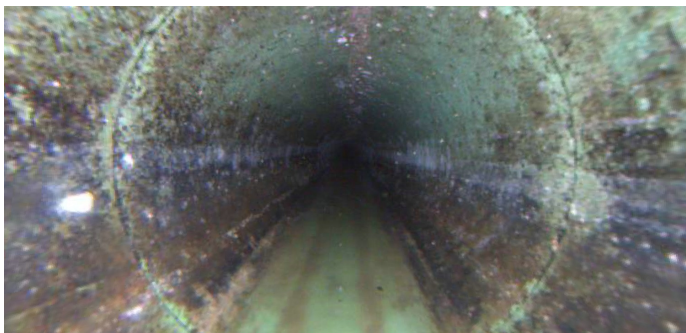
Code: **AMH**
Description: **Manhole**

Distance (ft): **.0**
Structural Grade: **0**
O&M Grade: **0**
Clock Start/From:
Clock To:
1st Value:
2nd Value:
Value Percent:
Continuous Index:
Within 8" of Joint: **NO**
Remarks: **M-607-032**

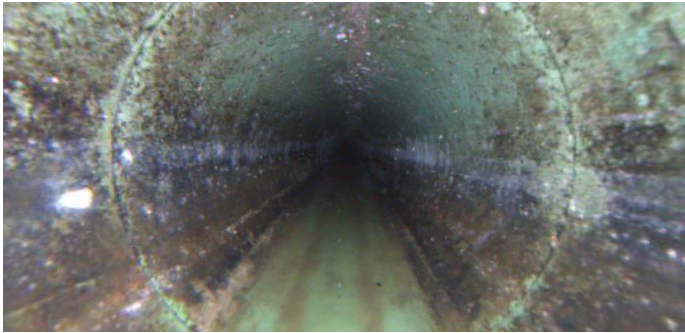
Code:	MWL
Description:	Water Level

Distance (ft):	.0
Structural Grade:	0
O&M Grade:	0
Clock Start/From:	
Clock To:	
1st Value:	
2nd Value:	
Value Percent:	5.000
Continuous Index:	
Within 8" of Joint:	NO
Remarks:

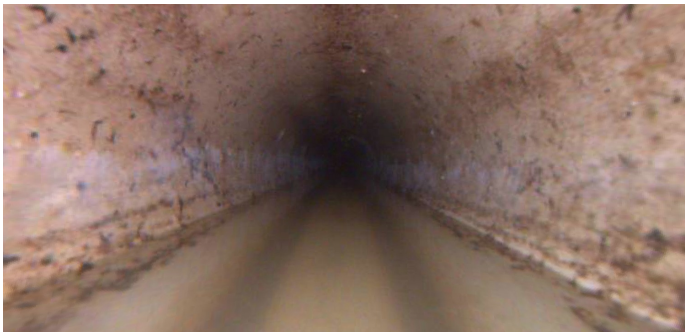
Code:	MWL
Description:	Water Level

Distance (ft):	24.2
Structural Grade:	0
O&M Grade:	0
Clock Start/From:	
Clock To:	
1st Value:	
2nd Value:	
Value Percent:	20.000
Continuous Index:	
Within 8" of Joint:	NO
Remarks:

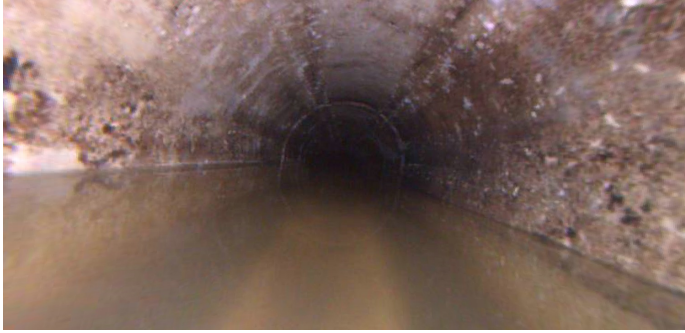
Code: **MWL**
Description: **Water Level**

Distance (ft): **50.7**
Structural Grade: **0**
O&M Grade: **0**
Clock Start/From:
Clock To:
1st Value:
2nd Value:
Value Percent: **40.000**
Continuous Index:
Within 8" of Joint: **NO**
Remarks:

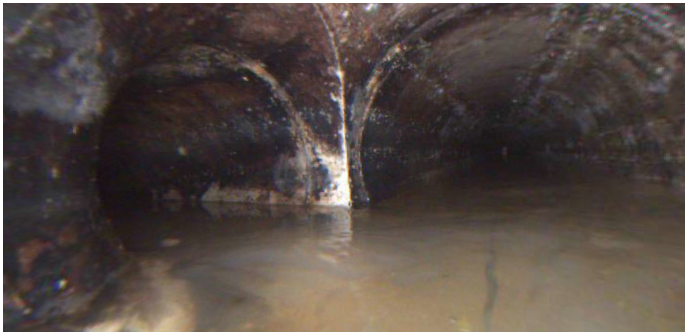
Code: **TFA**
Description: **Tap Factory Active**

Distance (ft): **52.9**
Structural Grade: **0**
O&M Grade: **0**
Clock Start/From: **3**
Clock To:
1st Value: **4.000**
2nd Value:
Value Percent:
Continuous Index:
Within 8" of Joint:
Remarks:

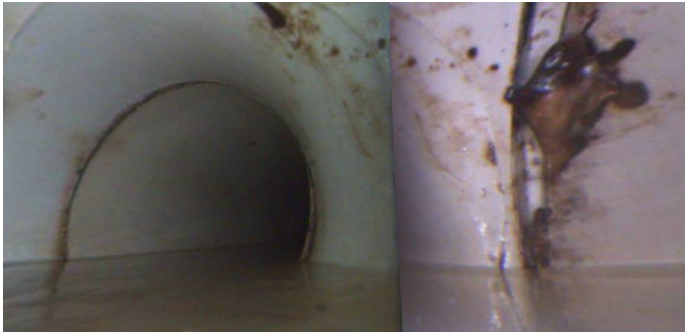
Code: **TFA**
Description: **Tap Factory Active**

Distance (ft): **66.1**
Structural Grade: **0**
O&M Grade: **0**
Clock Start/From: **9**
Clock To:
1st Value: **4.000**
2nd Value:
Value Percent:
Continuous Index:
Within 8" of Joint:
Remarks:
