## Profile/Photo Observation Report

Street:	<b>WASHINGTON ST</b>	Flow Control:	<b>Not Controlled</b>
City:	<b>Hobart, IN</b>	Year Renewed:	
Location:	<b>Light Highway</b>	Tape/Media #:	
Purpose:	<b>Routine Assessment</b>	Dia/Height:	<b>10"</b>
Use:	<b>Sanitary</b>	Material:	<b>PVC</b>
Drain Area:	<b>NA</b>	Lining:	
Category:	<b>NA</b>		
Comment:	<b>Flow direction wrong</b>		
Location Details:		Direction of Survey:	<b>Upstream</b>
US MH:	<b>M-607-077</b>	DS MH:	<b>M-608-041</b>
		Total Length Surveyed (ft):	<b>349.9</b>

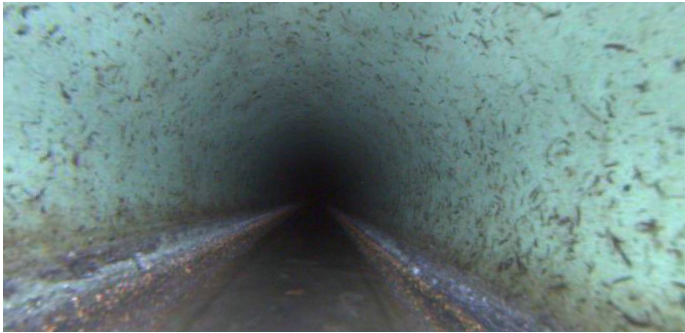
Code:	<b>MWL</b>
Description:	<b>Water Level</b>

Distance (ft):	<b>.0</b>
Structural Grade:	<b>0</b>
O&M Grade:	<b>0</b>
Clock Start/From:	
Clock To:	
1st Value:	
2nd Value:	
Value Percent:	<b>10.000</b>
Continuous Index:	
Within 8" of Joint:	<b>NO</b>
Remarks:

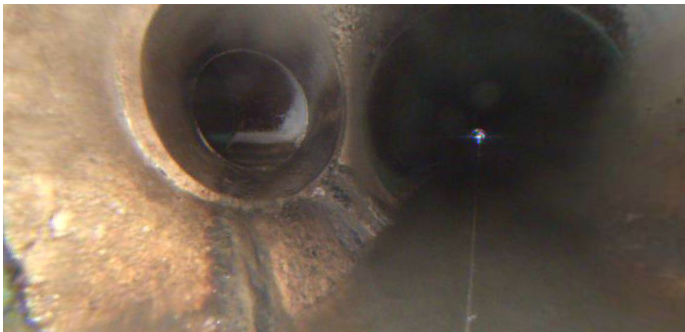
Code:	<b>TF</b>
Description:	<b>Tap Factory</b>

Distance (ft):	<b>130.0</b>
Structural Grade:	<b>0</b>
O&M Grade:	<b>0</b>
Clock Start/From:	<b>3</b>
Clock To:	
1st Value:	<b>4.000</b>
2nd Value:	
Value Percent:	
Continuous Index:	
Within 8" of Joint:	
Remarks:

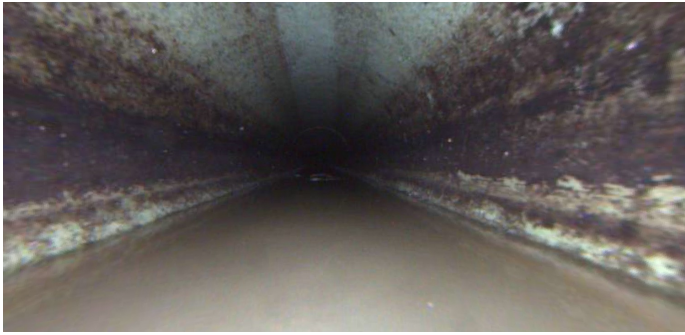
Code: **MWL**  
Description: **Water Level**

Distance (ft): **325.2**  
Structural Grade: **0**  
O&M Grade: **0**  
Clock Start/From:  
Clock To:  
1st Value:  
2nd Value:  
Value Percent: **30.000**  
Continuous Index:  
Within 8" of Joint: **NO**  
Remarks:

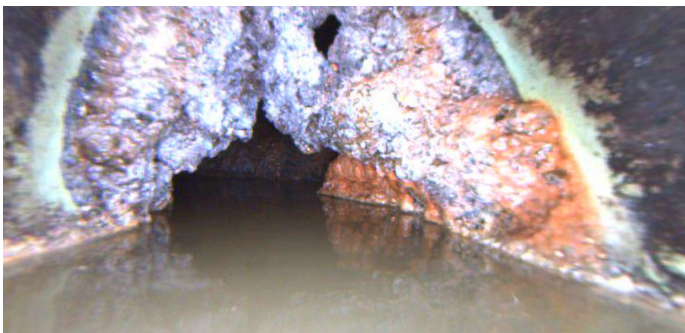
Code: **DAE**  
Description: **Deposits Attached Encrustation**

Distance (ft): **347.3**  
Structural Grade: **0**  
O&M Grade: **5**  
Clock Start/From: **8**  
Clock To: **4**  
1st Value:  
2nd Value:  
Value Percent: **60.000**  
Continuous Index:  
Within 8" of Joint: **NO**  
Remarks: **AT MH**

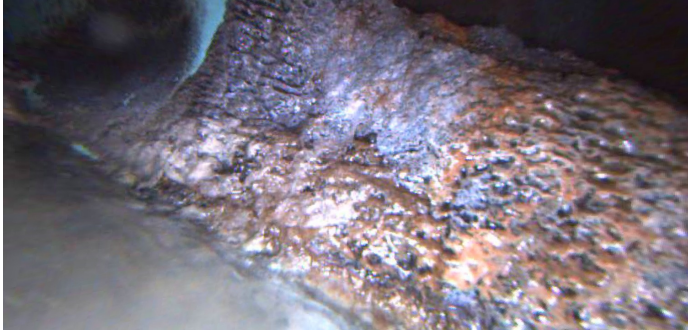
Code:	AMH
Description:	Manhole
Distance (ft):	349.9
Structural Grade:	0
O&M Grade:	0
Clock Start/From:	
Clock To:	
1st Value:	
2nd Value:	
Value Percent:	
Continuous Index:	
Within 8" of Joint:	NO
Remarks:	M-607-077
