Profile/Photo Observation Report

| Street: | S ASH ST | Flow Control: | Not Controlled |
| City: | Hobart, IN | Year Renewed: | |

| US MH: | M-607-080 | DS MH: | M-607-079 |

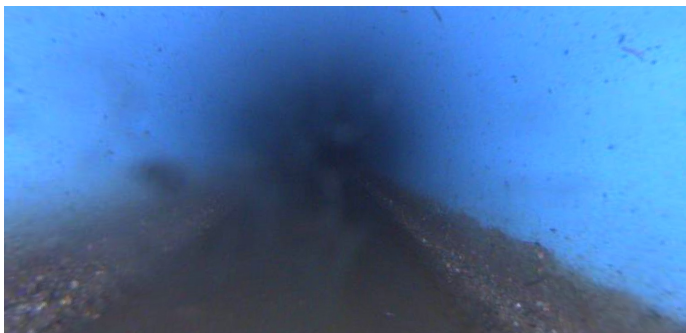
Code: **AMH**
Description: **Manhole**

Distance (ft): **.0**
Structural Grade: **0**
O&M Grade: **0**
Clock Start/From:
Clock To:
1st Value:
2nd Value:
Value Percent:
Continuous Index:
Within 8" of Joint: **NO**
Remarks: **M-607-080**

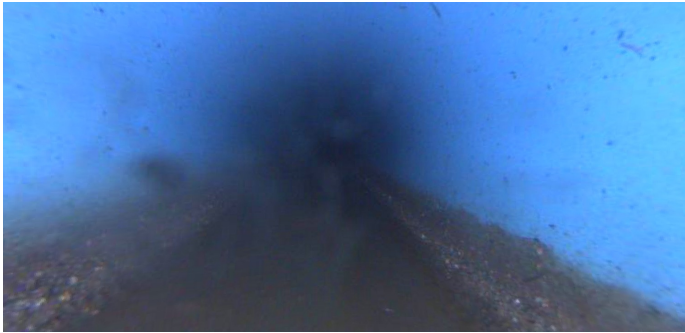
| Code: | MWL |
| Description: | Water Level |

| Distance (ft): | .0 |
| Value Percent: | 10.000 |

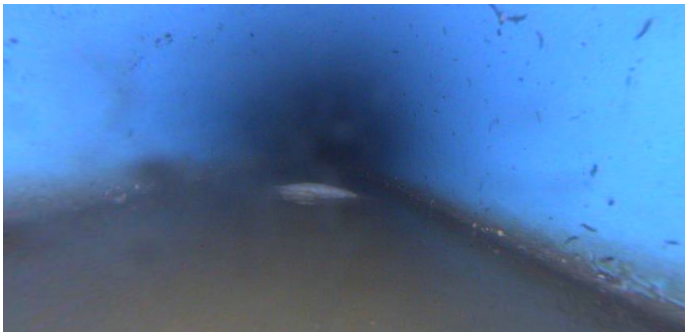
| Code: | MWL |
| Description: | Water Level |

| Distance (ft): | 19.7 |
| Value Percent: | 40.000 |

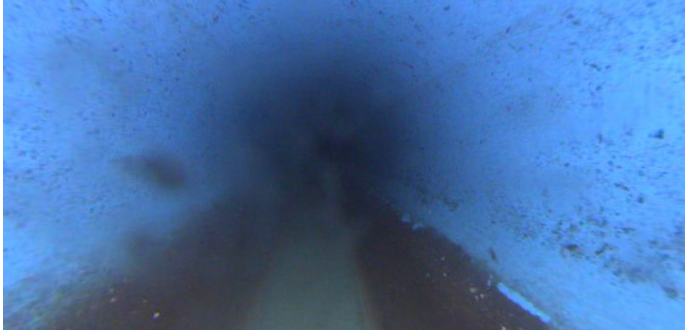
Code: **MWL**
Description: **Water Level**

Distance (ft): **42.9**
Structural Grade: **0**
O&M Grade: **0**
Clock Start/From:
Clock To:
1st Value:
2nd Value:
Value Percent: **5.000**
Continuous Index:
Within 8" of Joint: **NO**
Remarks:

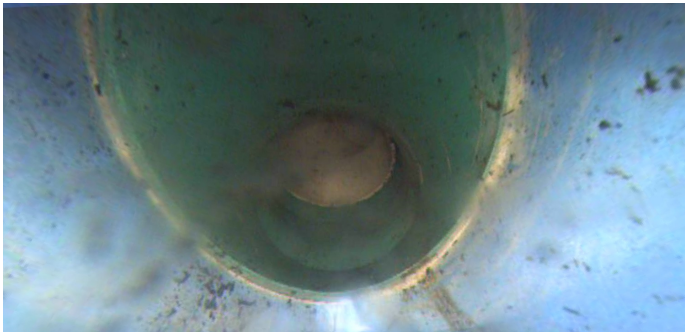
Code: **TF**
Description: **Tap Factory**

Distance (ft): **71.8**
Structural Grade: **0**
O&M Grade: **0**
Clock Start/From: **12**
Clock To:
1st Value: **4.000**
2nd Value:
Value Percent:
Continuous Index:
Within 8" of Joint:
Remarks:

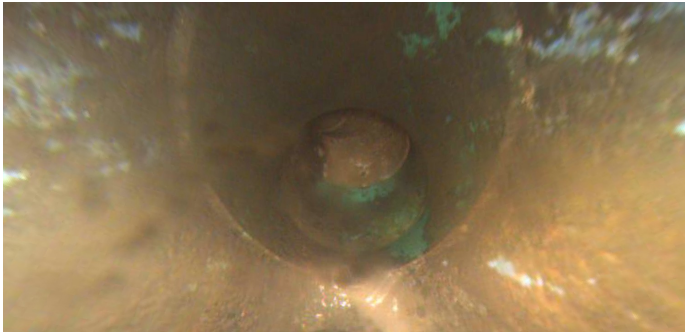
Code: **TF**
Description: **Tap Factory**

Distance (ft): **86.9**
Structural Grade: **0**
O&M Grade: **0**
Clock Start/From: **12**
Clock To:
1st Value: **4.000**
2nd Value:
Value Percent:
Continuous Index:
Within 8" of Joint:
Remarks:

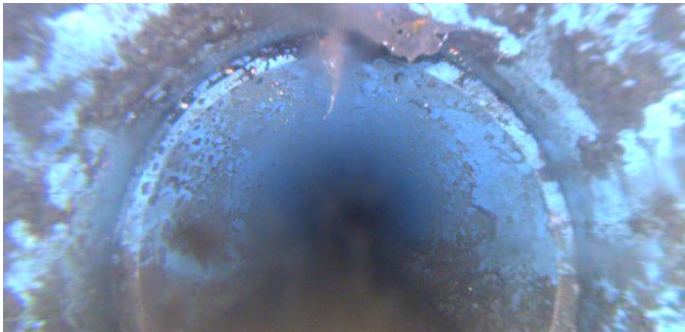
| | Position | Code | Observation | Video (sec) | Grade |
|--|---|---|---|---|---|
| | 86.9 | RFJ | Roots Fine Joint | 261 | M 1 |

Code: **RFJ**
Description: **Roots Fine Joint**

Distance (ft): **86.9**
Structural Grade: **0**
O&M Grade: **1**
Clock Start/From: **12**
Clock To:
1st Value:
2nd Value:
Value Percent:
Continuous Index:
Within 8" of Joint: **YES**
Remarks:

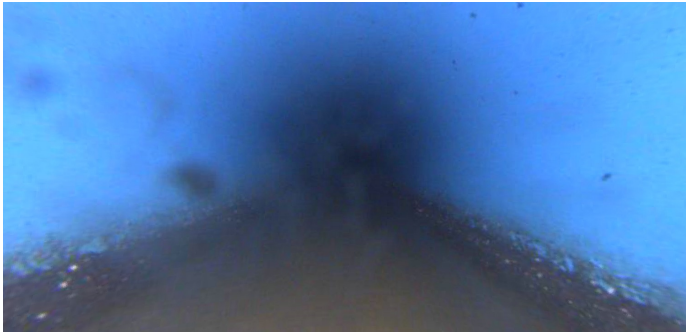
Code: **MWL**
Description: **Water Level**

Distance (ft): **96.9**
Structural Grade: **0**
O&M Grade: **0**
Clock Start/From:
Clock To:
1st Value:
2nd Value:
Value Percent: **20.000**
Continuous Index:
Within 8" of Joint: **NO**
Remarks:

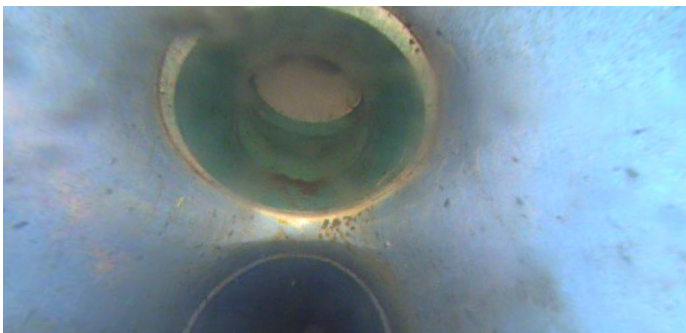
Code: **TF**
Description: **Tap Factory**

Distance (ft): **137.9**
Structural Grade: **0**
O&M Grade: **0**
Clock Start/From: **12**
Clock To:
1st Value: **4.000**
2nd Value:
Value Percent:
Continuous Index:
Within 8" of Joint:
Remarks:

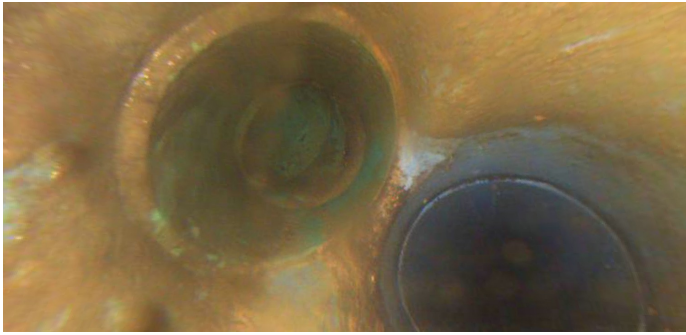
Code: **TF**
Description: **Tap Factory**

Distance (ft): **313.7**
Structural Grade: **0**
O&M Grade: **0**
Clock Start/From: **2**
Clock To:
1st Value: **4.000**
2nd Value:
Value Percent:
Continuous Index:
Within 8" of Joint:
Remarks:

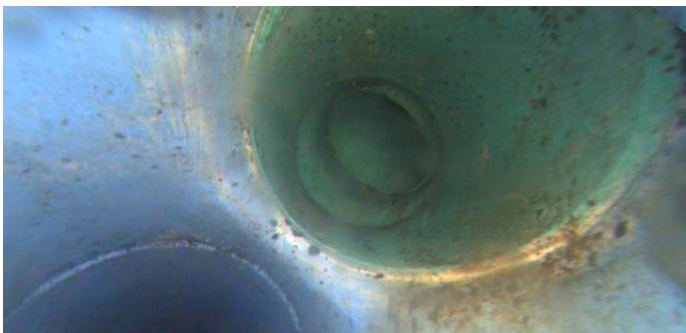
Code: **TF**
Description: **Tap Factory**

Distance (ft): **337.1**
Structural Grade: **0**
O&M Grade: **0**
Clock Start/From: **11**
Clock To:
1st Value: **4.000**
2nd Value:
Value Percent:
Continuous Index:
Within 8" of Joint:
Remarks:

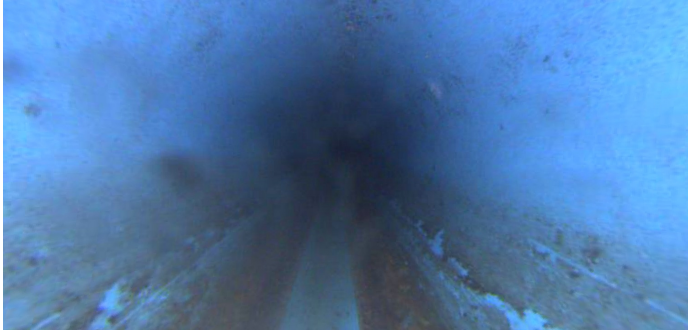
| Code: | MSA |
| Description: | Abandoned Survey |
| Distance (ft): | 351.8 |
| Remarks: | unknown |
