Profile/Photo Observation Report

Street:	S ASH ST	Flow Control:	Not Controlled
City:	Hobart, IN	Year Renewed:	
Location:	Yard	Tape/Media #:	
Purpose:	Routine Assessment	Dia/Height:	8"
Use:	Sanitary	Material:	PVC
Drain Area:	NA	Lining:	
Category:	NA		
Comment:

Location Details:		Direction of Survey:	Upstream
US MH:	M-607-080	DS MH:	M-607-079
		Total Length Surveyed (ft):	350.8

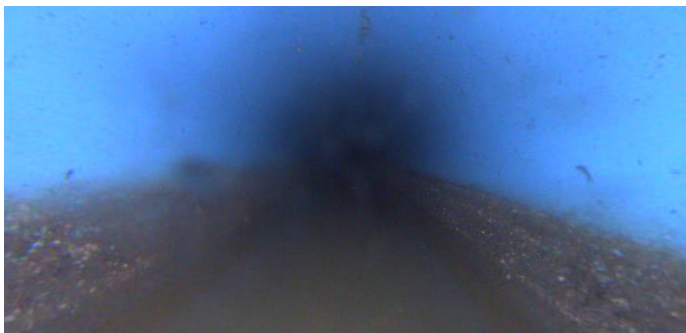
Code: **AMH**
Description: **Manhole**

Distance (ft): **.0**
Structural Grade: **0**
O&M Grade: **0**
Clock Start/From:
Clock To:
1st Value:
2nd Value:
Value Percent:
Continuous Index:
Within 8" of Joint: **NO**
Remarks: **M-607-079**

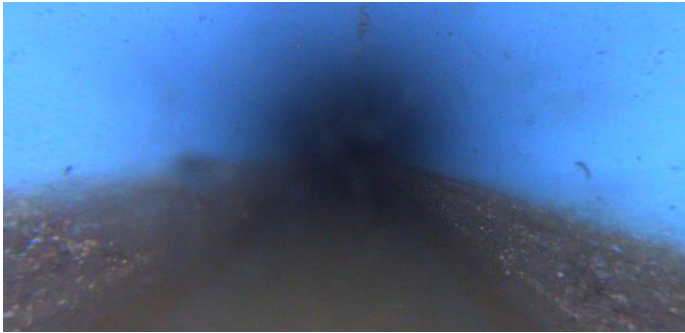
Code:	MWL
Description:	Water Level

Distance (ft):	.0
Structural Grade:	0
O&M Grade:	0
Clock Start/From:	
Clock To:	
1st Value:	
2nd Value:	
Value Percent:	30.000
Continuous Index:	
Within 8" of Joint:	NO
Remarks:

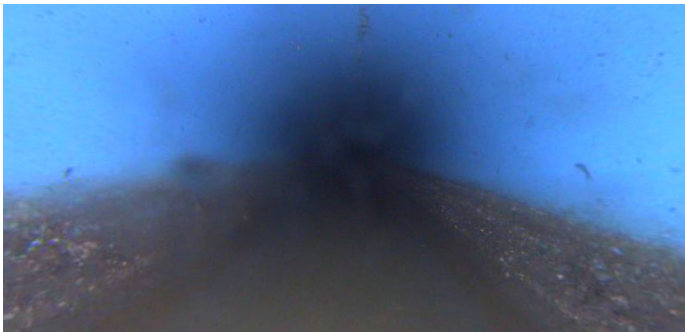
Code:	DAGS
Description:	Deposits Attached Grease

Distance (ft):	.0
Structural Grade:	0
O&M Grade:	2
Clock Start/From:	8
Clock To:	4
1st Value:	
2nd Value:	
Value Percent:	5.000
Continuous Index:	S01
Within 8" of Joint:	NO
Remarks:

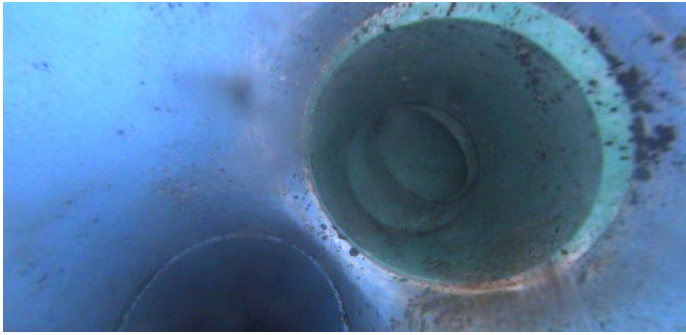
Code: **TF**
Description: **Tap Factory**

Distance (ft): **61.3**
Structural Grade: **0**
O&M Grade: **0**
Clock Start/From: **2**
Clock To:
1st Value: **4.000**
2nd Value:
Value Percent:
Continuous Index:
Within 8" of Joint:
Remarks:

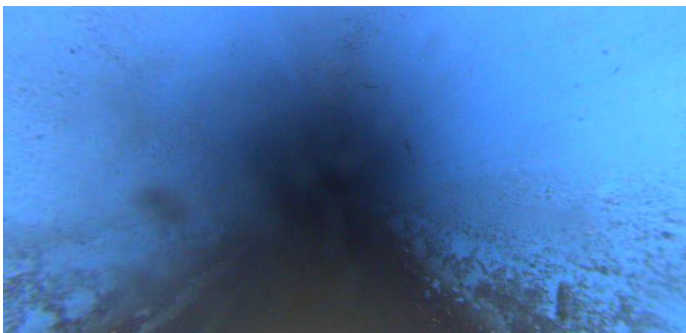
Code: **DAGS**
Description: **Deposits Attached Grease**

Distance (ft): **64.9**
Structural Grade: **0**
O&M Grade: **2**
Clock Start/From: **8**
Clock To: **4**
1st Value:
2nd Value:
Value Percent: **5.000**
Continuous Index: **F01**
Within 8" of Joint: **NO**
Remarks:

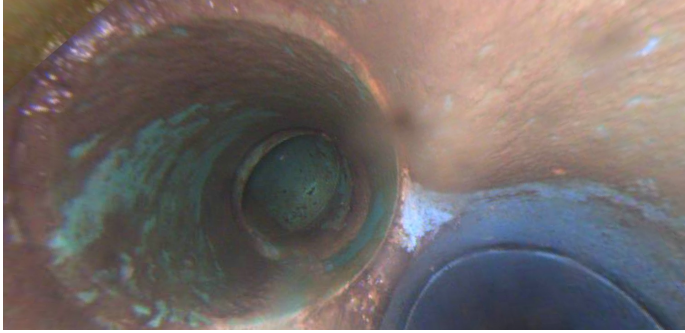
Code: **TF**
Description: **Tap Factory**

Distance (ft): **85.0**
Structural Grade: **0**
O&M Grade: **0**
Clock Start/From: **10**
Clock To:
1st Value: **4.000**
2nd Value:
Value Percent:
Continuous Index:
Within 8" of Joint:
Remarks:

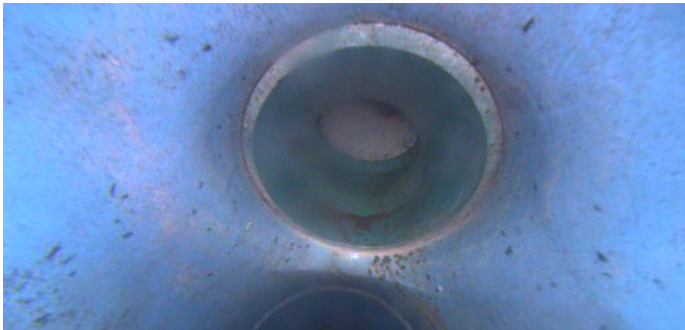
Code: **TF**
Description: **Tap Factory**

Distance (ft): **260.7**
Structural Grade: **0**
O&M Grade: **0**
Clock Start/From: **12**
Clock To:
1st Value: **4.000**
2nd Value:
Value Percent:
Continuous Index:
Within 8" of Joint:
Remarks:

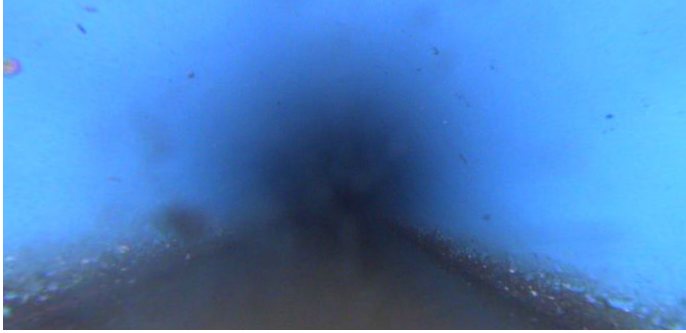
Code: **MWL**
Description: **Water Level**

Distance (ft): **302.7**
Structural Grade: **0**
O&M Grade: **0**
Clock Start/From:
Clock To:
1st Value:
2nd Value:
Value Percent: **30.000**
Continuous Index:
Within 8" of Joint: **NO**
Remarks:

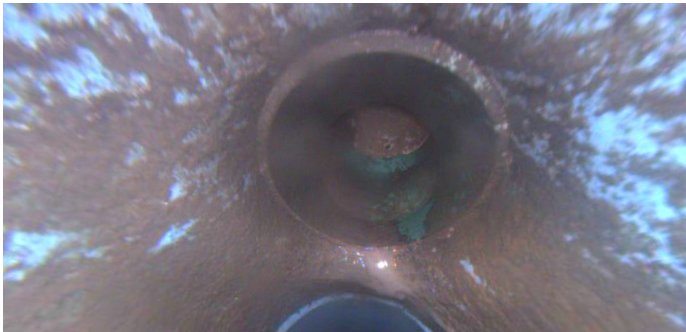
Code: **TF**
Description: **Tap Factory**

Distance (ft): **311.5**
Structural Grade: **0**
O&M Grade: **0**
Clock Start/From: **12**
Clock To:
1st Value: **4.000**
2nd Value:
Value Percent:
Continuous Index:
Within 8" of Joint:
Remarks:

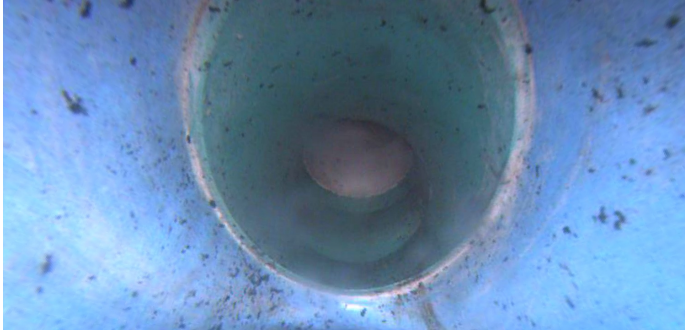
Code: **TF**
Description: **Tap Factory**

Distance (ft): **326.8**
Structural Grade: **0**
O&M Grade: **0**
Clock Start/From: **12**
Clock To:
1st Value: **4.000**
2nd Value:
Value Percent:
Continuous Index:
Within 8" of Joint:
Remarks:

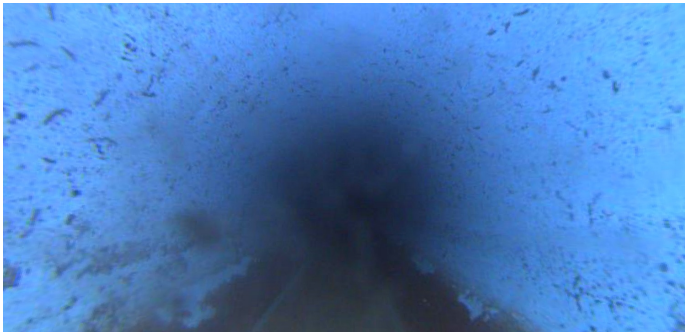
Code: **MSA**
Description: **Abandoned Survey**

Distance (ft): **350.8**
Structural Grade: **0**
O&M Grade: **0**
Clock Start/From:
Clock To:
1st Value:
2nd Value:
Value Percent:
Continuous Index:
Within 8" of Joint: **NO**
Remarks: **UNKNOWN**
