## Profile/Photo Observation Report

| Street: | <b>S ASH ST &amp; W 12TH ST</b> | Flow Control: | <b>Not Controlled</b> |
| City: | <b>Hobart, IN</b> | Year Renewed: | |
| US MH: | <b>M-607-081</b> | DS MH: | <b>M-607-080</b> |

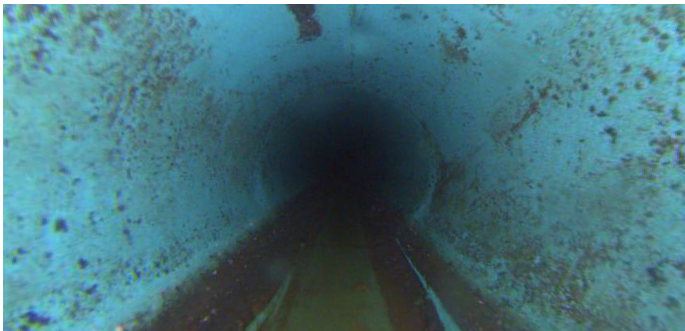
Code: **AMH**  
Description: **Manhole**

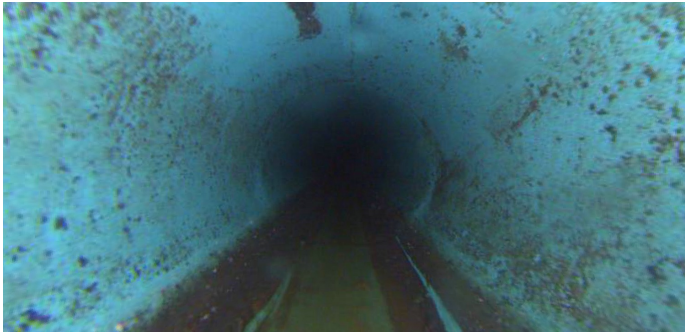
| Code: | <b>MWL</b> |
| Description: | <b>Water Level</b> |

| Distance (ft): | <b>.0</b> |
| Value Percent: | <b>5.000</b> |

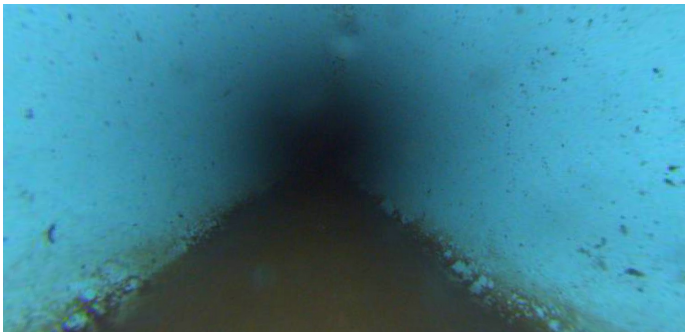
| Code: | <b>MWL</b> |
| Description: | <b>Water Level</b> |

| Distance (ft): | <b>23.5</b> |
| Value Percent: | <b>10.000</b> |

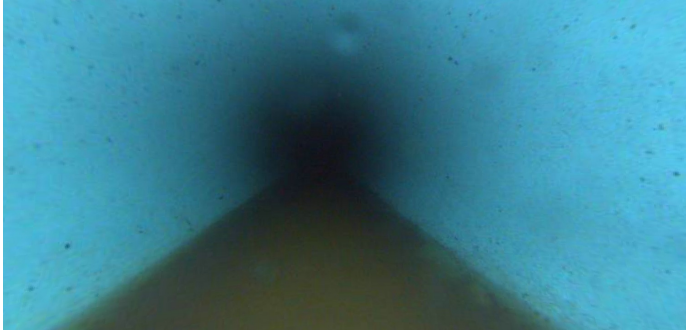
Code: **MWL**  
Description: **Water Level**

Distance (ft): **46.0**  
Structural Grade: **0**  
O&M Grade: **0**  
Clock Start/From:  
Clock To:  
1st Value:  
2nd Value:  
Value Percent: **20.000**  
Continuous Index:  
Within 8" of Joint: **NO**  
Remarks:

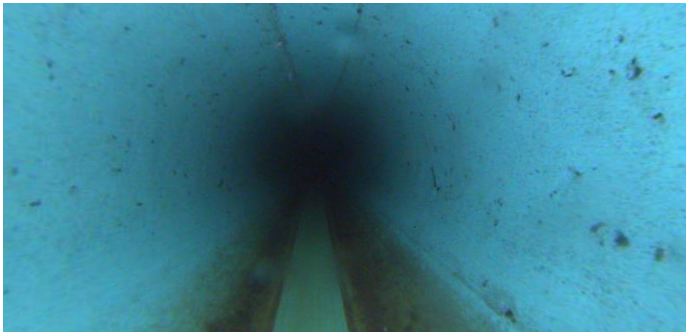
Code: **MWL**  
Description: **Water Level**

Distance (ft): **57.2**  
Structural Grade: **0**  
O&M Grade: **0**  
Clock Start/From:  
Clock To:  
1st Value:  
2nd Value:  
Value Percent: **5.000**  
Continuous Index:  
Within 8" of Joint: **NO**  
Remarks:

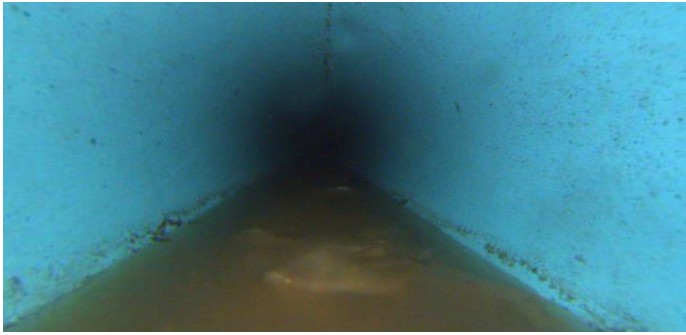
Code: **MWL**  
Description: **Water Level**

Distance (ft): **80.7**  
Structural Grade: **0**  
O&M Grade: **0**  
Clock Start/From:  
Clock To:  
1st Value:  
2nd Value:  
Value Percent: **20.000**  
Continuous Index:  
Within 8" of Joint: **NO**  
Remarks:

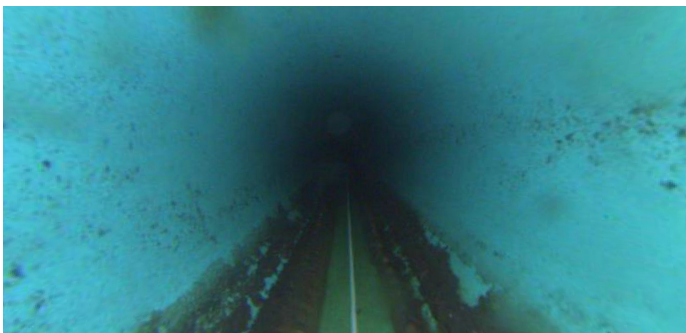
Code: **MGO**  
Description: **General Observation**

Distance (ft): **200.2**  
Structural Grade: **0**  
O&M Grade: **0**  
Clock Start/From:  
Clock To:  
1st Value:  
2nd Value:  
Value Percent:  
Continuous Index:  
Within 8" of Joint: **NO**  
Remarks: **REAR CAMERA**

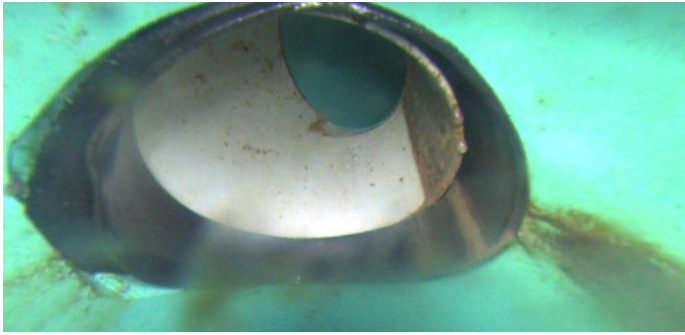
Code: **TS**  
Description: **Tap Saddle**

Distance (ft): **282.8**  
Structural Grade: **0**  
O&M Grade: **0**  
Clock Start/From: **12**  
Clock To:  
1st Value: **4.000**  
2nd Value:  
Value Percent:  
Continuous Index:  
Within 8" of Joint:  
Remarks:

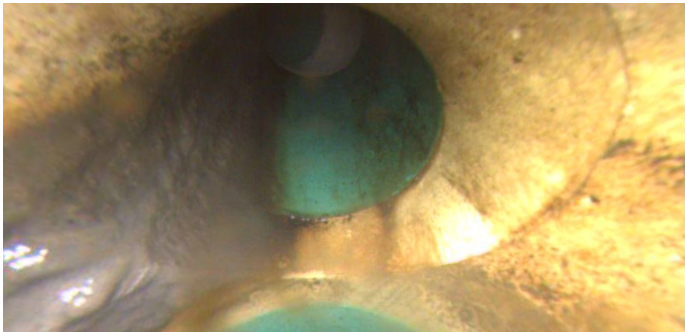
Code: **TFA**  
Description: **Tap Factory Active**

Distance (ft): **376.3**  
Structural Grade: **0**  
O&M Grade: **0**  
Clock Start/From: **12**  
Clock To:  
1st Value: **4.000**  
2nd Value:  
Value Percent:  
Continuous Index:  
Within 8" of Joint:  
Remarks:

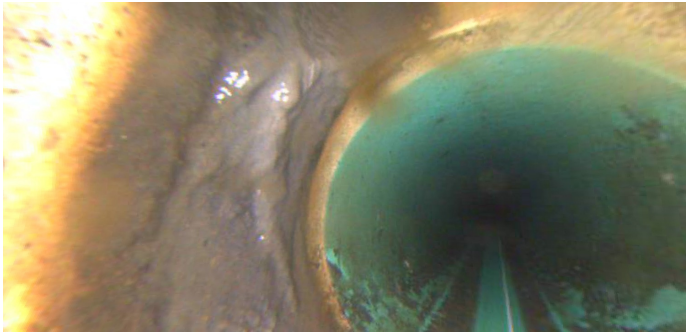
| Position | Code | Observation | Video (sec) | Grade |
|---|---|---|---|---|
| 376.3 | DAGS | Deposits Attached Grease | 870 | M 2 |

Code: **DAGS**  
Description: **Deposits Attached Grease**

Distance (ft): **376.3**  
Structural Grade: **0**  
O&M Grade: **2**  
Clock Start/From: **1**  
Clock To: **4**  
1st Value:  
2nd Value:  
Value Percent: **5.000**  
Continuous Index:  
Within 8" of Joint: **NO**  
Remarks:

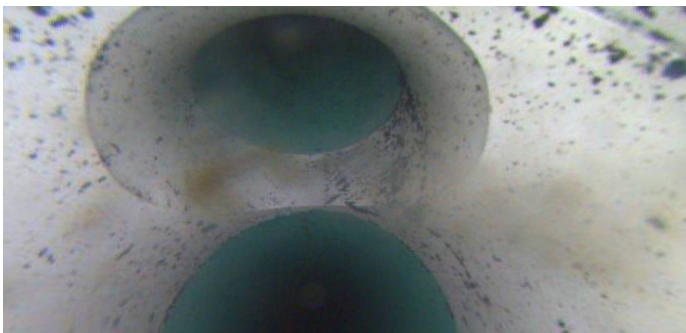
Code: **TF**  
Description: **Tap Factory**

Distance (ft): **385.0**  
Structural Grade: **0**  
O&M Grade: **0**  
Clock Start/From: **12**  
Clock To:  
1st Value: **4.000**  
2nd Value:  
Value Percent:  
Continuous Index:  
Within 8" of Joint:  
Remarks:

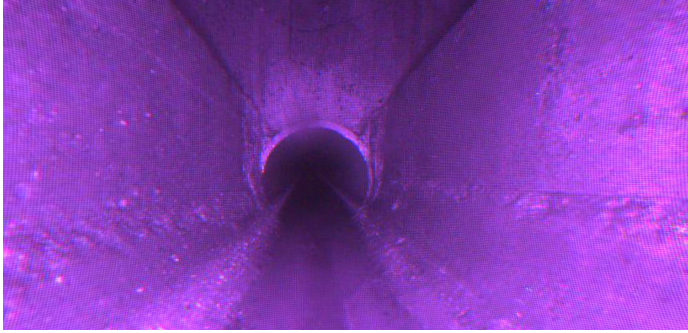
| Code: | AMH |
| Description: | Manhole |
| Distance (ft): | 400.5 |
| Remarks: | M-607-080 |
