Profile/Photo Observation Report

Street:	FOXCROFT STREET	Flow Control:	Not Controlled
City:	Hobart, IN	Year Renewed:	
Location:	Yard	Tape/Media #:	
Purpose:	Routine Assessment	Dia/Height:	8"
Use:	Sanitary	Material:	PVC
Drain Area:	NA	Lining:	
Category:	NA		
Comment:

Location Details:		Direction of Survey:	Upstream
US MH:	M-607-083	DS MH:	M-607-082
		Total Length Surveyed (ft):	314.4

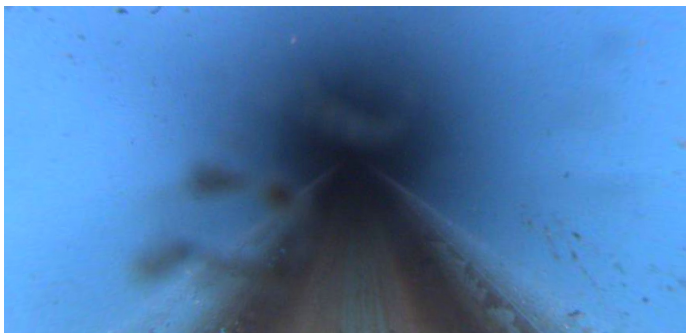
Code: **AMH**
Description: **Manhole**

Distance (ft): **.0**
Structural Grade: **0**
O&M Grade: **0**
Clock Start/From:
Clock To:
1st Value:
2nd Value:
Value Percent:
Continuous Index:
Within 8" of Joint: **NO**
Remarks: **M-607-082**

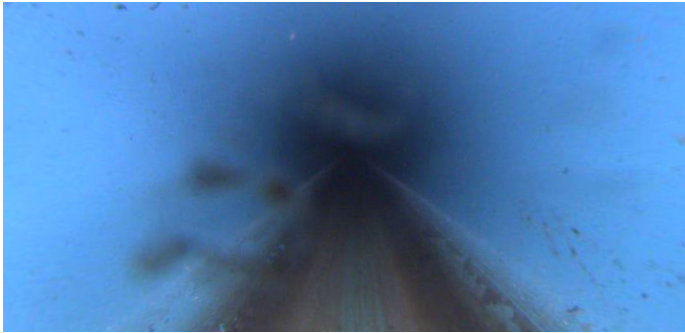
Code:	MWL
Description:	Water Level

Distance (ft):	.0
Structural Grade:	0
O&M Grade:	0
Clock Start/From:	
Clock To:	
1st Value:	
2nd Value:	
Value Percent:	5.000
Continuous Index:	
Within 8" of Joint:	NO
Remarks:

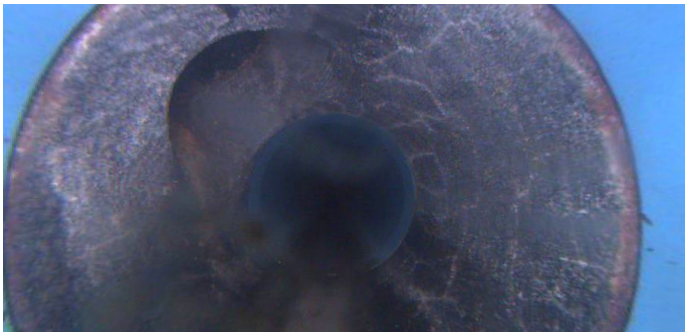
Code:	MMC
Description:	Material Change

Distance (ft):	21.4
Structural Grade:	0
O&M Grade:	0
Clock Start/From:	
Clock To:	
1st Value:	
2nd Value:	
Value Percent:	
Continuous Index:	
Within 8" of Joint:	NO
Remarks:	cp

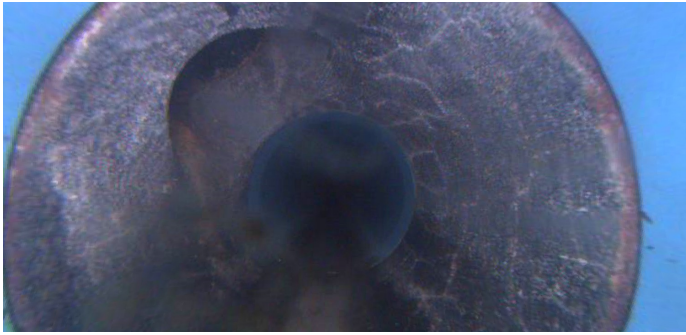
Code: **CM**
Description: **Crack Multiple**

Distance (ft): **21.4**
Structural Grade: **3**
O&M Grade: **0**
Clock Start/From: **12**
Clock To: **6**
1st Value:
2nd Value:
Value Percent:
Continuous Index:
Within 8" of Joint:
Remarks:

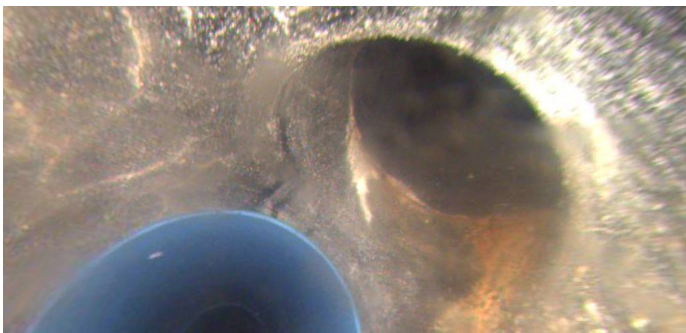
Code: **TF**
Description: **Tap Factory**

Distance (ft): **22.6**
Structural Grade: **0**
O&M Grade: **0**
Clock Start/From: **11**
Clock To:
1st Value: **4.000**
2nd Value:
Value Percent:
Continuous Index:
Within 8" of Joint:
Remarks:

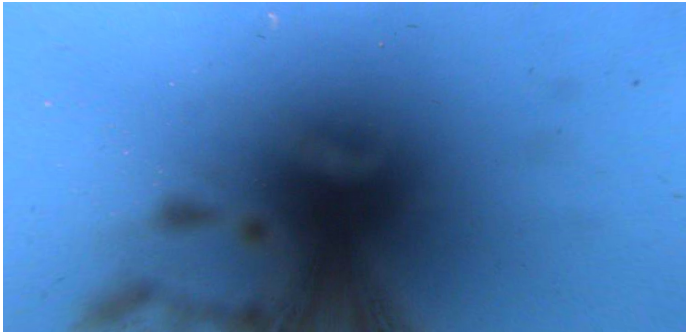
Code: **MMC**
Description: **Material Change**

Distance (ft): **22.7**
Structural Grade: **0**
O&M Grade: **0**
Clock Start/From:
Clock To:
1st Value:
2nd Value:
Value Percent:
Continuous Index:
Within 8" of Joint: **NO**
Remarks: **PVC**

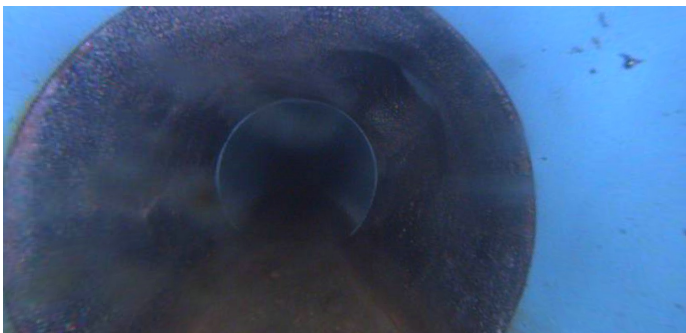
Code: **MMC**
Description: **Material Change**

Distance (ft): **60.6**
Structural Grade: **0**
O&M Grade: **0**
Clock Start/From:
Clock To:
1st Value:
2nd Value:
Value Percent:
Continuous Index:
Within 8" of Joint: **NO**
Remarks: **DIP**

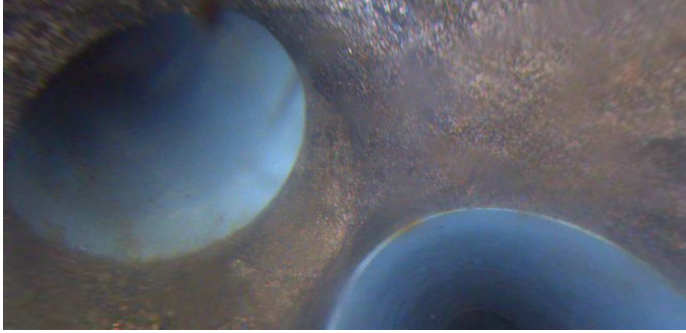
Code: **TF**
Description: **Tap Factory**

Distance (ft): **61.7**
Structural Grade: **0**
O&M Grade: **0**
Clock Start/From: **2**
Clock To:
1st Value: **4.000**
2nd Value:
Value Percent:
Continuous Index:
Within 8" of Joint:
Remarks:

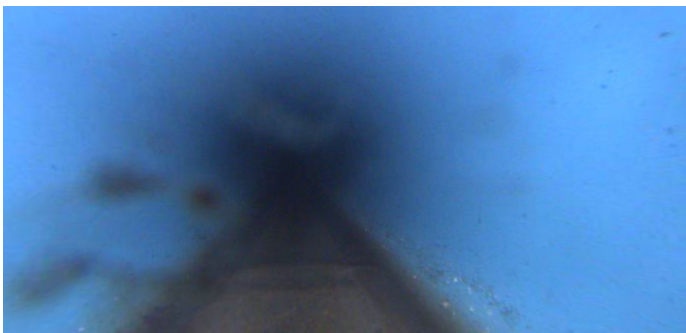
Code: **MMC**
Description: **Material Change**

Distance (ft): **62.0**
Structural Grade: **0**
O&M Grade: **0**
Clock Start/From:
Clock To:
1st Value:
2nd Value:
Value Percent:
Continuous Index:
Within 8" of Joint: **NO**
Remarks: **pvc**

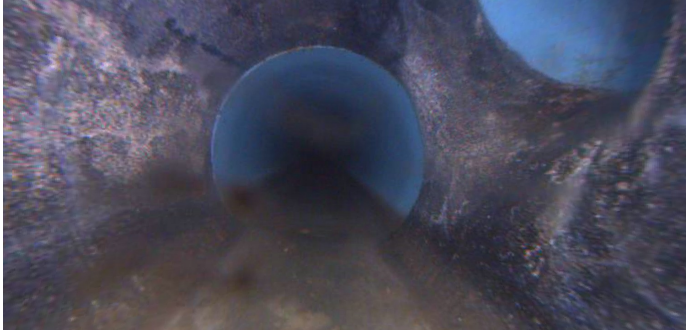
Code: **MMC**
Description: **Material Change**

Distance (ft): **84.0**
Structural Grade: **0**
O&M Grade: **0**
Clock Start/From:
Clock To:
1st Value:
2nd Value:
Value Percent:
Continuous Index:
Within 8" of Joint: **NO**
Remarks: **DIP**

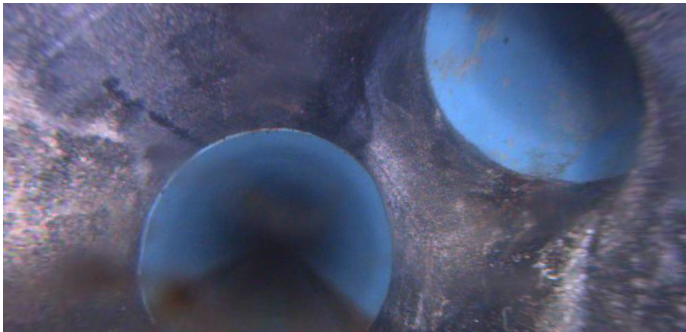
Code: **TF**
Description: **Tap Factory**

Distance (ft): **84.1**
Structural Grade: **0**
O&M Grade: **0**
Clock Start/From: **2**
Clock To:
1st Value: **4.000**
2nd Value:
Value Percent:
Continuous Index:
Within 8" of Joint:
Remarks:

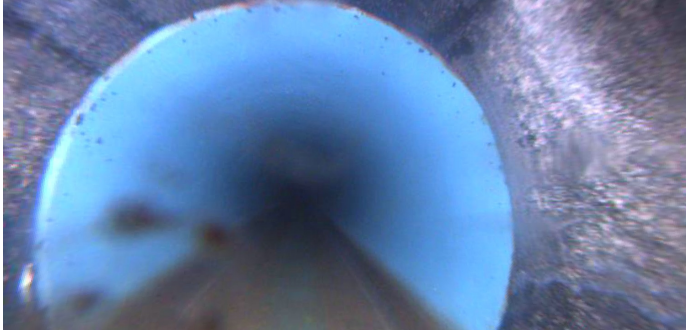
Code: **MMC**
Description: **Material Change**

Distance (ft): **84.4**
Structural Grade: **0**
O&M Grade: **0**
Clock Start/From:
Clock To:
1st Value:
2nd Value:
Value Percent:
Continuous Index:
Within 8" of Joint: **NO**
Remarks: **pvc**

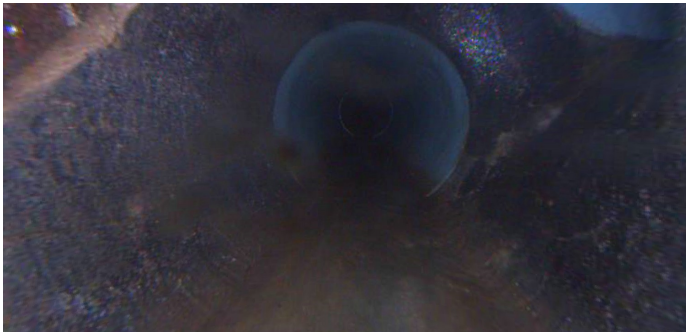
Code: **MMC**
Description: **Material Change**

Distance (ft): **241.0**
Structural Grade: **0**
O&M Grade: **0**
Clock Start/From:
Clock To:
1st Value:
2nd Value:
Value Percent:
Continuous Index:
Within 8" of Joint: **NO**
Remarks: **CP**

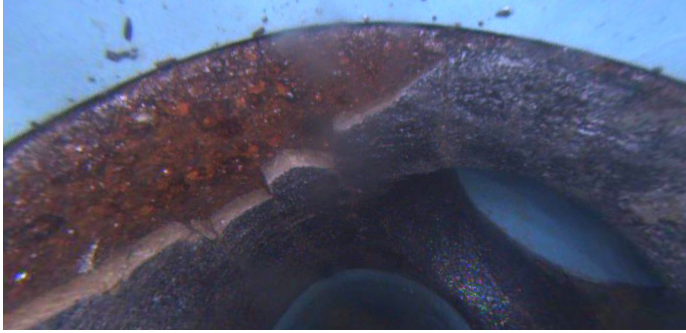
Code: **SMW**
Description: **Surface Missing Wall**

Distance (ft): **241.0**
Structural Grade: **5**
O&M Grade: **0**
Clock Start/From: **9**
Clock To: **12**
1st Value:
2nd Value:
Value Percent:
Continuous Index:
Within 8" of Joint: **YES**
Remarks:

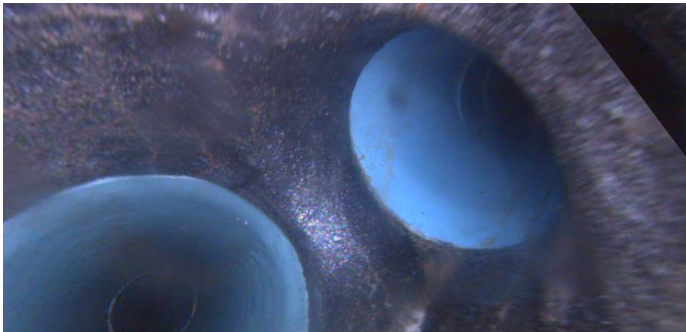
Code: **TF**
Description: **Tap Factory**

Distance (ft): **241.3**
Structural Grade: **0**
O&M Grade: **0**
Clock Start/From: **2**
Clock To:
1st Value: **4.000**
2nd Value:
Value Percent:
Continuous Index:
Within 8" of Joint:
Remarks:

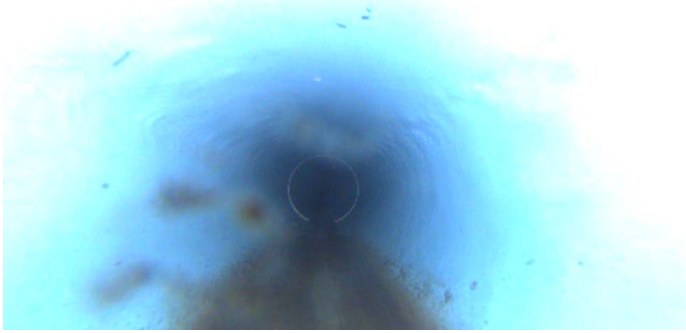
Code: **MMC**
Description: **Material Change**

Distance (ft): **242.0**
Structural Grade: **0**
O&M Grade: **0**
Clock Start/From:
Clock To:
1st Value:
2nd Value:
Value Percent:
Continuous Index:
Within 8" of Joint: **NO**
Remarks: **pvc**

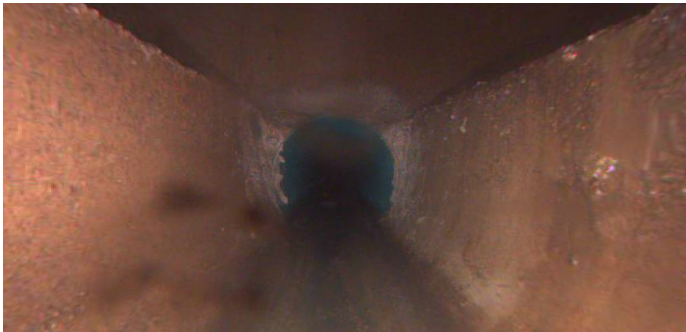
Code: **AMH**
Description: **Manhole**

Distance (ft): **314.4**
Structural Grade: **0**
O&M Grade: **0**
Clock Start/From:
Clock To:
1st Value:
2nd Value:
Value Percent:
Continuous Index:
Within 8" of Joint: **NO**
Remarks: **M-607-083**
