Profile/Photo Observation Report

Street:	12th. St.	Flow Control:	Not Controlled
City:	Hobart, IN	Year Renewed:	
Location:	Light Highway	Tape/Media #:	
Purpose:	Routine Assessment	Dia/Height:	8"
Use:	Sanitary	Material:	PVC
Drain Area:	NA	Lining:	
Category:	NA		
Comment:	NULL - DC @ MH-M-507-059

Location Details:		Direction of Survey:	Upstream
US MH:	M-607-084	DS MH:	M-607-081
		Total Length Surveyed (ft):	2.2

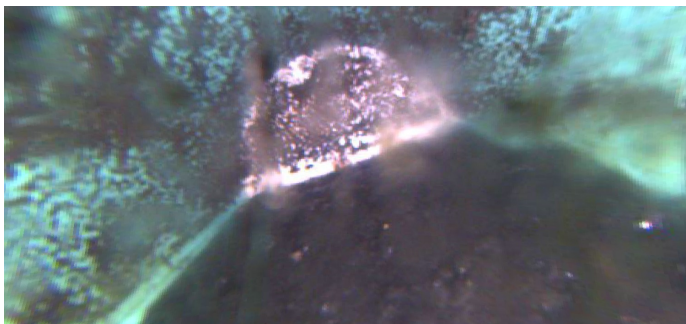
Code: **AMH**
Description: **Manhole**

Distance (ft): **.0**
Structural Grade: **0**
O&M Grade: **0**
Clock Start/From:
Clock To:
1st Value:
2nd Value:
Value Percent:
Continuous Index:
Within 8" of Joint: **NO**
Remarks: **M-607-081**

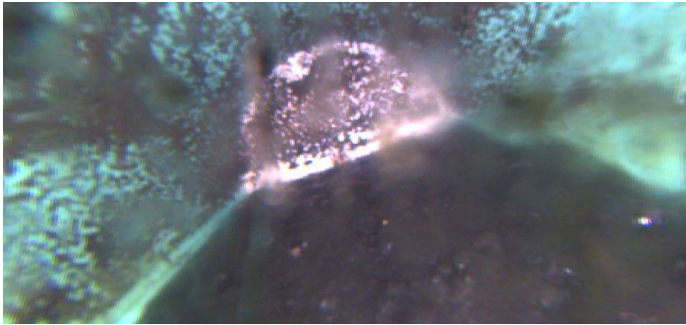
Code:	MWL
Description:	Water Level

Distance (ft):	.0
Structural Grade:	0
O&M Grade:	0
Clock Start/From:	
Clock To:	
1st Value:	
2nd Value:	
Value Percent:	5.000
Continuous Index:	
Within 8" of Joint:	NO
Remarks:
