Profile/Photo Observation Report

| Street: | S WISCONSIN ST & W 61ST AVE | Flow Control: | Not Controlled |

| US MH: | M-608-002 | DS MH: | M-608-001 |

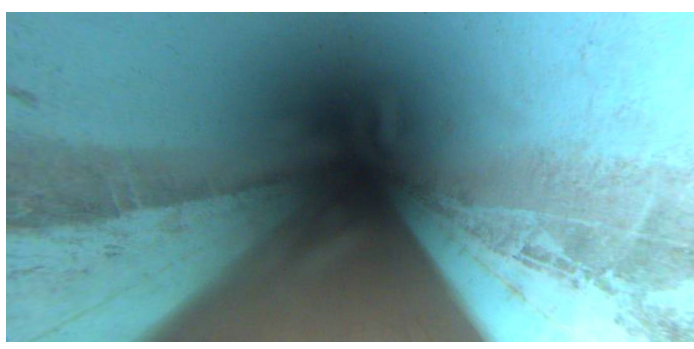
Code: **AMH**
Description: **Manhole**

Distance (ft): **.0**
Structural Grade: **0**
O&M Grade: **0**
Clock Start/From:
Clock To:
1st Value:
2nd Value:
Value Percent:
Continuous Index:
Within 8" of Joint: **NO**
Remarks: **M-608-002**

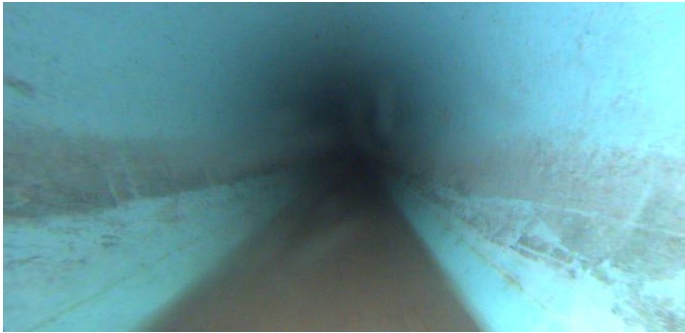
| Code: | MWL |
| Description: | Water Level |

| Distance (ft): | .0 |
| Value Percent: | 5.000 |

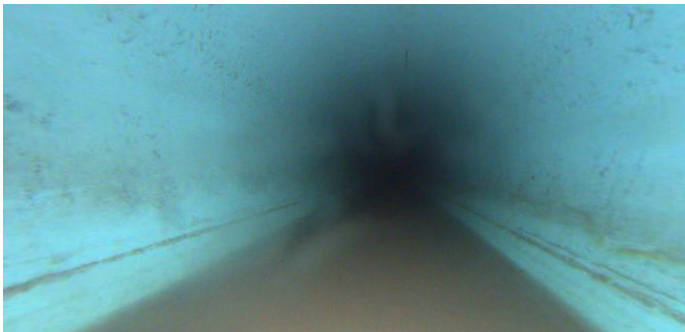
| Code: | MSA |
| Description: | Abandoned Survey |

| Distance (ft): | 10.3 |
| Remarks: | debris under water |
