Profile/Photo Observation Report

| Street: | FOXCROFT STREET | Flow Control: | Not Controlled |
| City: | Hobart, IN | Year Renewed: | |

| US MH: | M-608-002 | DS MH: | M-608-001 |

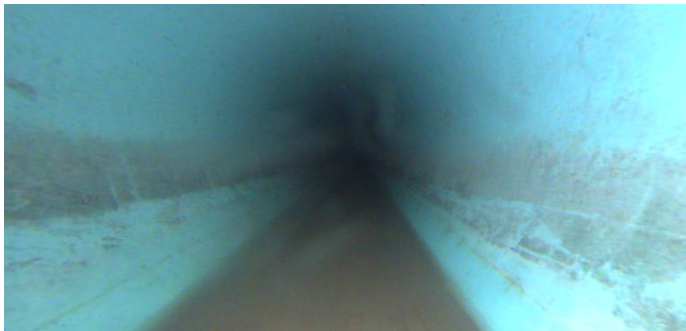
Code: **AMH**
Description: **Manhole**

Distance (ft): **.0**
Structural Grade: **0**
O&M Grade: **0**
Clock Start/From:
Clock To:
1st Value:
2nd Value:
Value Percent:
Continuous Index:
Within 8" of Joint: **NO**
Remarks: **M-608-002**

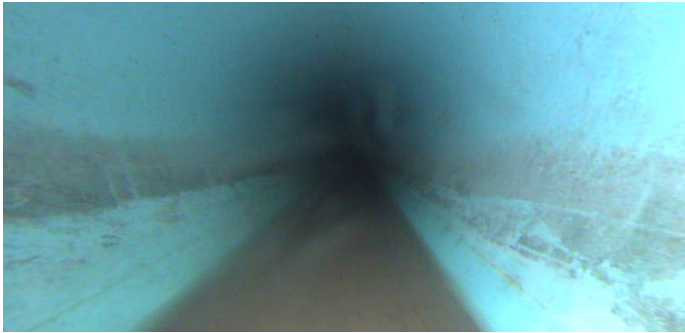
| Code: | MWL |
| Description: | Water Level |

| Distance (ft): | .0 |
| Value Percent: | 5.000 |

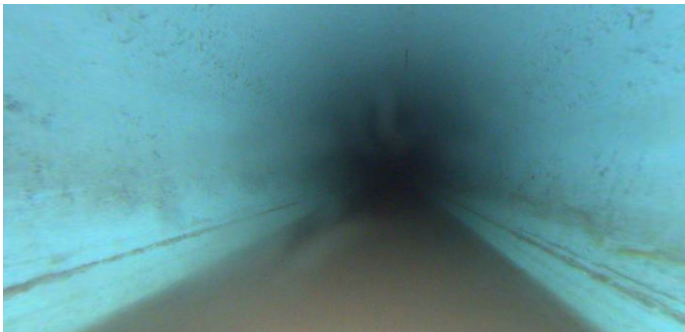
| Code: | MSA |
| Description: | Abandoned Survey |

| Distance (ft): | 10.3 |
| Remarks: | debris under water |
