Profile/Photo Observation Report

Street: South Wisconsin Street Flow Control: Not Controlled

City: Hobart, IN Year Renewed:

US MH: M-608-004 DS MH: M-608-003 Total Length Surveyed (ft): 399.2

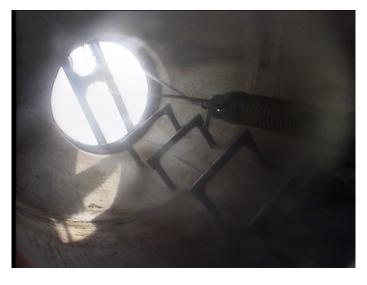
AMH

Description:	Manhole	
Distance (ft):	.0	
Structural Grade:	0	
O&M Grade:	0	
Clock Start/From:		
Clock To:		
1st Value:		
2nd Value:		
Value Percent:		
Continuous Index:		
Within 8" of Joint:	NO	
Remarks:	M-608-003

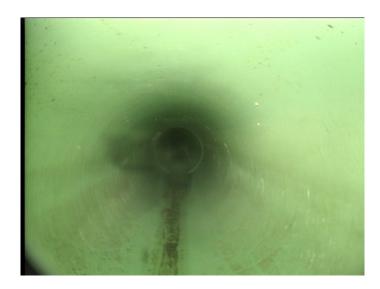
Code: MWL Description: **Water Level**

Distance (ft): .0 Structural Grade: 0 O&M Grade: 0

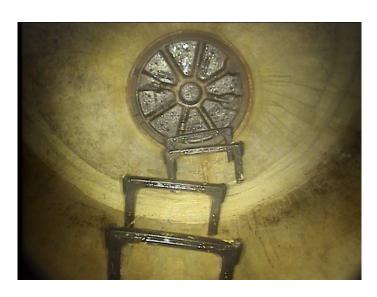
Code: AMH Description: Manhole

Distance (ft): 399.2 Structural Grade: 0 O&M Grade: 0 Clock Start/From:

Remarks: M-608-004
