Profile/Photo Observation Report

Street:	W 61ST AVE	Flow Control:	Not Controlled
City:	Hobart, IN	Year Renewed:	
Location:	Yard	Tape/Media #:	
Purpose:	Routine Assessment	Dia/Height:	8"
Use:	Sanitary	Material:	PVC
Drain Area:	NA	Lining:	
Category:	NA		
Comment:	Flow direction is wrong.

Location Details:		Direction of Survey:	Upstream
US MH:	M-608-005	DS MH:	M-608-010
		Total Length Surveyed (ft):	118.8

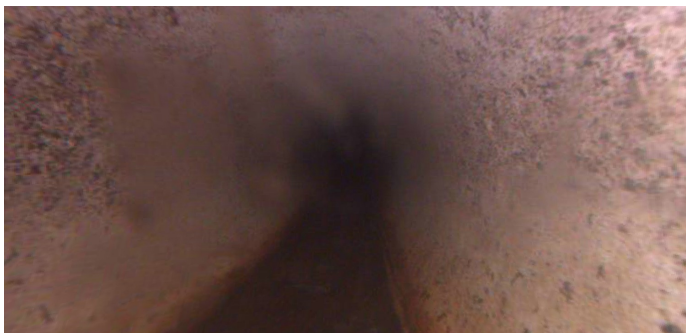
Code: **AMH**
Description: **Manhole**

Distance (ft): **.0**
Structural Grade: **0**
O&M Grade: **0**
Clock Start/From:
Clock To:
1st Value:
2nd Value:
Value Percent:
Continuous Index:
Within 8" of Joint: **NO**
Remarks: **M-608-010**

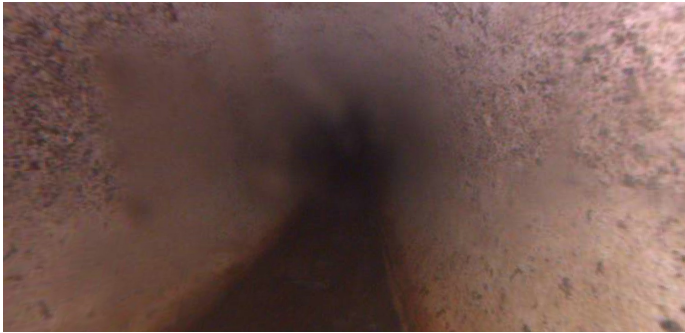
Code:	MWL
Description:	Water Level

Distance (ft):	.0
Structural Grade:	0
O&M Grade:	0
Clock Start/From:	
Clock To:	
1st Value:	
2nd Value:	
Value Percent:	5.000
Continuous Index:	
Within 8" of Joint:	NO
Remarks:

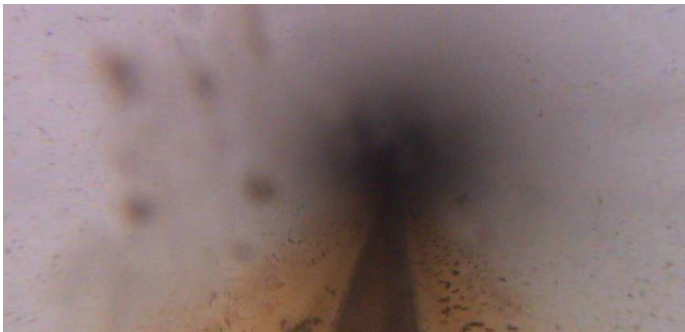
Code:	MSA
Description:	Abandoned Survey

Distance (ft):	118.8
Structural Grade:	0
O&M Grade:	0
Clock Start/From:	
Clock To:	
1st Value:	
2nd Value:	
Value Percent:	
Continuous Index:	
Within 8" of Joint:	NO
Remarks:	debris
