## Profile/Photo Observation Report

Street:	<b>FOXCROFT STREET</b>	Flow Control:	<b>Not Controlled</b>
City:	<b>Hobart, IN</b>	Year Renewed:	
Location:	<b>Yard</b>	Tape/Media #:	
Purpose:	<b>Routine Assessment</b>	Dia/Height:	<b>8"</b>
Use:	<b>Sanitary</b>	Material:	<b>PVC</b>
Drain Area:	<b>NA</b>	Lining:	
Category:	<b>NA</b>		
Comment:	<b>Flow direction is wrong.</b>

Location Details:		Direction of Survey:	<b>Upstream</b>
US MH:	<b>M-608-005</b>	DS MH:	<b>M-608-010</b>
		Total Length Surveyed (ft):	<b>118.8</b>

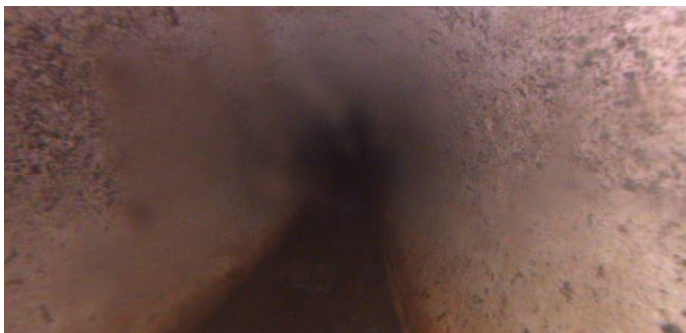
Code: **AMH**  
Description: **Manhole**

Distance (ft): **.0**  
Structural Grade: **0**  
O&M Grade: **0**  
Clock Start/From:  
Clock To:  
1st Value:  
2nd Value:  
Value Percent:  
Continuous Index:  
Within 8" of Joint: **NO**  
Remarks: **M-608-010**

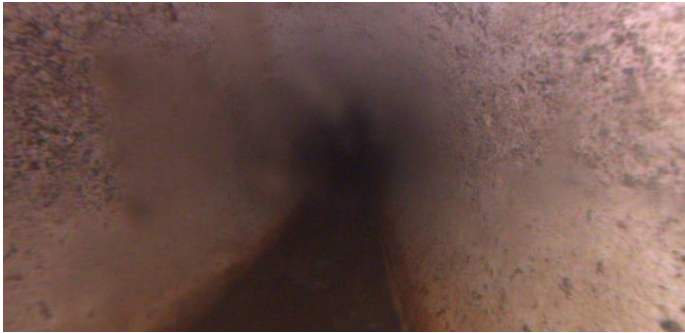
Code:	<b>MWL</b>
Description:	<b>Water Level</b>

Distance (ft):	<b>.0</b>
Structural Grade:	<b>0</b>
O&M Grade:	<b>0</b>
Clock Start/From:	
Clock To:	
1st Value:	
2nd Value:	
Value Percent:	<b>5.000</b>
Continuous Index:	
Within 8" of Joint:	<b>NO</b>
Remarks:

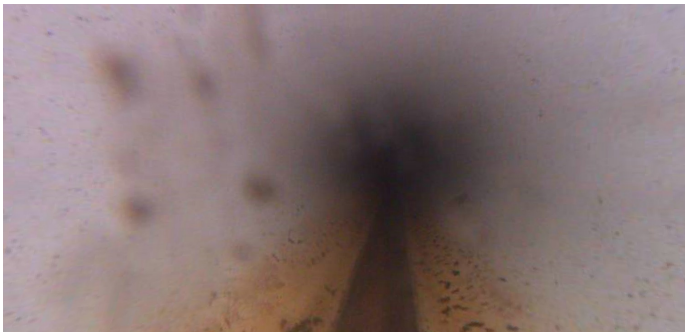
Code:	<b>MSA</b>
Description:	<b>Abandoned Survey</b>

Distance (ft):	<b>118.8</b>
Structural Grade:	<b>0</b>
O&M Grade:	<b>0</b>
Clock Start/From:	
Clock To:	
1st Value:	
2nd Value:	
Value Percent:	
Continuous Index:	
Within 8" of Joint:	<b>NO</b>
Remarks:	<b>debris</b>
